Project Name
192 Hawthorn Road_Bognor Regis_PO21_2UX

Project Date
01/06/2023

Section Pictures - 01/06/2023 - L1 FWGX

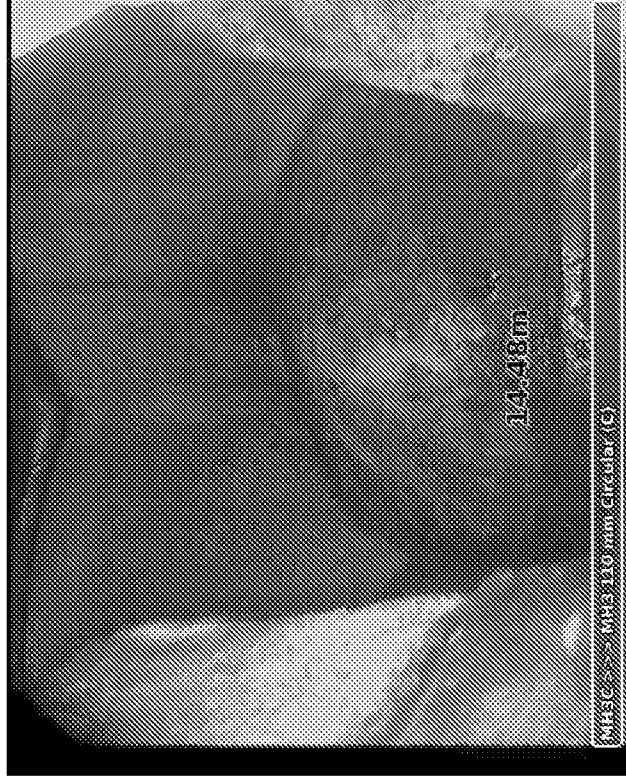
Town or Village:	Bognor Regis	Inspection Direction:	Downstream	Upstream Node:	MH3C
Road:	192 Hawthorn Road	Inspected Length:	14.48 m	Upstream Pipe Depth:	0.230 m
Location:	Other(state in comments)	Total Length:	14.48 m	Downstream Node:	MH3
Surface Type:		Joint Length:		Downstream Pipe Depth:	0.000 m
Use:	Combined	Pipe Shape:	Circular		
Type of Pipe:	Gravity drain/sewer	Dia/Height:	110 mm		
Flow Control:	Other (state in remarks)	Pipe Material:	Polyvinyl chloride		
Year Constructed:	1900	Lining Type:	No Lining		
Inspection Purpose:	Sample survey to determine asset condition		Lining Material:	No Lining	
Comments:	MH3 Buried - Scale and fouling deposits noted in line. Possibly due to poor gradient fall?				
Recommendations:	Jet/Picote clean & Re Survey to show the true condition

Construction Features					Miscellaneous Features				
Structural Defects					Service & Operational Observations				
STR No. Def	STR Peak	STR Mean	STR Total	STR Grade	SER No. Def	SER Peak	SER Mean	SER Total	SER Grade
0	0.0	0.0	0.0	1.0	2	3.0	2.7	39.0	4.0

MH3CX_ b4abe6b0-a93a-4149-9b1a-79f2151d9ded_20230614_095409_114.jpg, 00:02:08, 13.53 m
Loss of vision, camera under water

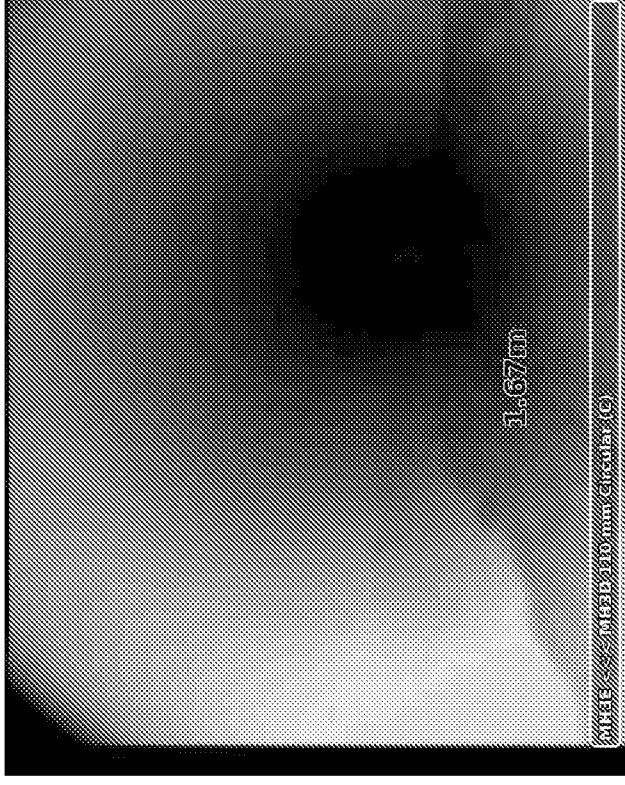
Town or Village:	Bognor Regis	Inspection Direction:	Upstream	Upstream Node:	MH3D
Road:	192 Hawthorn Road	Inspected Length:	3.04 m	Upstream Pipe Depth:	0.000 m
Location:	Other(state in comments)	Total Length:	3.04 m	Downstream Node:	MH3E
Surface Type:		Joint Length:		Downstream Pipe Depth:	0.230 m
Use:	Foul	Pipe Shape:	Circular		
Type of Pipe:	Gravity drain/sewer	Dia/Height:	110 mm		
Flow Control:	Other (state in remarks)	Pipe Material:	Polyvinyl chloride		
Year Constructed:	1900	Lining Type:	No Lining		
Inspection Purpose:	Sample survey to determine asset condition	Lining Material:	No Lining		
Comments:	Unable to open MH3D due to screws being seized - Hole noted @ 1 o'clock				
Recommendations:	Drill out screws to allow access / Install 1x 100mm Patch Liner to seal broken pipe

Construction Features					Miscellaneous Features				
Structural Defects					Service & Operational Observations				
STR No. Def	STR Peak	STR Mean	STR Total	STR Grade	SER No. Def	SER Peak	SER Mean	SER Total	SER Grade
1	80.0	26.3	80.0	4.0	1	1.0	1.3	4.0	3.0

MH3DX_12079f60-eeef-47b3-9e33-27eedd567b02_20230615_143944_949.jpg, 00:00:03, 0.20 m
Hole in drain or sewer at 1 o'clock
