Section Pictures - 01/06/2023 - MH3EX

Project Name	Date	Time	Camera	Vehicle	Operator	Client's Job Ref	Contractor's Job Ref	Item No.
192HawthornRoad_BognorRegis_PO21_2UX	01/06/2023	07:24	Push cam	Van pack	LEWIS	01		16

Section Inspection - 01/06/2023 - L11X

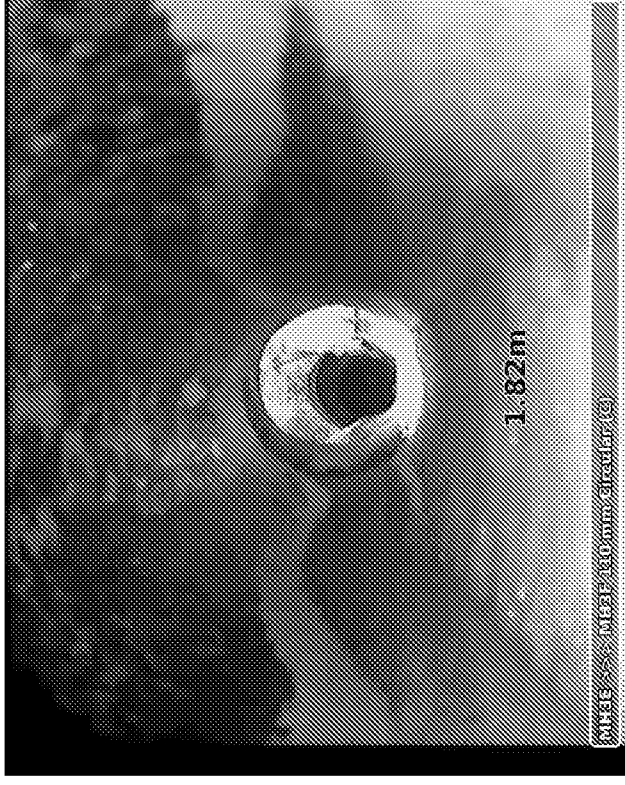
MH3EX_edcdc153-664b-46c4-86db-154381696d09_20230614_100004_480.jpg, 00:00:17, 1.82 m
General photograph taken at this point

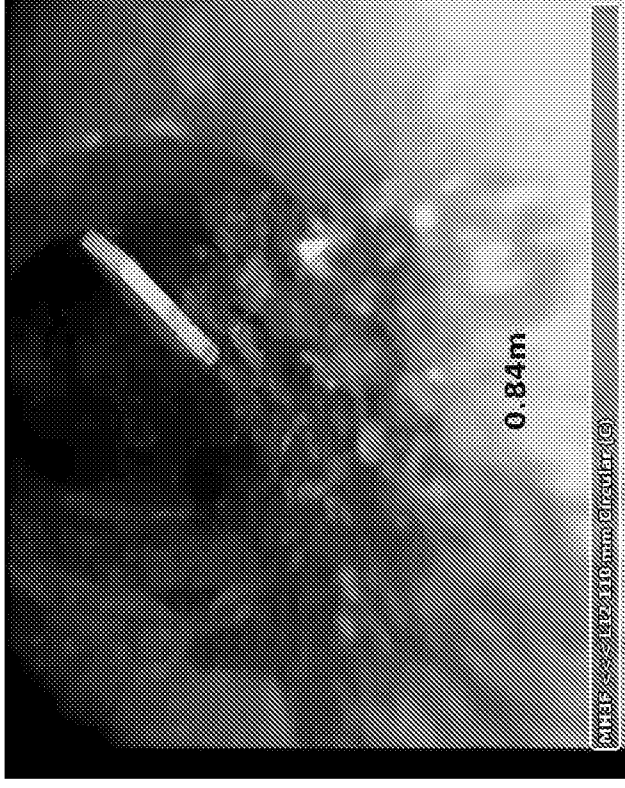
L12X_13347527-c20e-4f1c-813b-bf377eada74b_20230614_10
0903_100.jpg, 00:00:07, 0.84 m
General photograph taken at this point

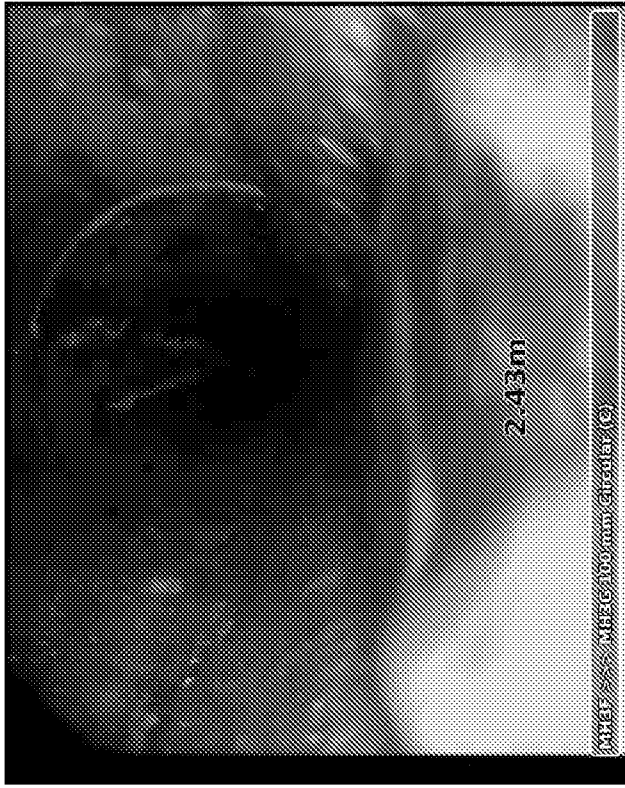
MH3FX_f4941aac-d2ab-4c48-b4bf-7ac05d75eb85_20230614_1
01324_465.jpg, 00:00:51, 2.43 m
Water level, 20% of the vertical dimension

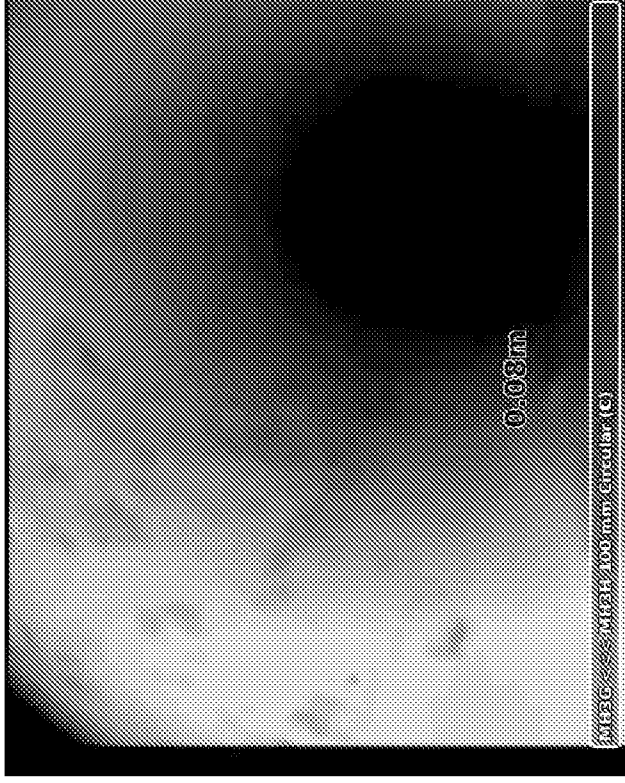
MH3HX_9a84b0c1-91a4-4af4-933a-175c8ca574cc_20230614_101507_126.jpg, 00:00:01, 0.04 m
Material changes to polyvinyl chloride

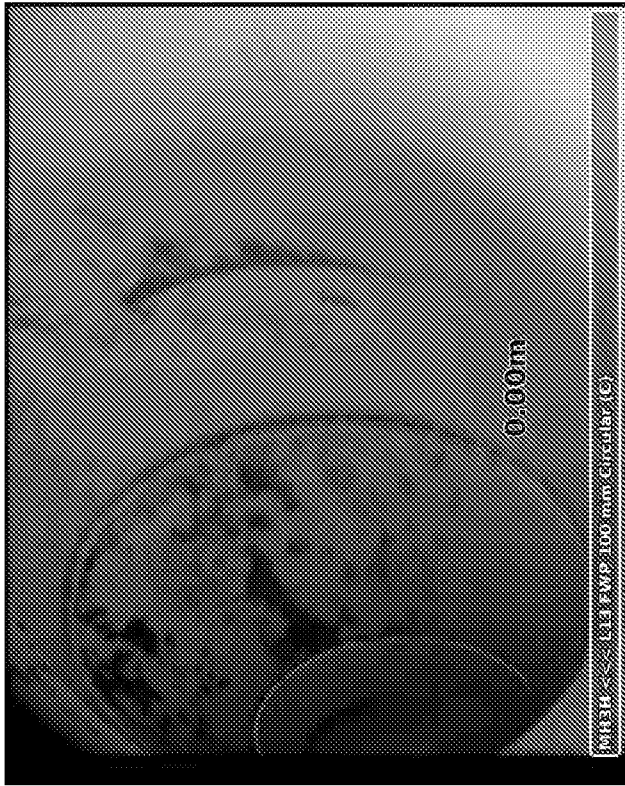
20230601-074514-snap0001.jpg, 00:00:11, 0.00 m
General photograph taken at this point

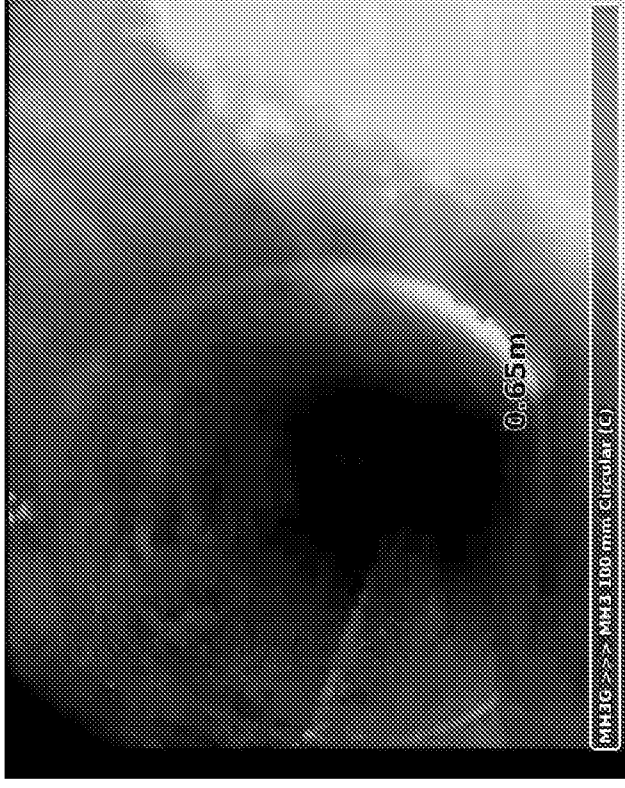
MH3GX_3c7bc5db-d2f4-4fc8-8ae7-f794c5c5c623_20230614_1
01930_203.jpg, 00:00:12, 0.65 m
Water level, 10% of the vertical dimension

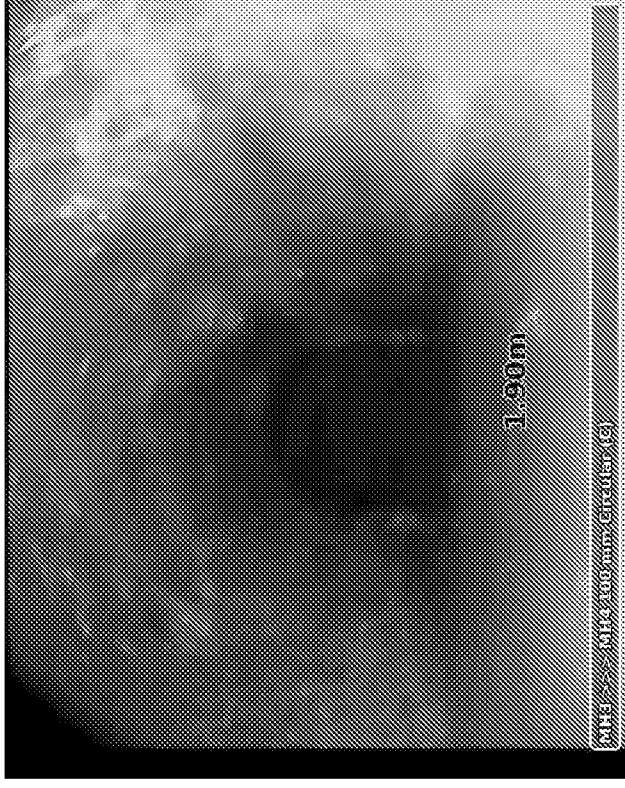
MH3X_c82d175f-90ef-4a86-b861-dc71ca4787b6_20230614_10
2256_091.jpg, 00:00:23, 1.90 m
Water level, 20% of the vertical dimension
