**Project Name:** 63 Annandale Avenue PO21 2ET  
**Project Description:** General CCTV - Condition Check  
**Project Number:** JSD9596  
**Project Status:** Complete  
**Project Date:** 09/03/2026  
**Inspection Standard:** MSCC4 Sewers & Drainage GB (SRM4 Scoring)

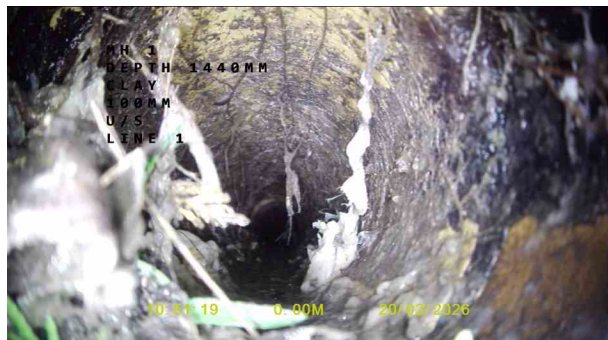
UNKNOWNX\_3b2c1061-6c95-4655-96e3-44802cee786f\_202  
60309\_150213\_458.jpg, 00:00:09, 0.00 m  
Start node, manhole, reference: MANHOLE 1 (MH1)

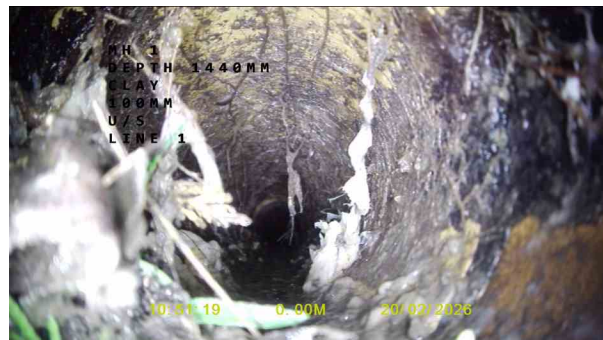
UNKNOWNX\_45a1e1be-29f3-454e-84f0-9b7c49525b5a\_202  
60309\_150219\_777.jpg, 00:00:09, 0.00 m  
Water level, 0% of the vertical dimension

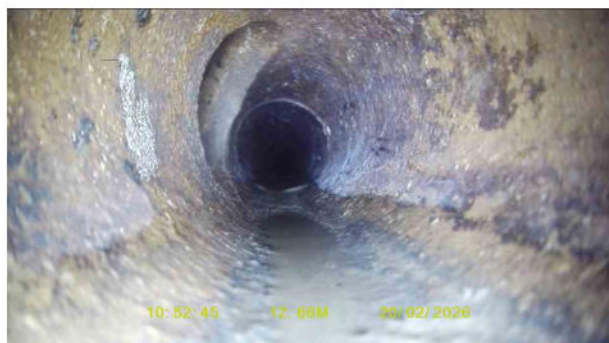
UNKNOWNX\_2e3493d6-f1b9-4e51-ab53-bfb978736c69\_20260309\_150812\_778.jpg, 00:01:35, 12.66 m  
Junction at 9 o'clock, diameter: 100mm

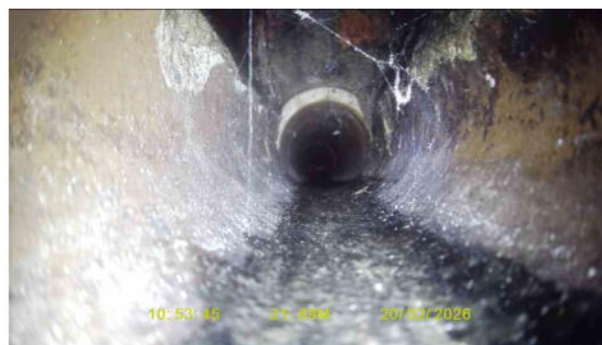
UNKNOWNX\_93352ea6-d9c8-4492-ad93-76e1ca90c16c\_20260309\_150944\_449.jpg, 00:02:35, 21.69 m  
General remark, \*\*ENTERS BURIED MANHOLE\*\*

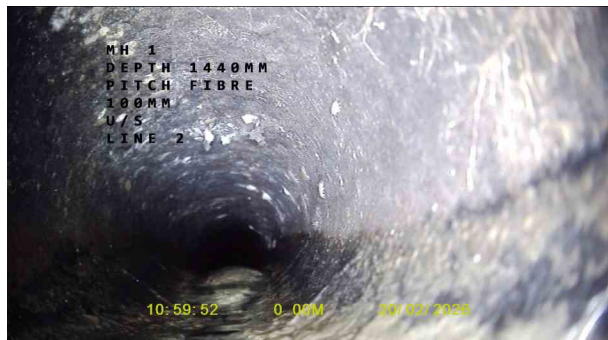
NEIGH  
MHX\_12957fd7-d5b7-4a95-a9a2-5440e2683dfa\_20260309\_1  
51253\_204.jpg, 00:00:07, 0.00 m  
Start node, manhole, reference: MANHOLE 1 (MH1)

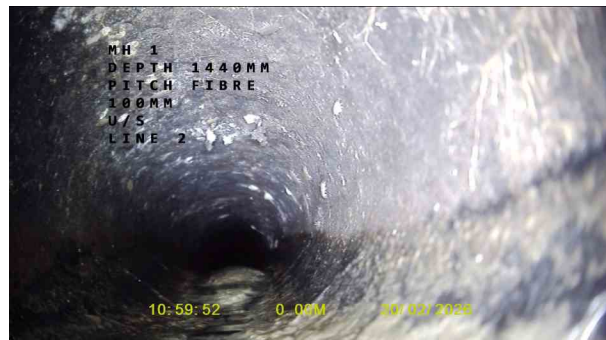
NEIGH  
MHX\_e6d13b93-f12c-4e34-b2fd-53931f37d549\_20260309\_15  
1300\_537.jpg, 00:00:07, 0.00 m  
Water level, 0% of the vertical dimension

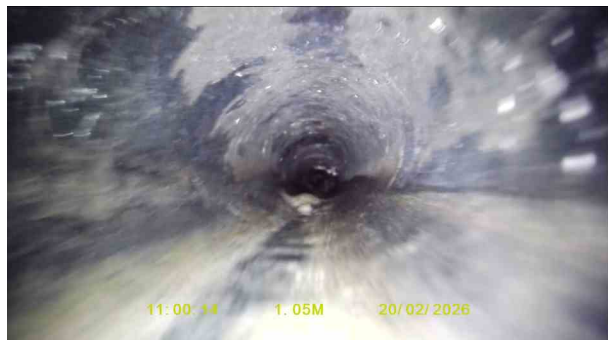
NEIGH  
MHX\_ac232ef7-f446-47b7-ab60-7a0adf0db53f\_20260309\_15  
1407\_697.jpg, 00:00:28, 1.00 m  
General remark, **\*\*BOUNDARY POINT\*\***

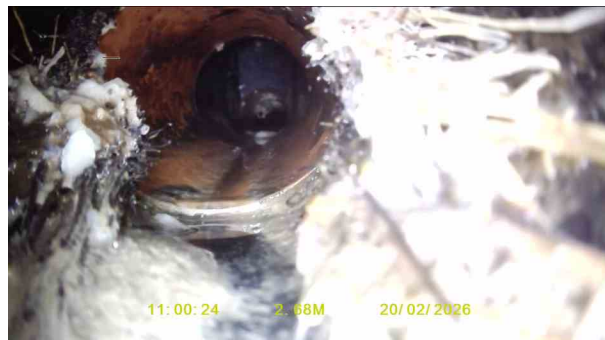
NEIGH  
MHX\_98e14b0c-5078-47af-9d1d-c4fecb05a7b2\_20260309\_1  
51545\_215.jpg, 00:00:38, 2.68 m  
Material changes to polyvinyl chloride

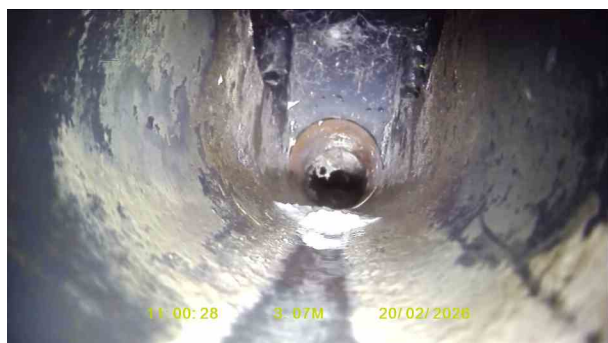
NEIGH  
MHX\_c82c0c81-083f-4f50-9db9-eb937cbde540\_20260309\_15  
1618\_648.jpg, 00:00:42, 3.07 m  
Finish node, manhole, reference: ENTERS MANHOLE IN THE  
NEIGHBOURING PROPERTY

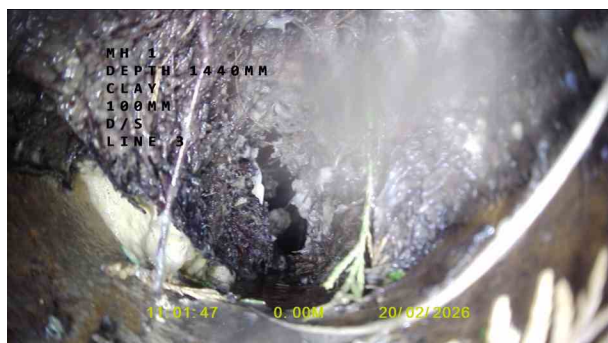
MH1X\_adaec02f-18b5-4ac4-94d2-7f08acbe9c62\_20260309\_1  
51823\_216.jpg, 00:00:07, 0.00 m  
Start node, manhole, reference: MANHOLE 1 (MH1)

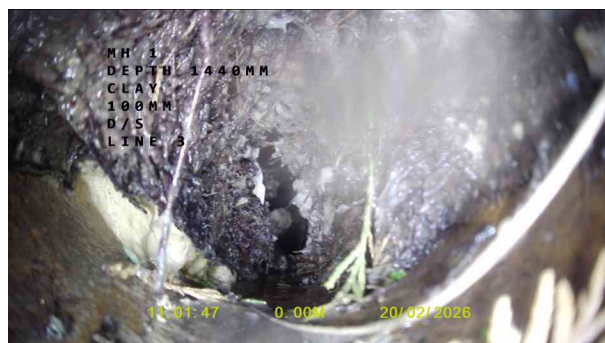
MH1X\_0e4f395e-c661-44f3-bef8-d5092db76894\_20260309\_1  
51829\_347.jpg, 00:00:07, 0.00 m  
Water level, 0% of the vertical dimension

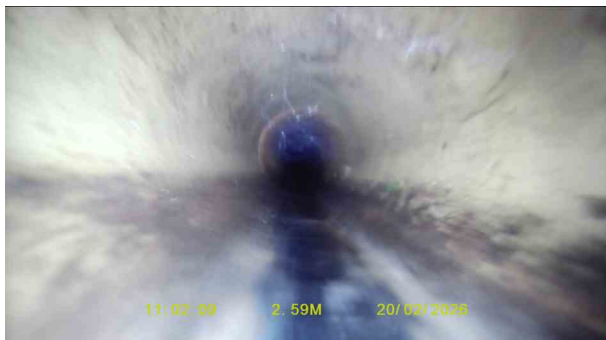
MH1X\_6f65906a-06d3-45d4-b19d-5ec31823dcc2\_20260309\_152124\_095.jpg, 00:00:29, 2.59 m  
General remark, **\*\*BOUNDARY POINT\*\***

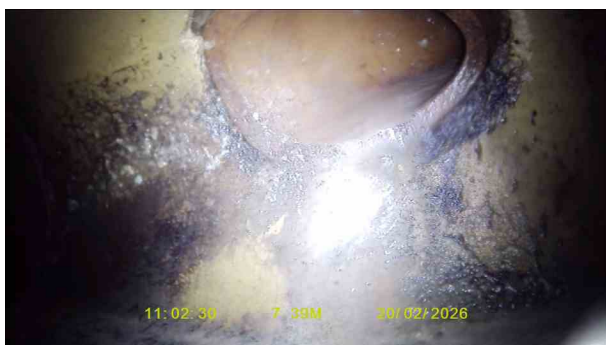
MH1X\_0cc10ae4-ed45-402d-be3a-c95dfc9df374\_20260309\_152253\_760.jpg, 00:00:51, 7.39 m  
Finish node, manhole, reference: MAIN SEWER
