# **Proposed Development Durban Road, Bognor Regis**

## **Stage 1 Road Safety Audit**

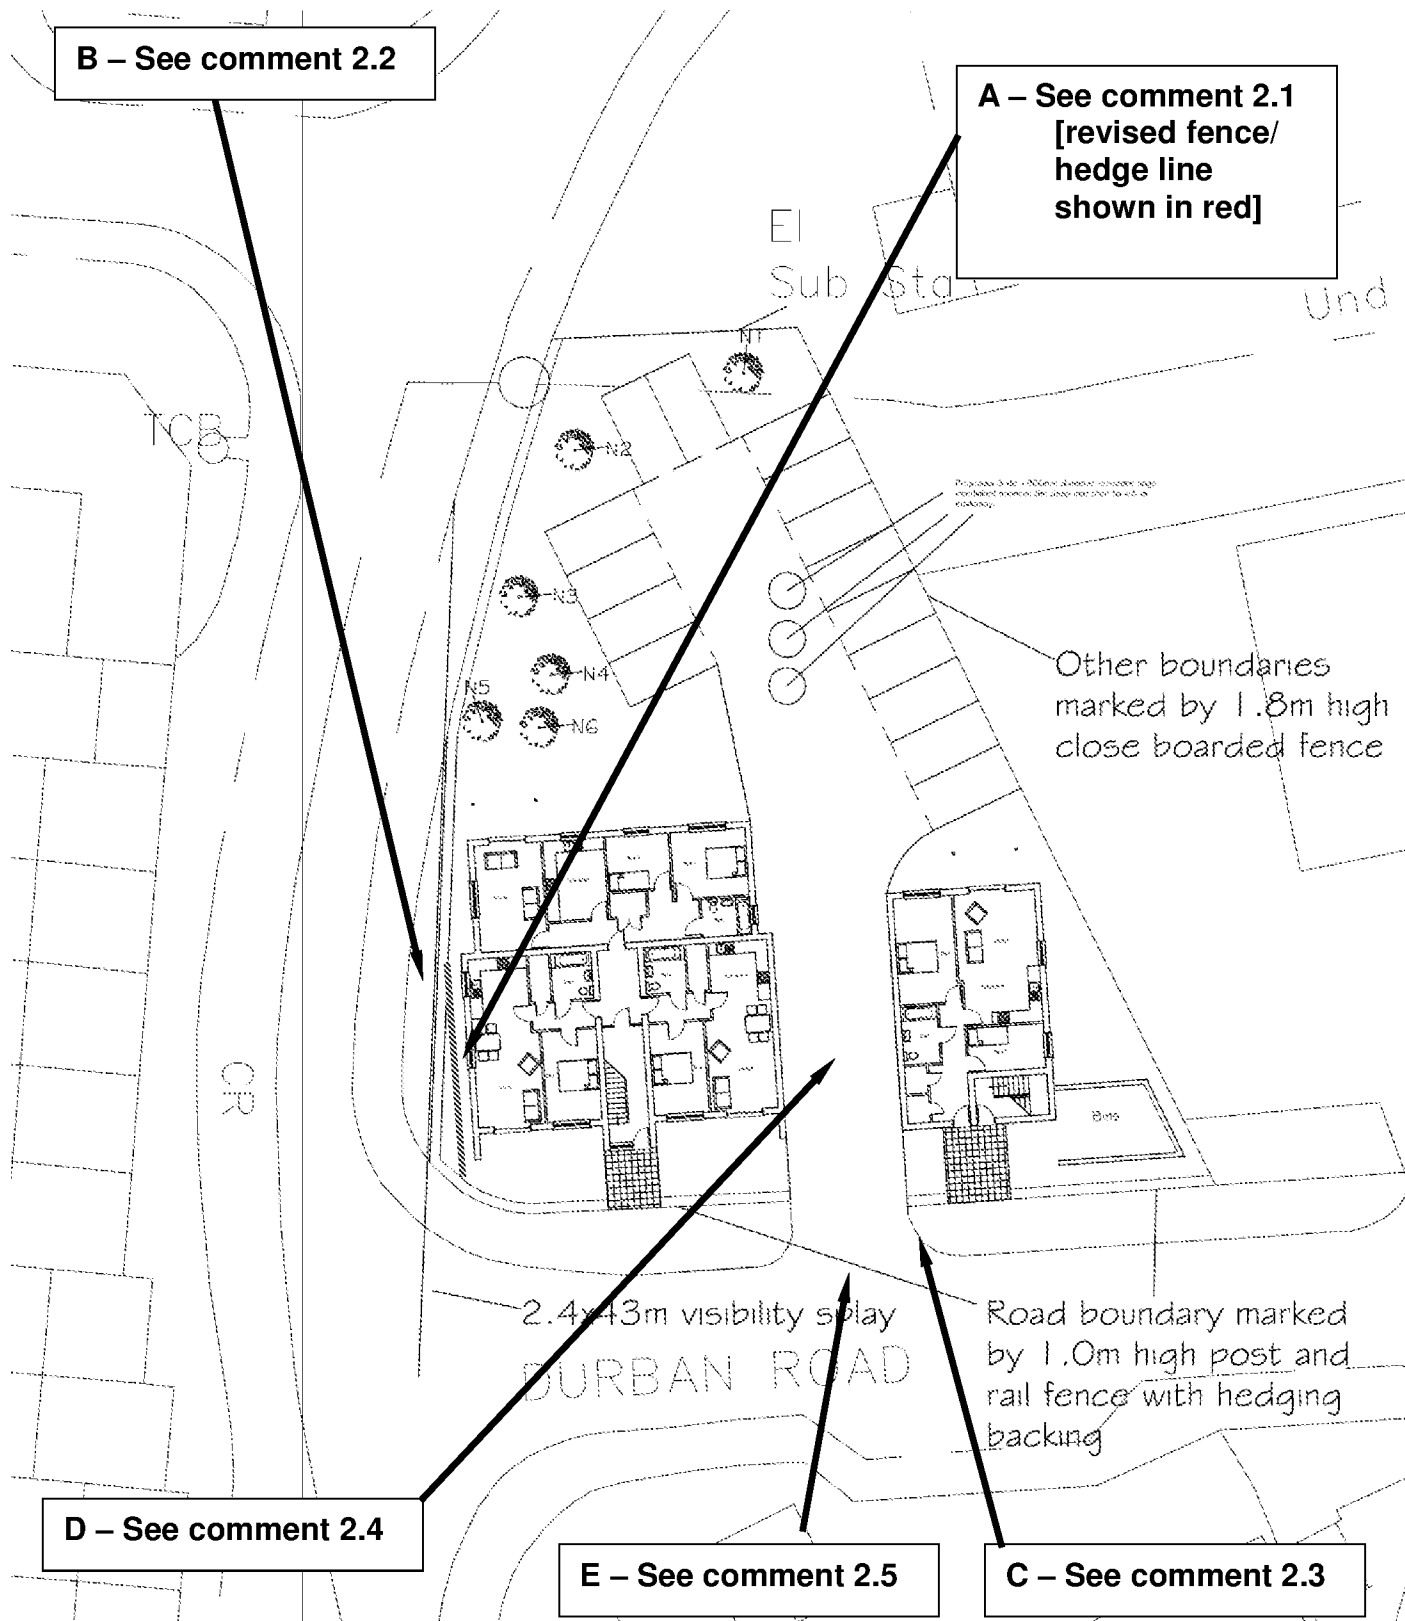
## Appendix C: Location Reference Plan

Summary: Trip hazard for pedestrians by site entrance.

Detail: The development access proposes to utilise the existing access but the proposals indicate no change to the access. There is currently a partial kerb face which creates a trip hazard for pedestrians.

RECOMMENDATION: The proposed fence and hedge line be set back to the same minimum gap to the building as the north west corner (highlighted in red on location plan in Appendix C).

RECOMMENDATION: Reconstruct entrance to remove trip hazard for pedestrians.
