## STRUCTURAL INSPECTION

Serpentine Wall

University of Chichester  
Bognor Regis Campus  
Upper Bognor Road  
Bognor Regis  
West Sussex  
PO21 1HR

December 2021

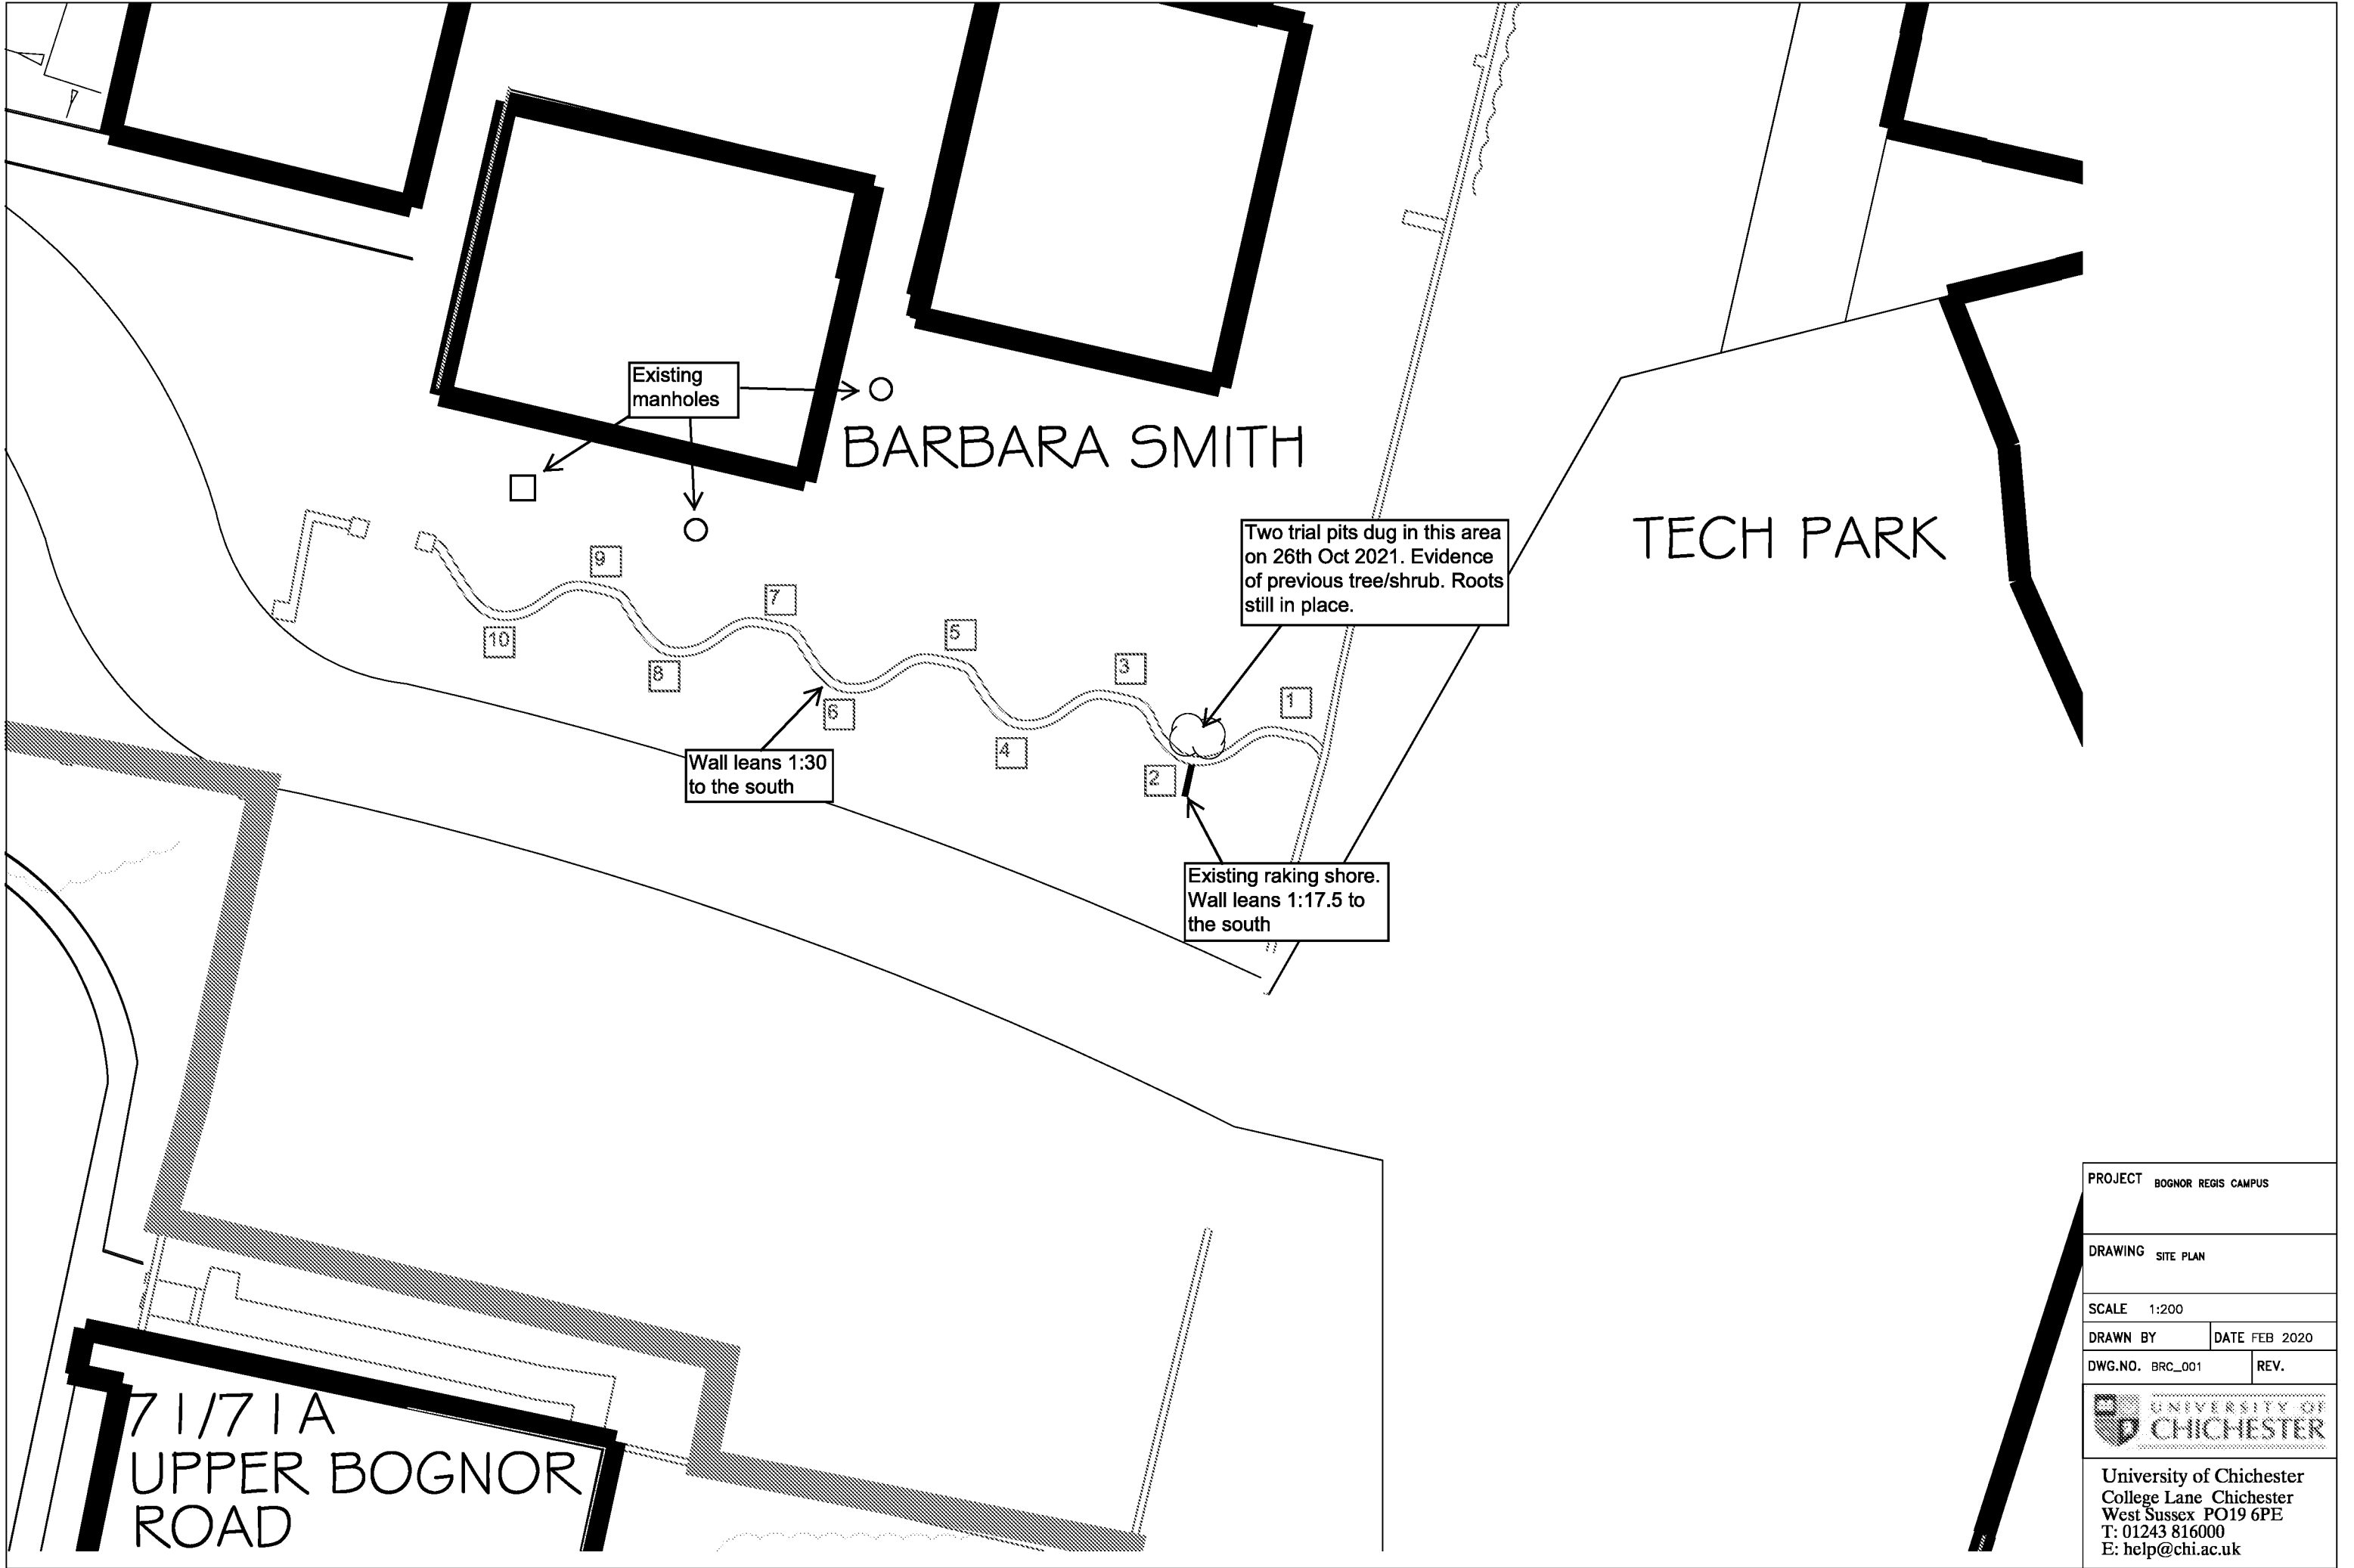
Site Plan

- 3.1 The wall is formed in red bricks in a rat trap bond of 225mm thickness and approximately 2400mm height. It is estimated that the wall is at least 150 years old. The wall derives its strength by virtue of its curved plan form and for the most part it retains good verticality and stability. This can be directly compared with the nearby much longer straight runs of wall of the same proportions which have been extensively shored. The wall has been split into 10 sections for ease of discussion, identified on the site plan in Appendix A.

- 3.7 There are two manholes approximately 4m to the north of the wall as noted on the site plan in Appendix A. These are assumed to be part of a drainage system that serves the nearby 'Barbara Smith' building. It would be prudent to commission a CCTV survey of the drain runs in this area to exclude any influence of defective drains on the wall.
