Julian Munn Drainage Services Ltd

Manhole Cards

Address: The Old Butcher Flat,
Climping Street, BN17 5RQ

Job No.S1423/07/25

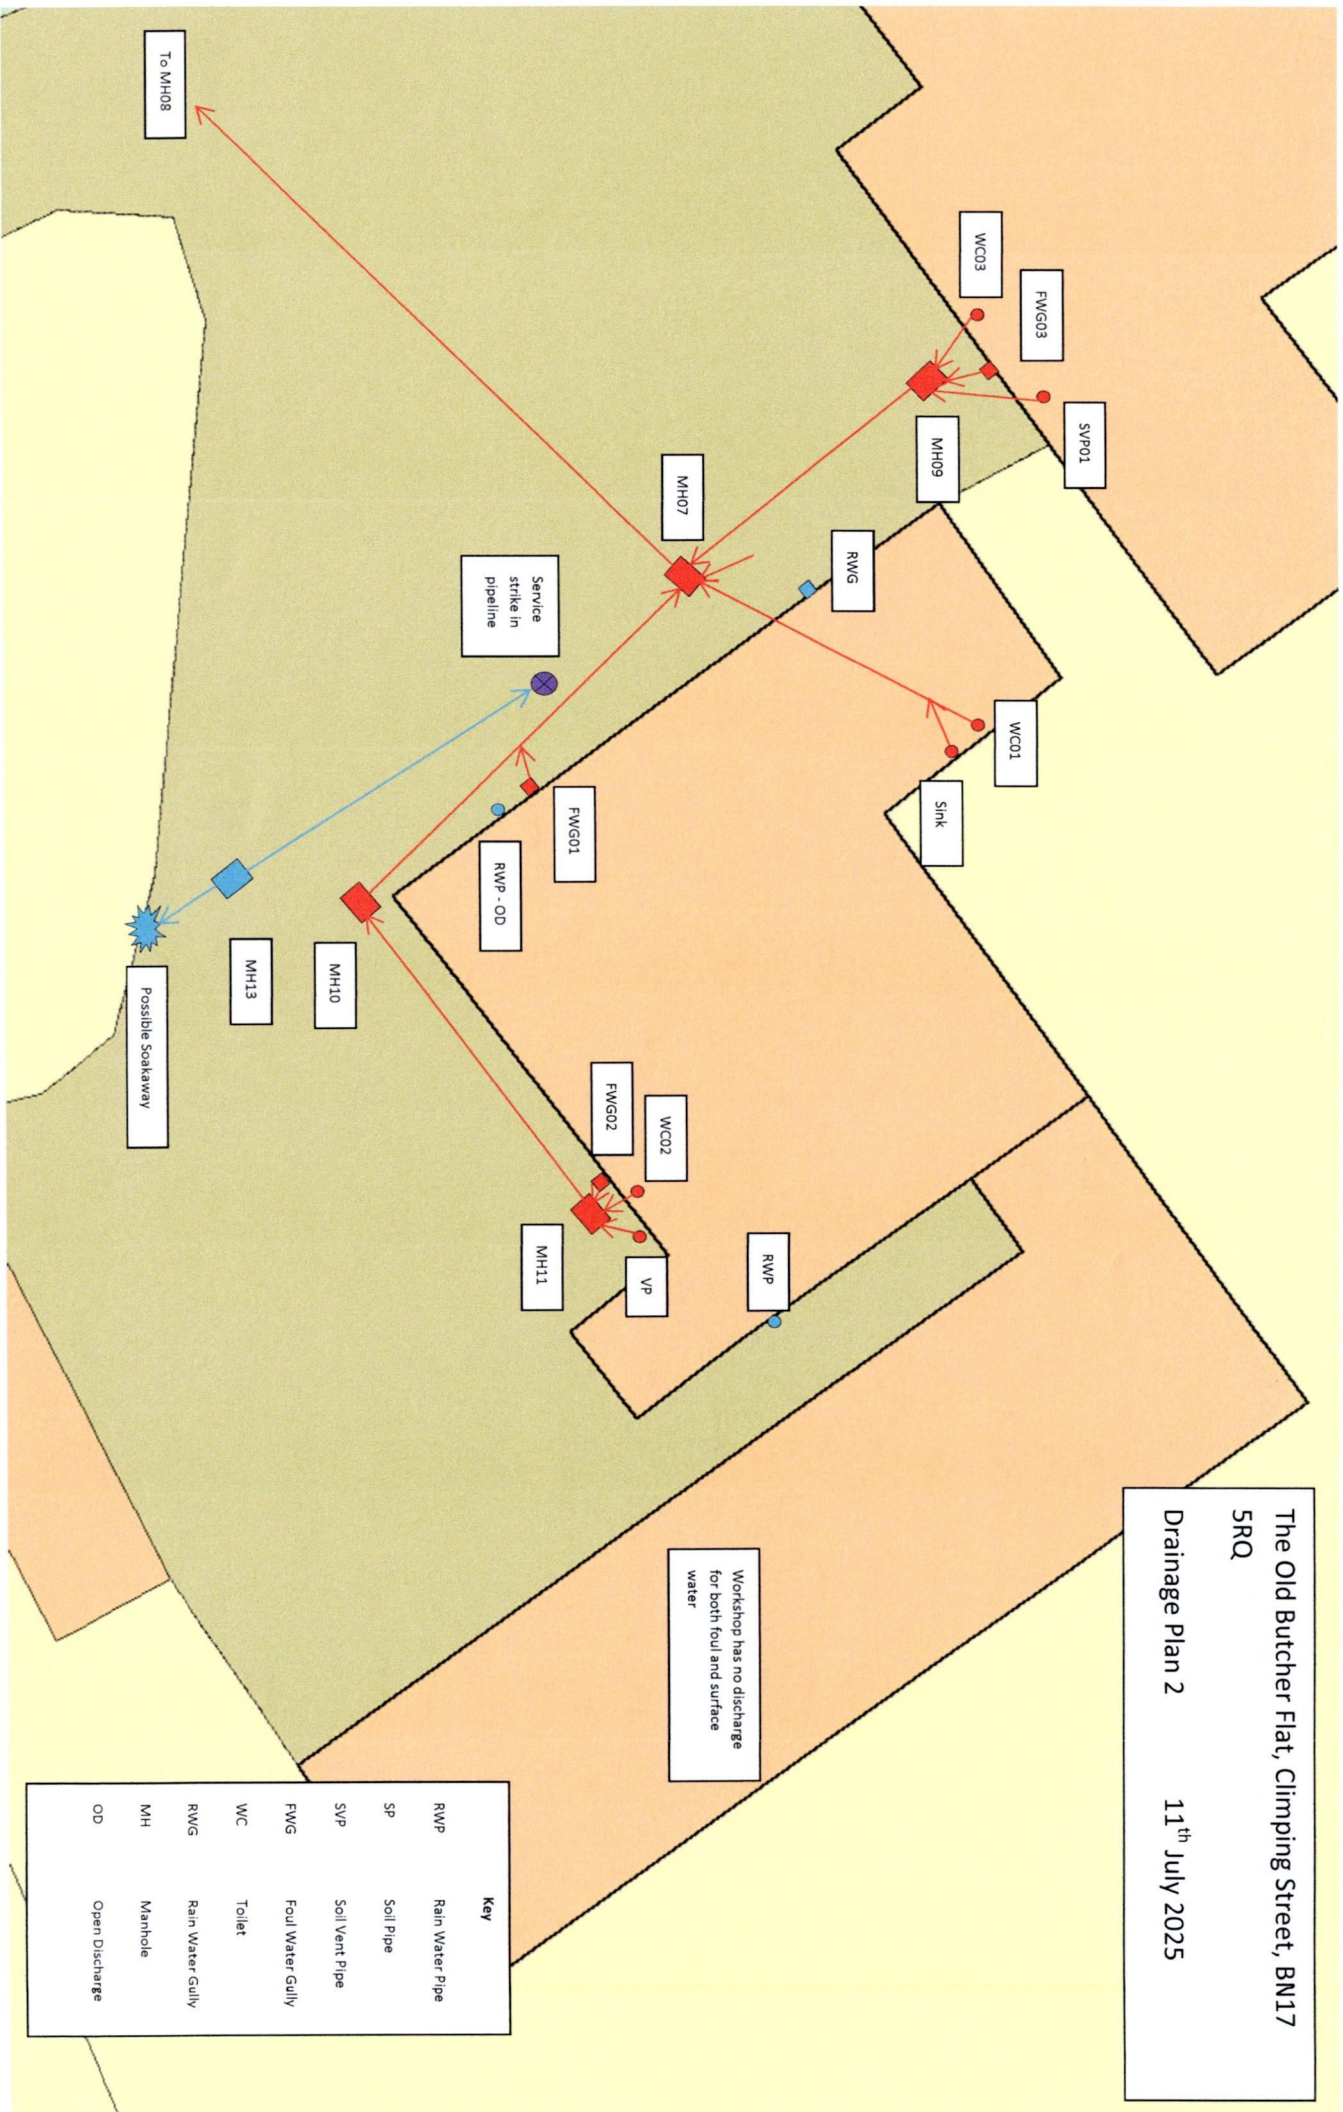
Drainage Plan 2 11th July 2025

Survey 01 – MH07 to Pipe X (MH08) – Heavy encrustation noted at joint causing poor flow. We would recommend extensive descaling to return a free flowing condition. For the sum of £420.00 plus VAT.

Survey 05 – MH07 to Pipe D (MH10) – Multiple fractures in pipeware noted. We would recommend the installation of CIPP patch liner repairs to return a watertight and free flowing condition. For the sum of £1230.00 plus VAT.

Survey 08 – MH11 to Pipe B (WC02) – Open joint observed. We would recommend the installation of a CIPP patch liner repair to return a watertight and free flowing condition. For the Sum of £310.00 plus VAT.

MH10 – Broken manhole cover – We would recommend replacing the cover and frame. For the sum of £320.00 plus VAT.

MH13 – Broken manhole cover – We would recommend replacing the cover and frame. For the sum of £390.00 plus VAT.
