## **PHOTOGRAPHIC APPENDICES I**

**Climping Mill, Littlehampton**  
**External**

DGC (Historic Buildings) Consultants  
Limited

REF: DGC21732  
Date of Issue: 15/08/2017  
Web: [www.dgc-consultants.com](http://www.dgc-consultants.com)

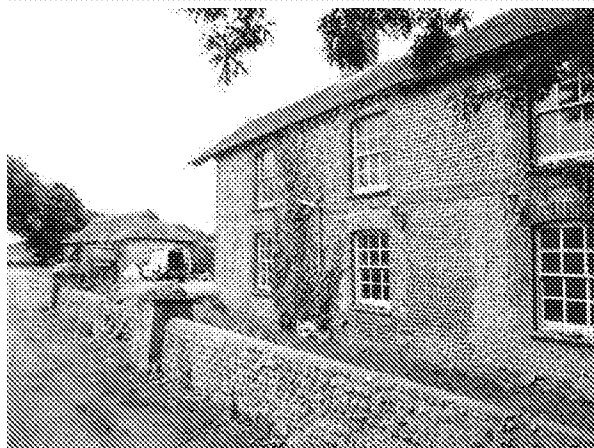
DSC02716 Garden wall to East Elevation

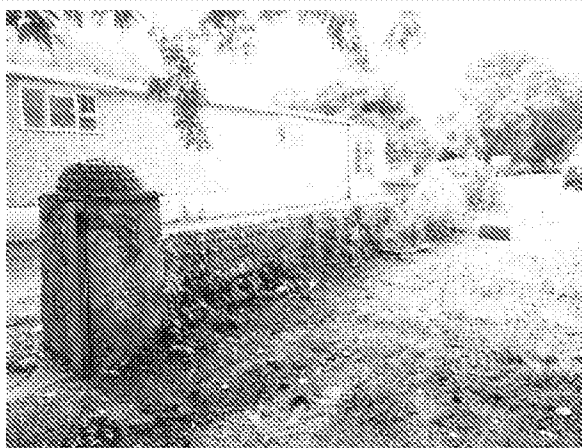
DSC02715 Inner face of garden wall

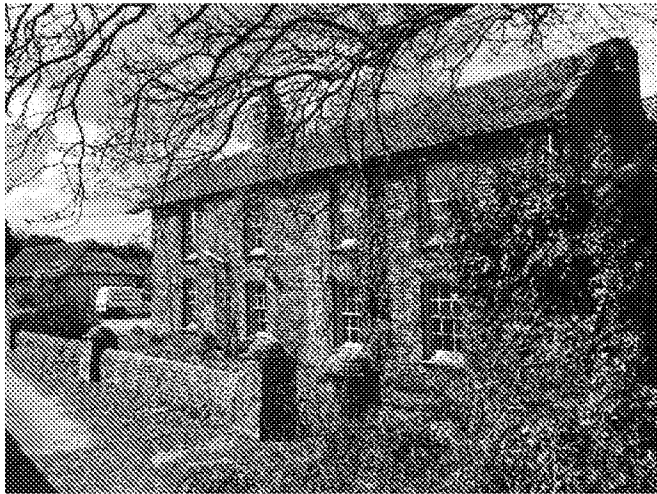
2017-04-26 11.48.49 East / Principal Façade

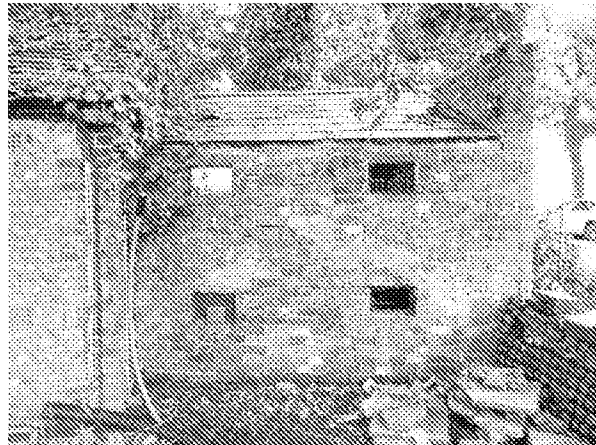
DSC02711 South Elevation of External Store (OB01)

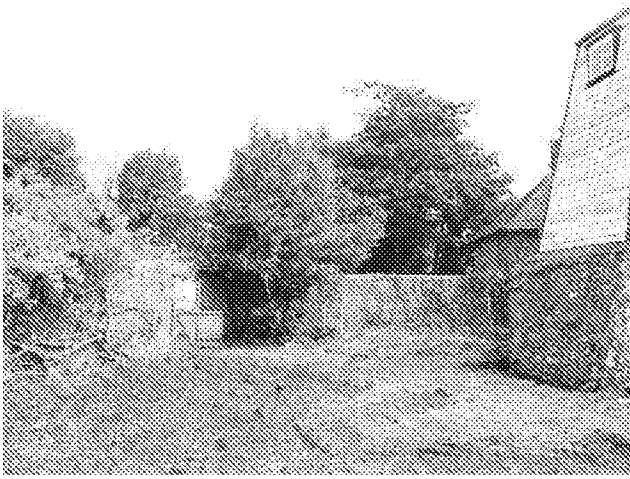
DSC02726 Internal view looking North
