**PHOTOGRAPHIC APPENDICES I**

**Climping Mill, Littlehampton**  
**External**

REF: DGC21732

Date of Issue: 15/08/2017

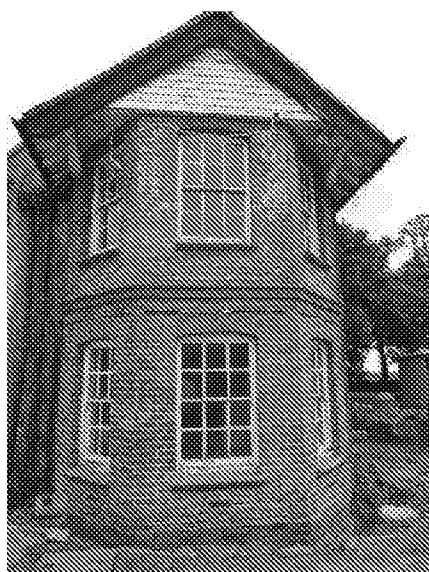
DSC03143 Double Height Canted Bay

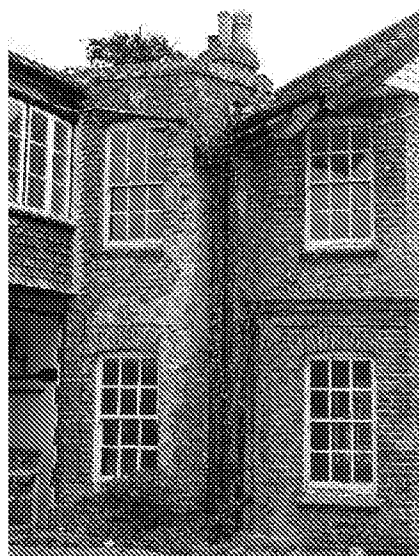
DSC03143 Parapet Gable

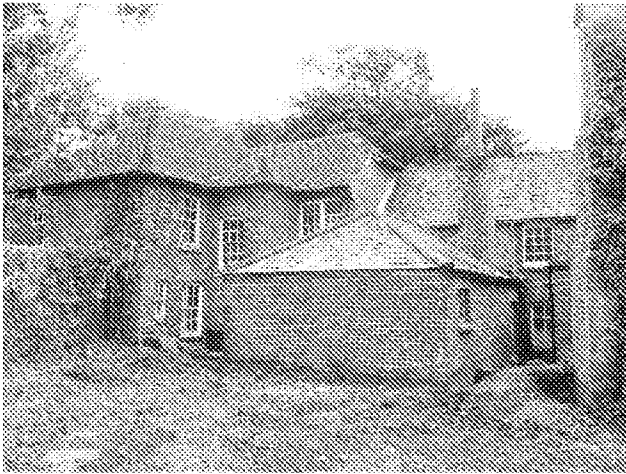
DSC02734 General view of extensions to Mill House

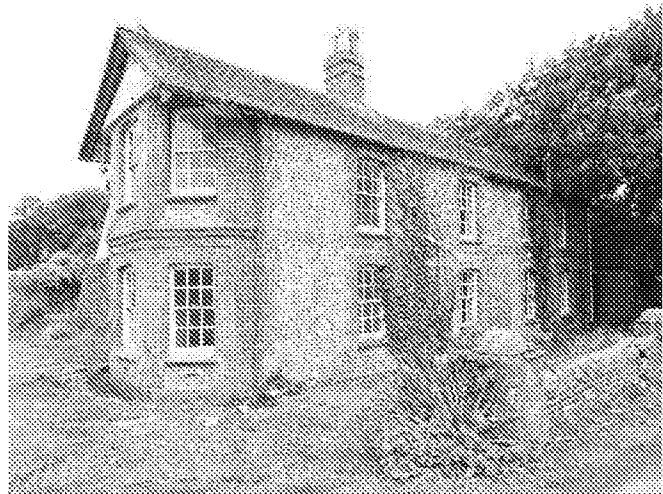
DSC02718 East & South Elevations, view looking North West

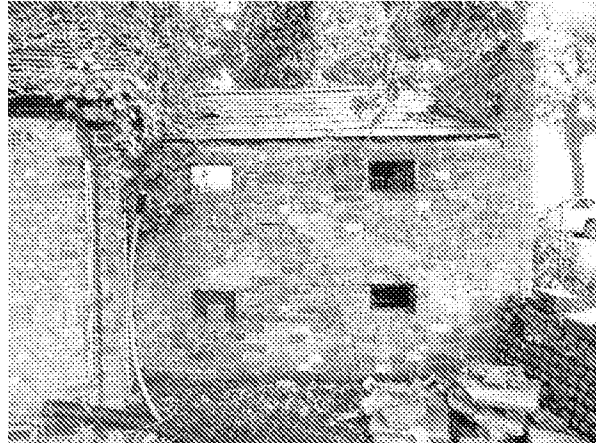
DSC02711 South Elevation of External Store (OB01)

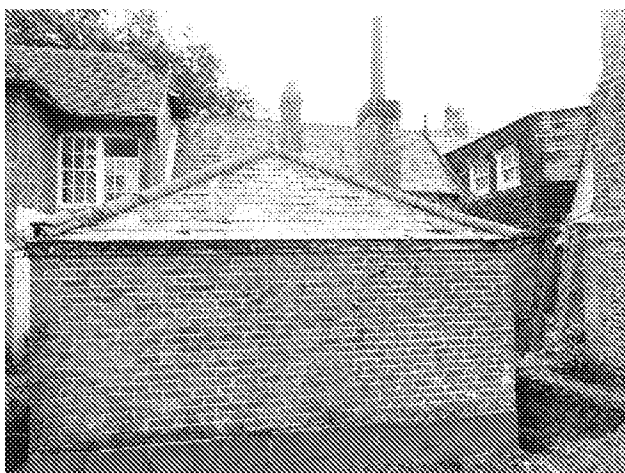
DSC02699 West Elevation
