## Appendix H Ultraflow Drainage Investigation Results

| Project name:<br><b>Church Lane Investigation</b> | Contract number:<br><b>163806AN</b> | Contact:<br><b>Katherine Richards</b> | Date:<br><b>25/08/2020</b> |

## Inspection report

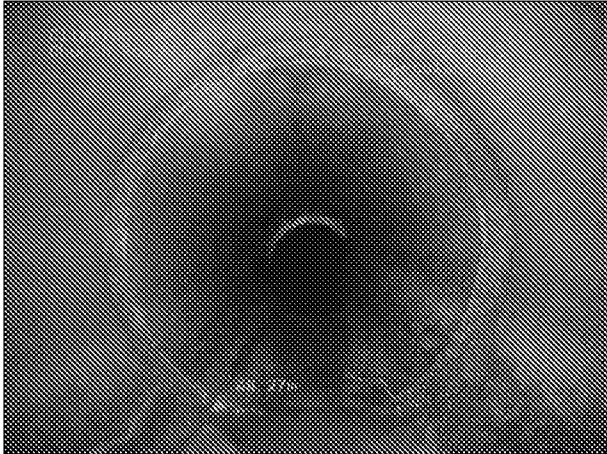
Photo: 27\_14a  
48.27m, Roots tap at joint

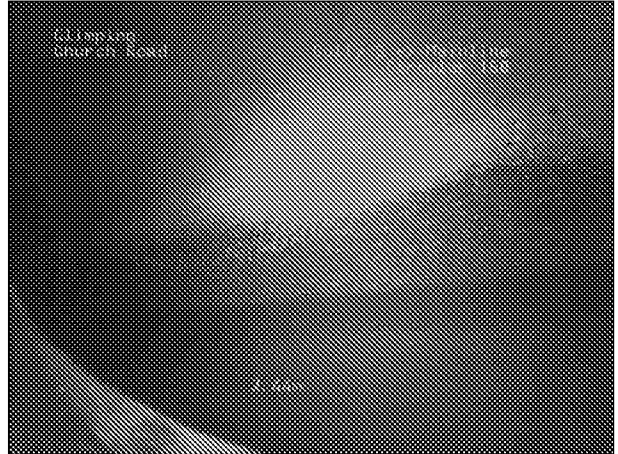
Photo: 54\_3a  
2.44m, Major connection without manhole

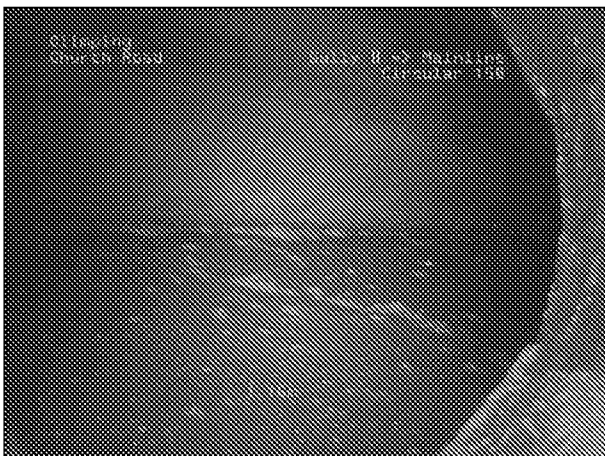
Photo: 91\_4a  
1.15m, Major connection without manhole

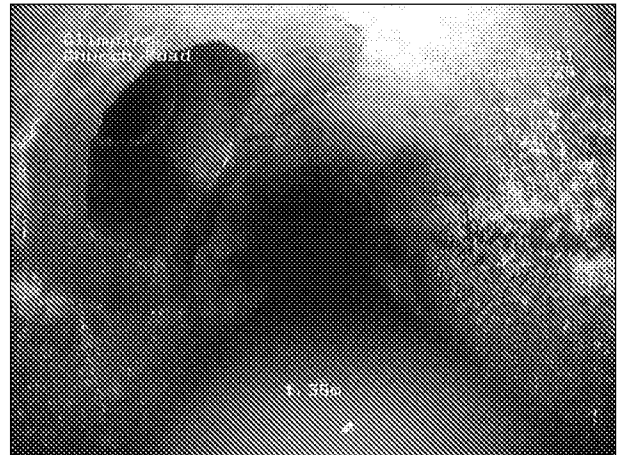
Photo: 118\_3a  
1.35m, Junction at 10 o'clock dia 150 mm

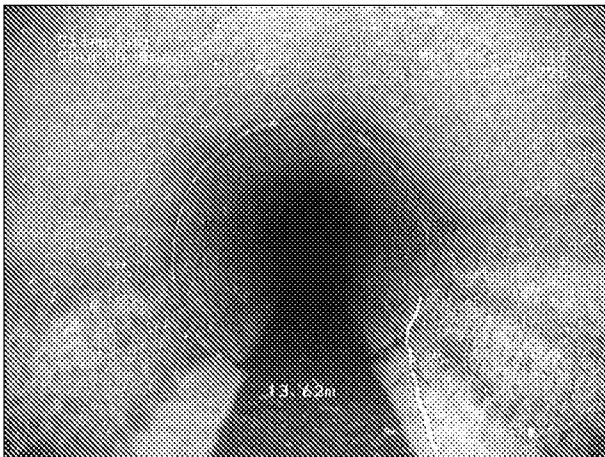
Photo: 120\_5a  
13.62m, Roots tap at joint

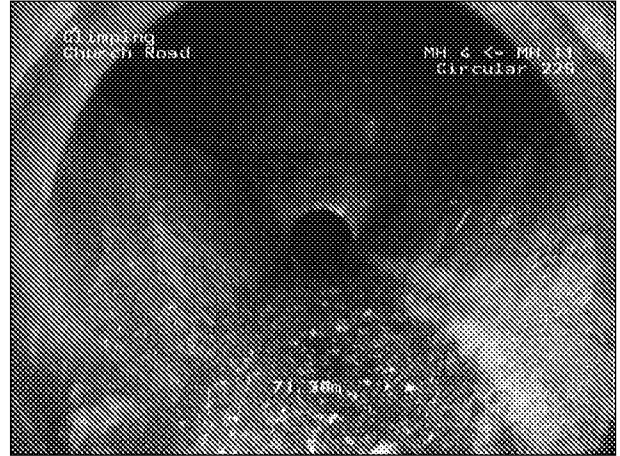
Photo: 129\_14a  
71.3m, Finish node type, manhole, reference number: MH 11
