## PHOTOGRAPHIC APPENDICES I

**Climping Mill, Littlehampton**  
**External**

DGC (Historic Buildings) Consultants  
Limited

REF: DGC21732 Rev A

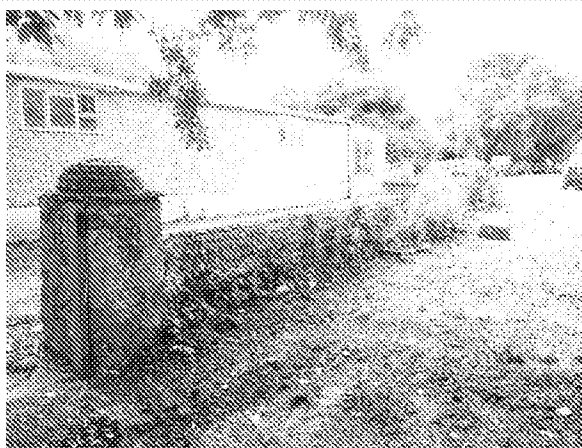
DSC02715 Inner face of garden wall

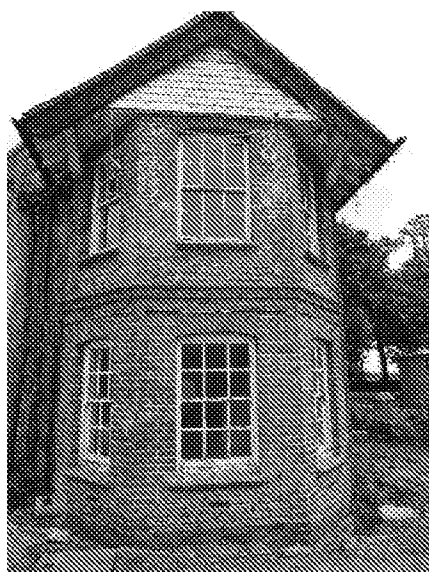
DSC03143 Double Height Canted Bay

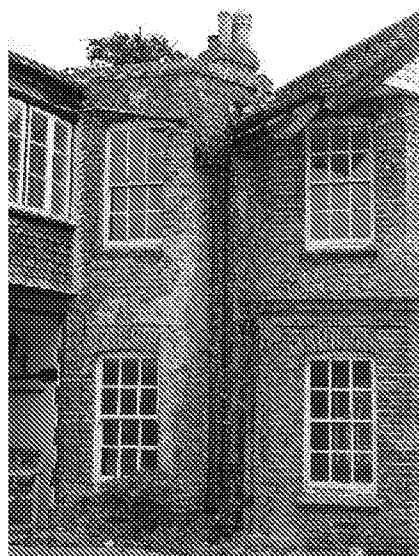
DSC03143 Parapet Gable

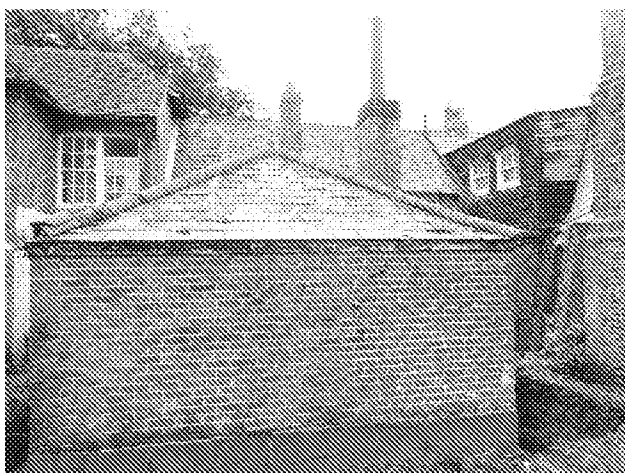
DSC02699 West Elevation

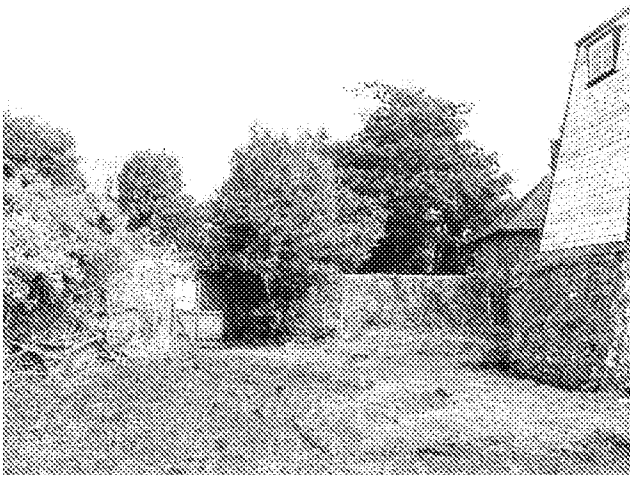
DSC02726 Internal view looking North

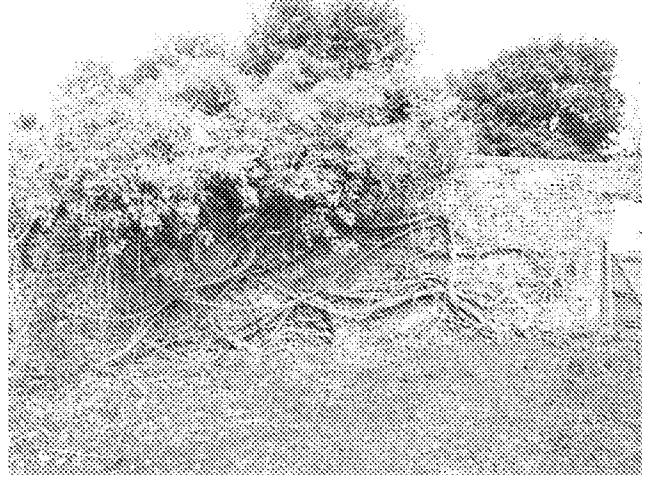
DSC02727 Internal view looking West by The Mill
