PRELIMINARY INVESTIGATION OF DAMP, DECAY AND RELATED BUILDING DEFECTS SUBSEQUENT TO PURCHASE OF THE MILL, CLIMPING STREET, CLIMPING, LITTLEHAMPTON BN17 5RG FOR 31 MAY–2 JUNE 2017, JOB NO. 147.12A

MR GARY LOVE

**Hutton+Rostron Environmental Investigations Ltd**, Netley House, Gomshall, Surrey, GU5 9QA,

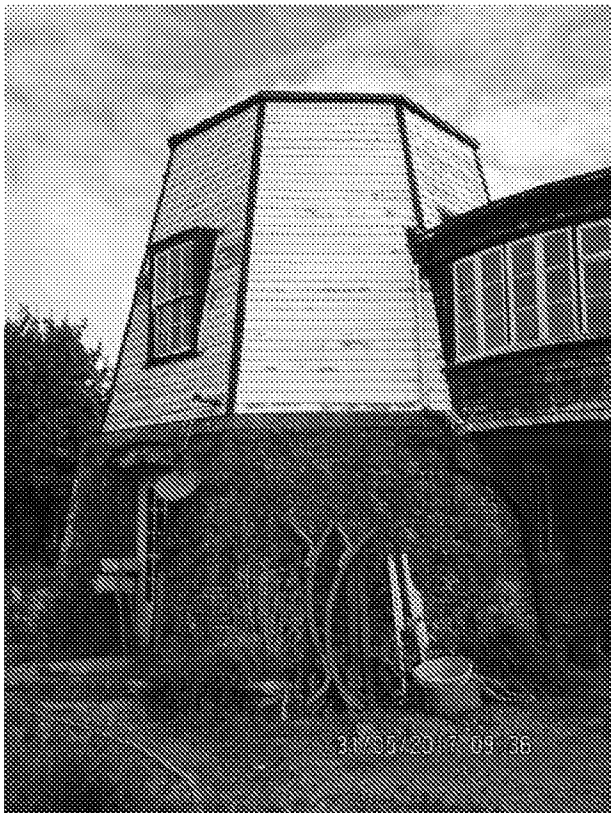
**Fig 2:**

Original mill structure as seen from the south; showing timber mill clad with softwood tongue and groove boarding in the 20<sup>th</sup> Century and painted with relatively impermeable paint. Also showing knapped flint masonry walls at ground floor level, subject to chronic water penetration and plant growth and with what may be structurally significant cracking

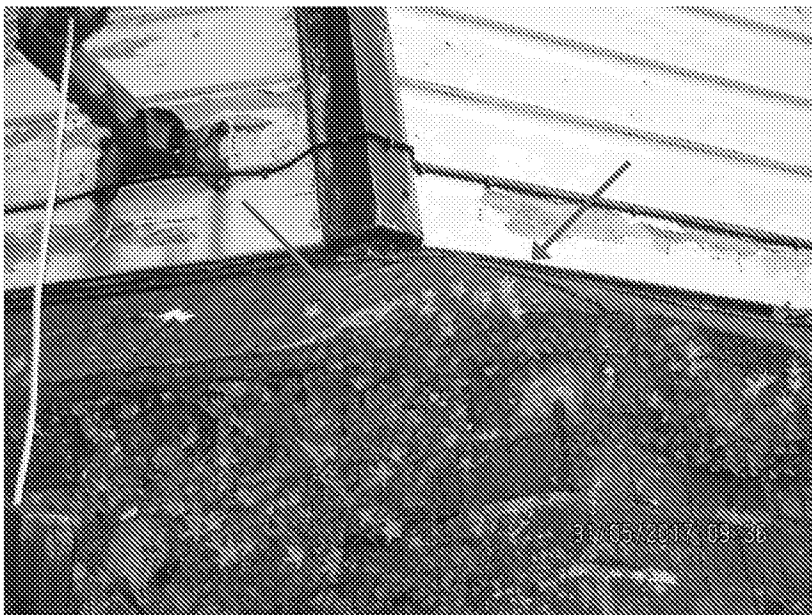
**Fig 4:**

South elevation of mill; showing cementitious flashing or flashing on masonry structure at ground floor level, cracked and at the end of its useful life. This is likely to allow water penetration but restrict drying, providing conditions for plant growth, damp and decay. Note cracks in knapped flint structure beneath. This may be structurally significant

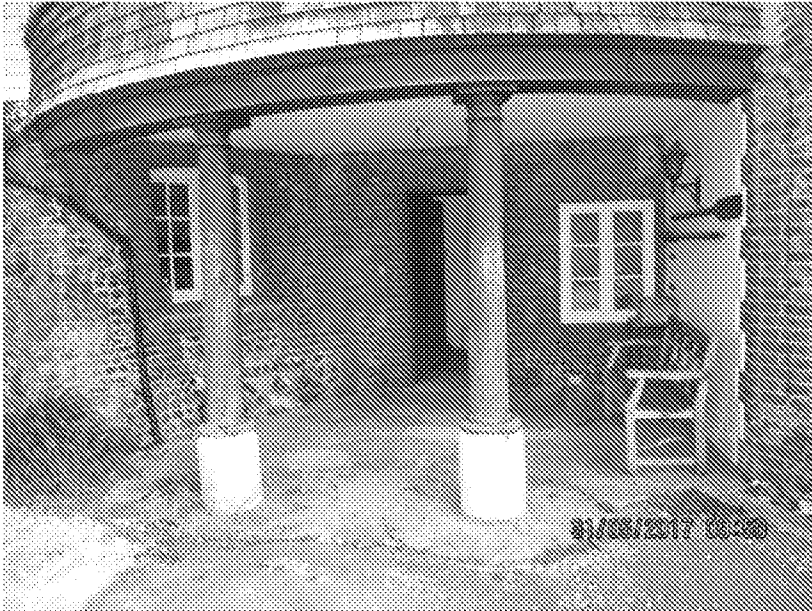
**Fig 9:**

Centre of south elevation; showing front porch beneath central bay, supported on oak posts

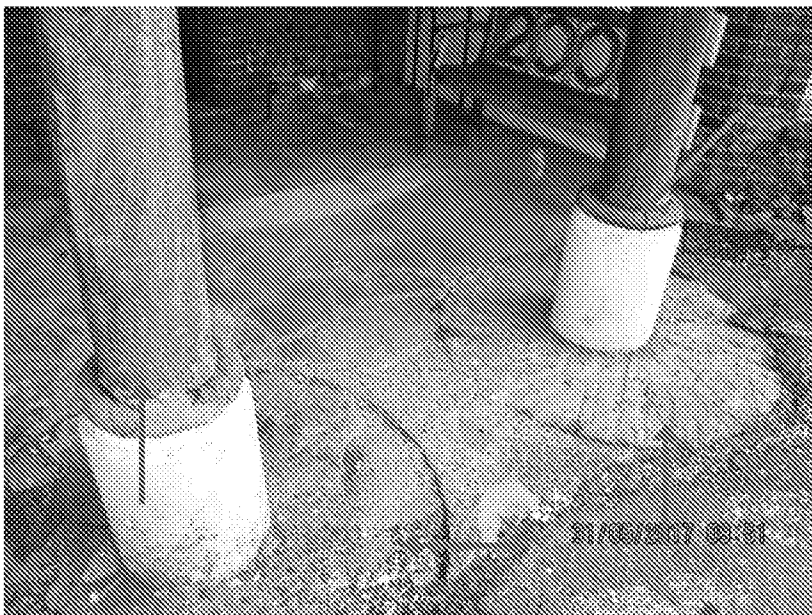
**Fig 10:**

South elevation; showing base of timber posts, partially decayed by wet rot. They bore onto padstones or pillars beneath. Note previous repairs with concrete. These were very vulnerable to further decay and may no longer be structurally adequate. Also showing original composite mill stones forming paving at base

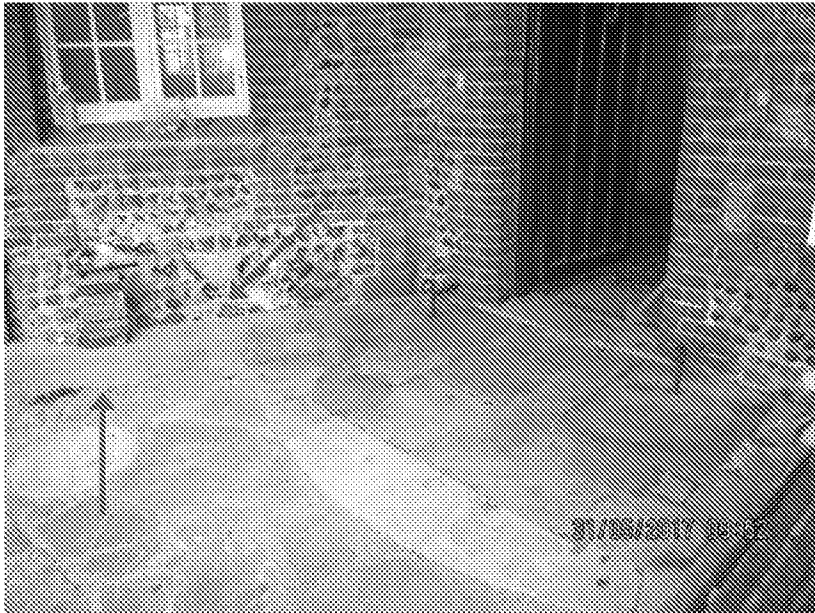
**Fig 11:**

Centre of south elevation; showing paving in front porch area, tending to drain water into the base of walls and foundations, especially in the area of the drainage gully to the west. Note ground levels at internal floor level and knapped flint masonry repaired with cementitious mortars on previous refurbishments

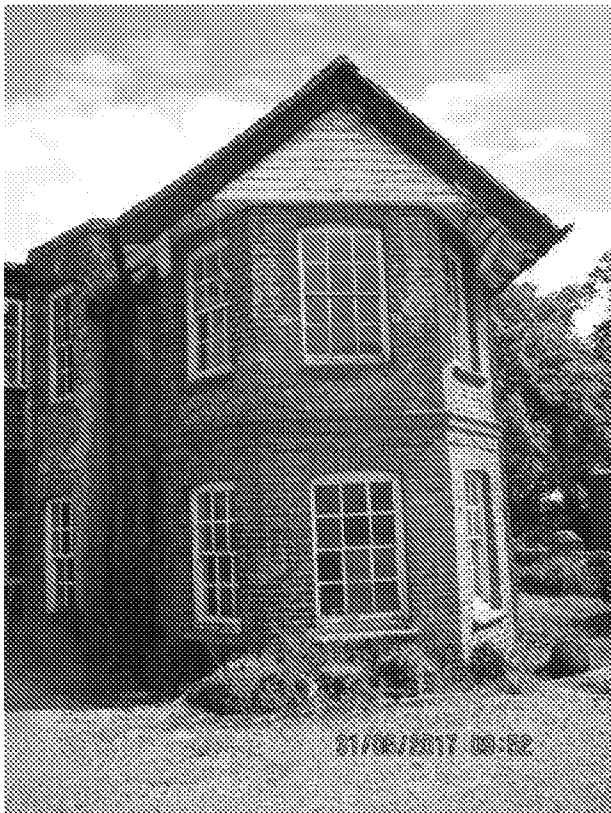
**Fig 12:**

South elevation of house to east; showing brick and knapped flint or beach cobbles facades with pointing repaired with cementitious mortars on previous refurbishments. These will allow water penetration but restrict drying. Also showing windows with timbers painted with layers of impermeable paint. This was allowing water penetration but restricted drying, resulting in wet rot decay to base of external frames and sills. Note ground levels generally above internal floor levels with ground and surface drainage tending to drain water into the base of the walls and foundations

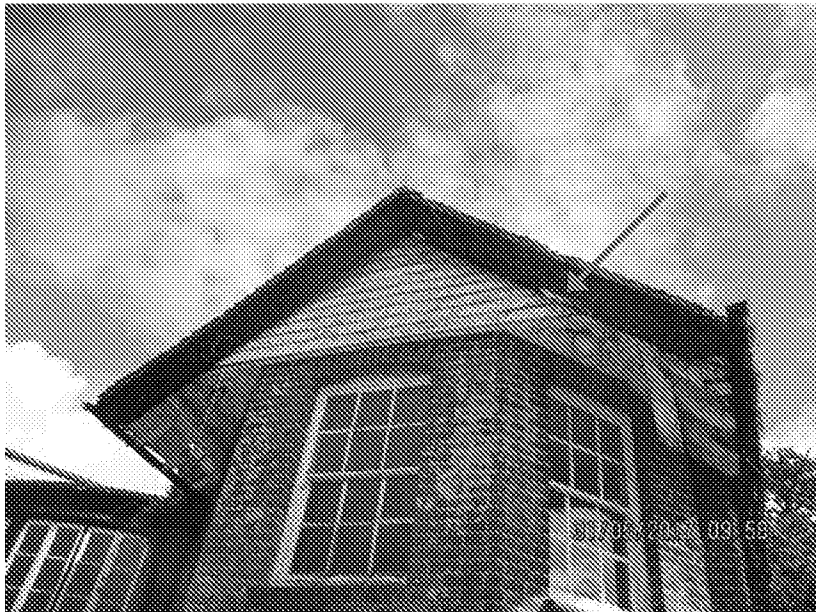
**Fig 13:**

South elevation; showing gable end with corbelled plates, exposed common rafters and tongue and groove boarding to gable end and barge boards above painted with layers of impermeable paint. This will allow water penetration but restrict drying, providing conditions for wet rot decay but these were not accessible for detailed inspection at the time of survey

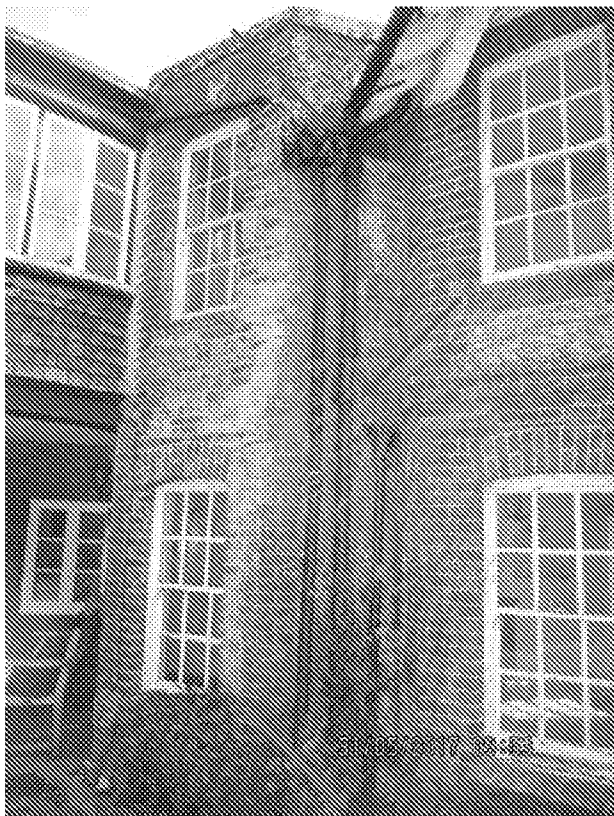
**Fig 14:**

South elevation; showing hopper and rainwater downpipes blocked and discharging water onto structures beneath, providing conditions for plant growth, damp and decay. Also showing settlement cracks in masonry. These may be structurally significant

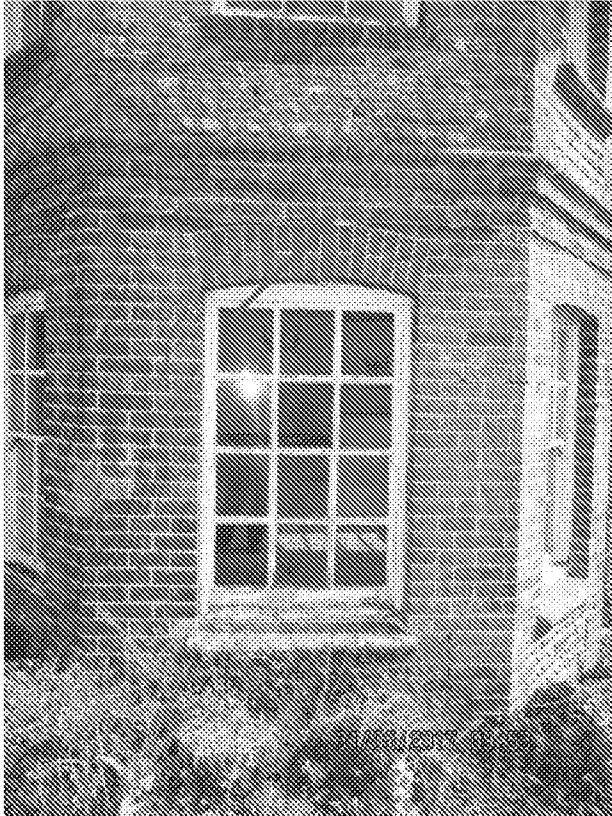
**Fig 15:**

South elevation; showing settlement cracks in masonry. These appear to be structurally significant. Also showing wet rot decay to window timbers

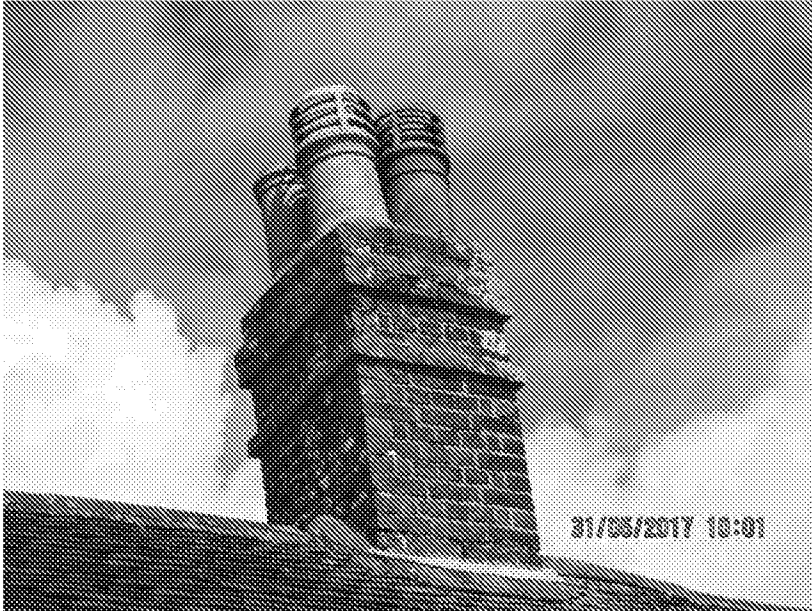
**Fig 19:**

East elevation; showing chimneystack with open flues. Also showing haunching, pointing, brickwork and flashings patched with cementitious mortars in the past. This will allow water penetration but restrict drying, providing conditions for further erosion, damp and decay

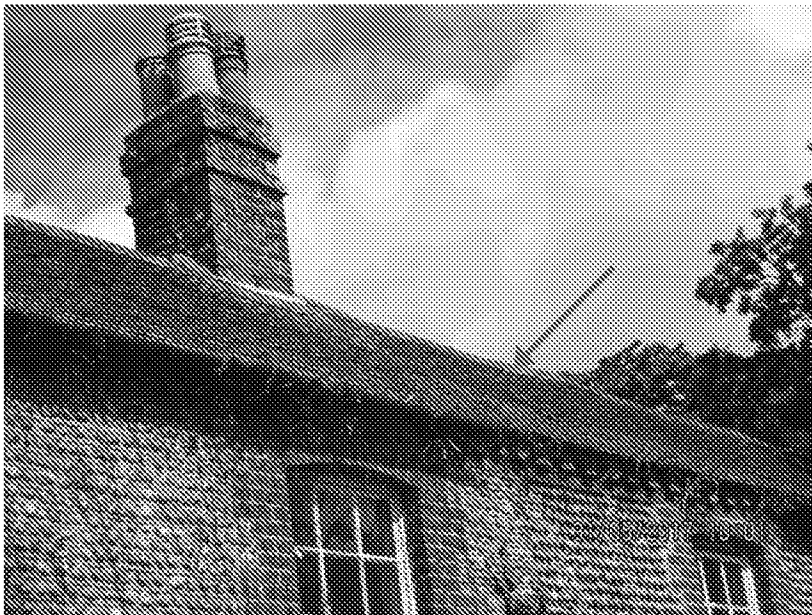
**Fig 20:**

East elevation; showing tiled roof surface with many slipped and eroded tiles. These had a very limited service life. Also showing settlement of ridge and roof structure to north. This may be structurally significant

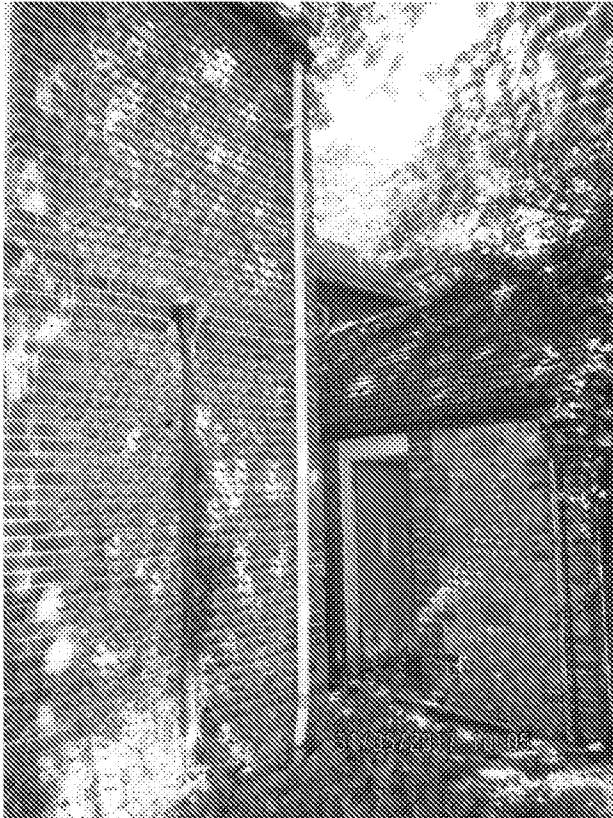
**Fig 25:**

North end of east elevation of main house; showing eaves gutter and rainwater downpipe replaced with relatively narrow plastic rainwater goods in the recent past, indicating failure of original rainwater goods. This had allowed chronic water penetration to structures beneath, providing conditions for damp and decay from roof to ground level. Also note erosion to pointing due to chronic water penetration in the past. This may be structurally significant

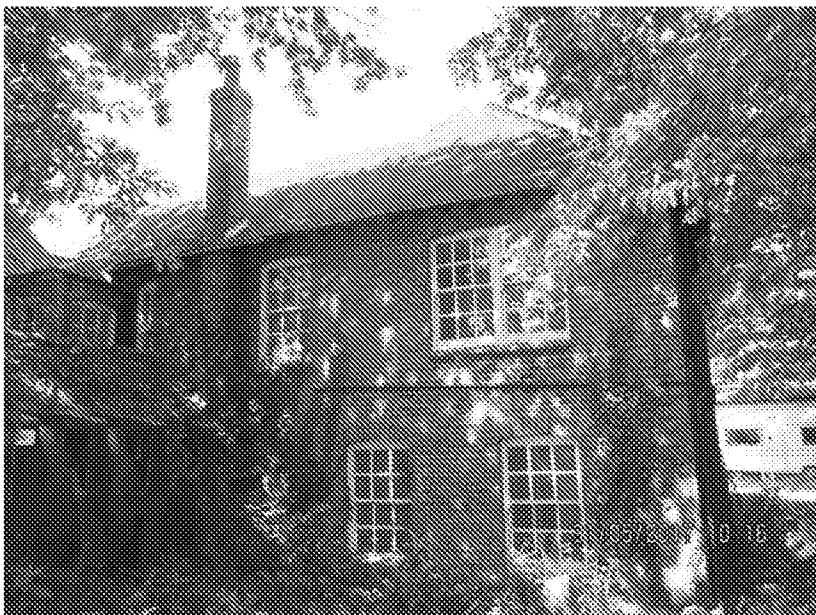
**Fig 32:**

North end of east elevation; showing pitched roof surface to north wing in relatively good condition. However, note eaves gutter missing, allowing water to discharge onto structures beneath

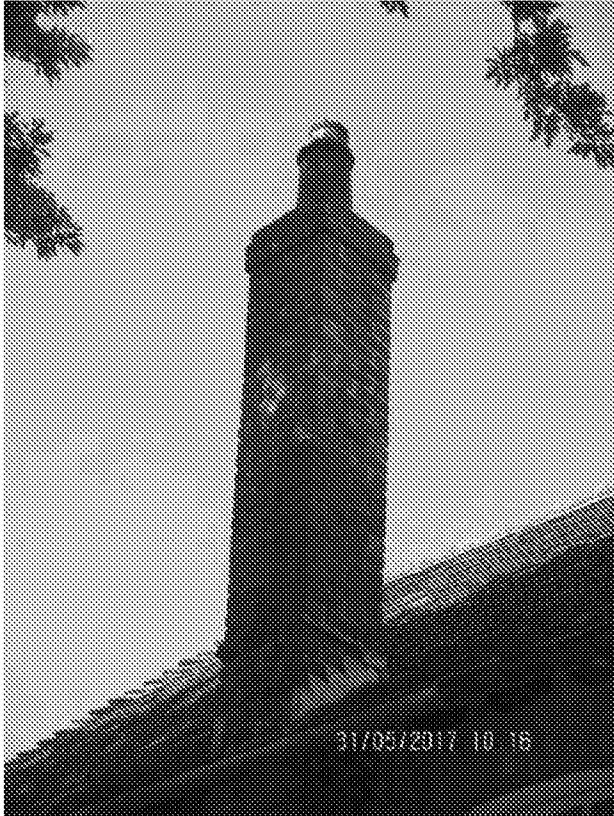
**Fig 33:**

North end of east elevation; showing chimneystack. Note original pointing eroded and original lead damp-proof course at base of stack

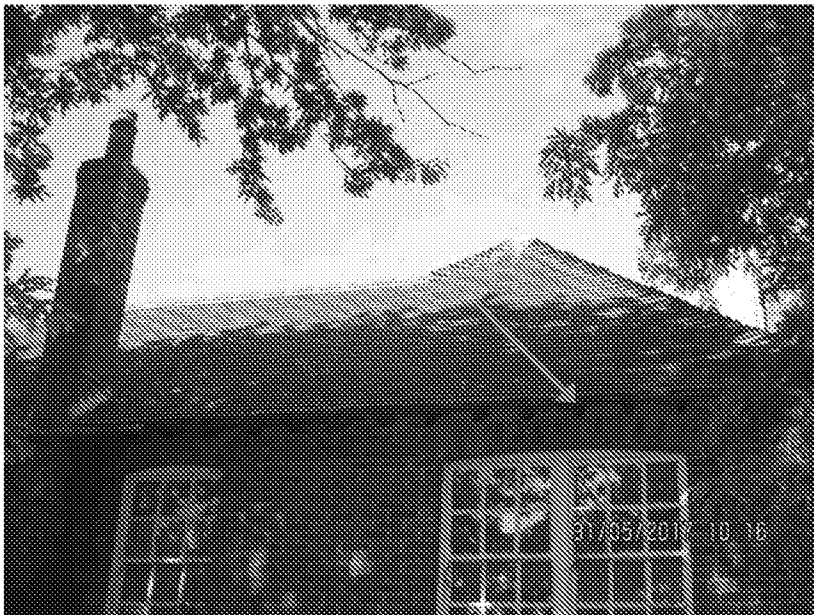
**Fig 34:**

North end of east elevation; showing pitched roof surface to north wing in relatively good condition. However, note eaves gutter missing, allowing water to discharge onto structures beneath

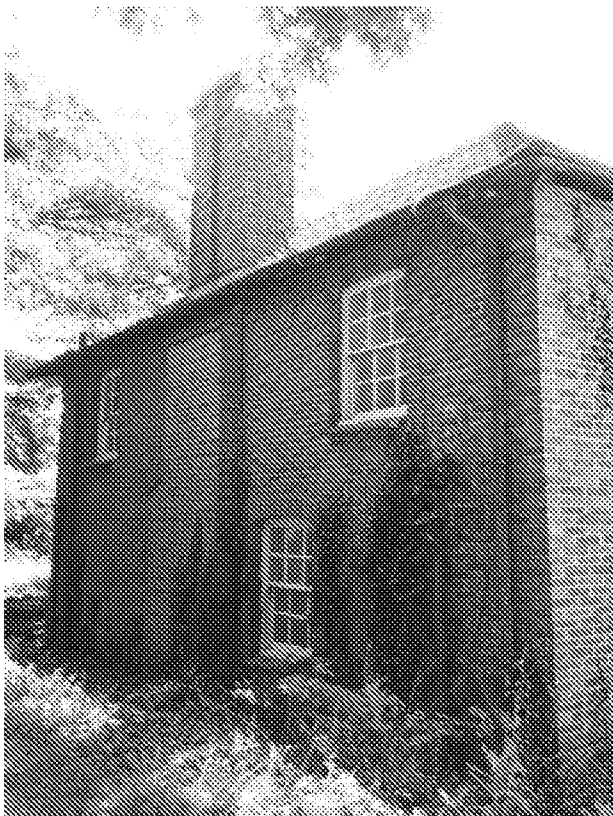
**Fig 36:**

North elevation of north wing; showing roof surfaces in relatively good condition. However, note pointing to chimneystack heavily eroded and roof drainage vulnerable to blockage and overcharging

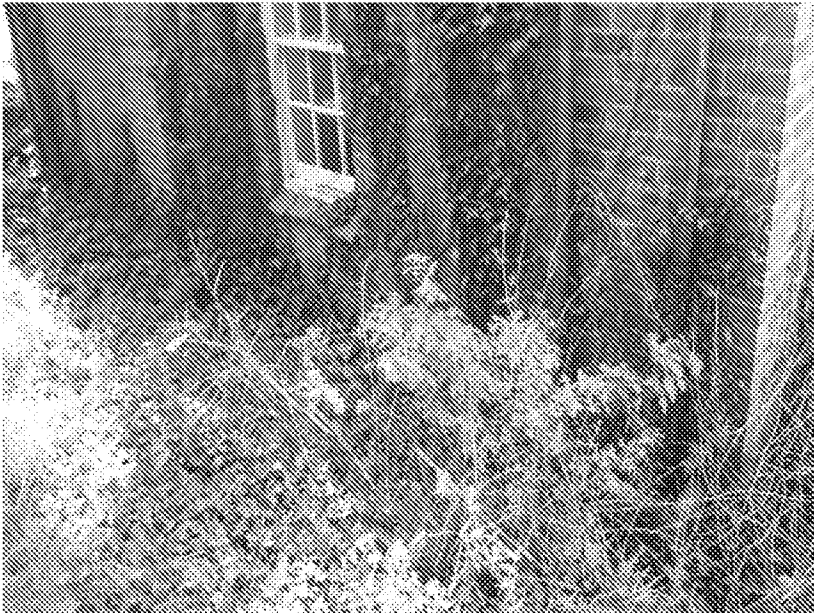
**Fig 37:**

North elevation of north wing; showing ground and surface drainage allowing water penetration to the base of walls and foundations. Note original physical damp-proof course approximately 100mm above existing ground levels and drainage gulley blocked and overcharging water into the base of walls and foundations

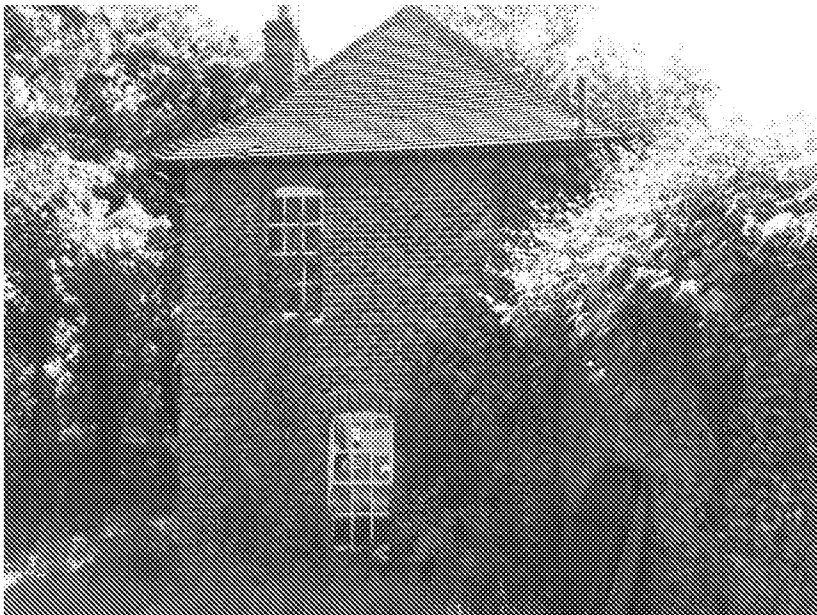
**Fig 38:**

West elevation of north wing; showing roof surface in relatively good condition with some slipped and damaged tiles. Also note showing roof drainage vulnerable to blockage and overcharging

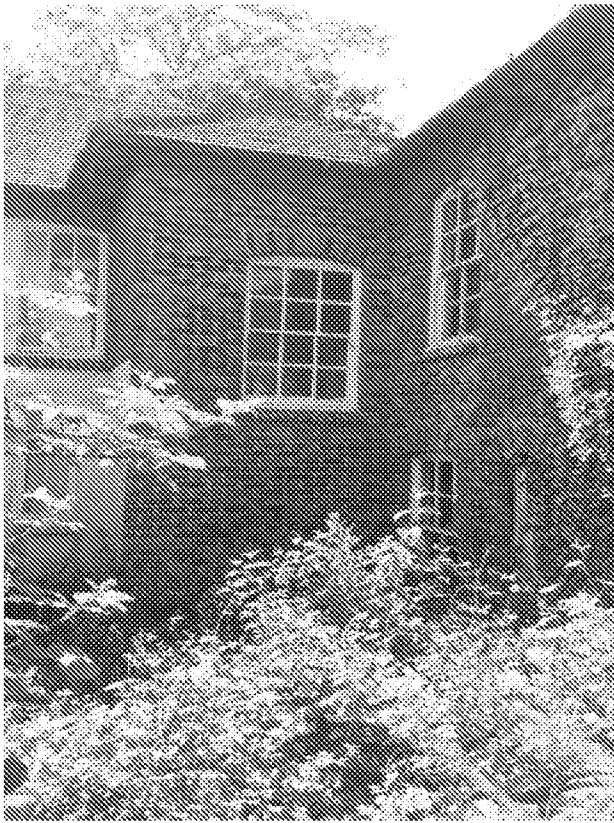
**Fig 41:**

West elevation of north wing; showing re-entrant corner with main building. Note defective eaves gutter discharging water onto structures beneath and cracks to brickwork at first floor level. Also note heavy erosion to pointing and previous patch repairs with cementitious materials

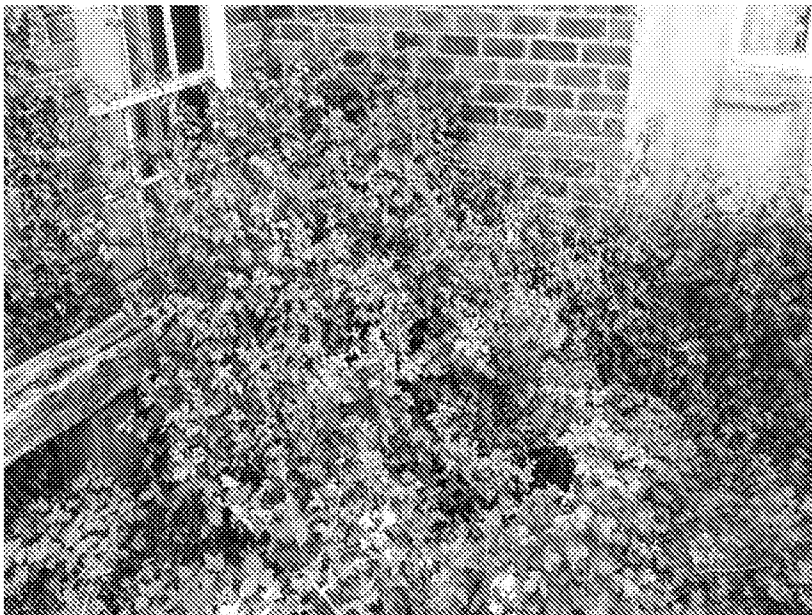
**Fig 42:**

West elevation; showing re-entrant corner to north wing and main building. Ground levels above internal floor levels to north and at and close to floor levels to the east. Note ground and surface drainage allowing water penetration to the base of walls and foundations, providing conditions for damp and decay

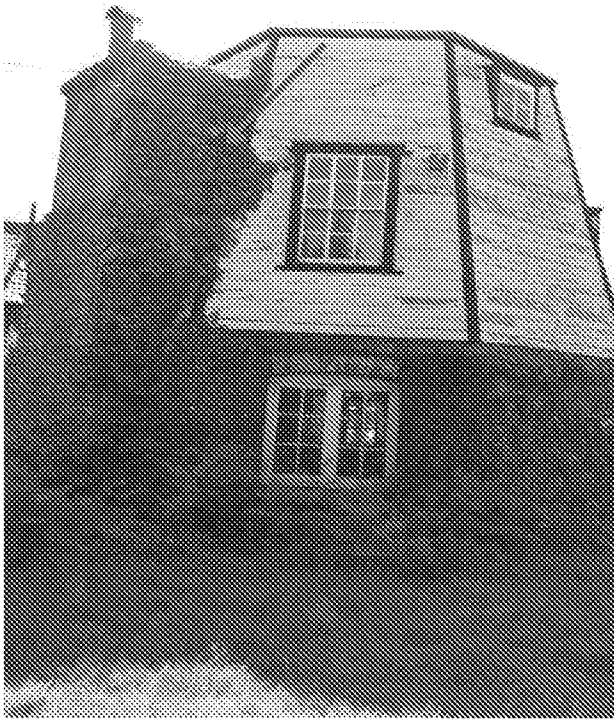
**Fig 47:**

West elevation; showing mill with masonry of original chimneystack, vulnerable to water penetration due to poor haunching and pointing. This was allowing chronic water penetration, providing conditions for plant growth, damp and decay. Also showing clapboarded timber structure built in contact with stack, vulnerable to wet rot decay and painted with layers of impermeable paint. This was allowing water penetration but restricting drying

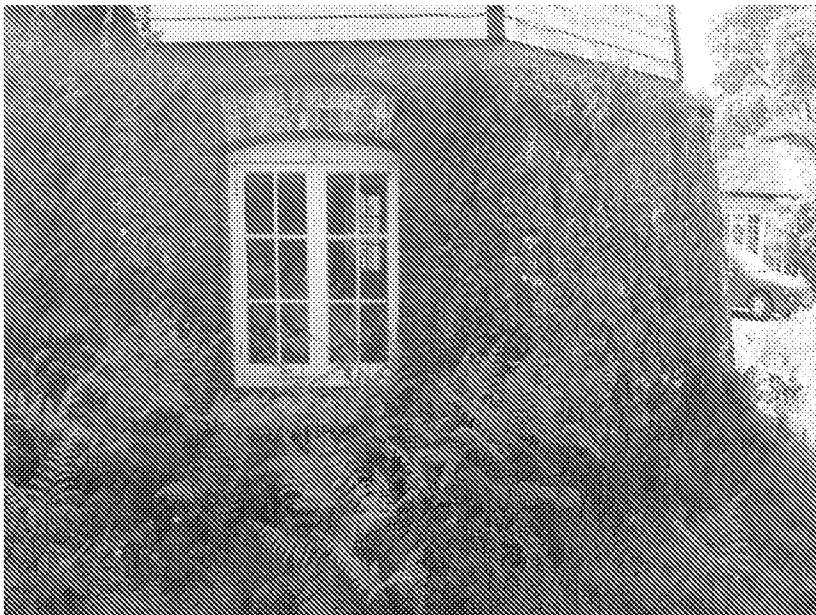
**Fig 48:**

West elevation; showing masonry wall at base of mill formed of knapped flints and brickwork. Note evidence of chronic water penetration from defective flashing and pointing, providing conditions for plant growth, damp and decay

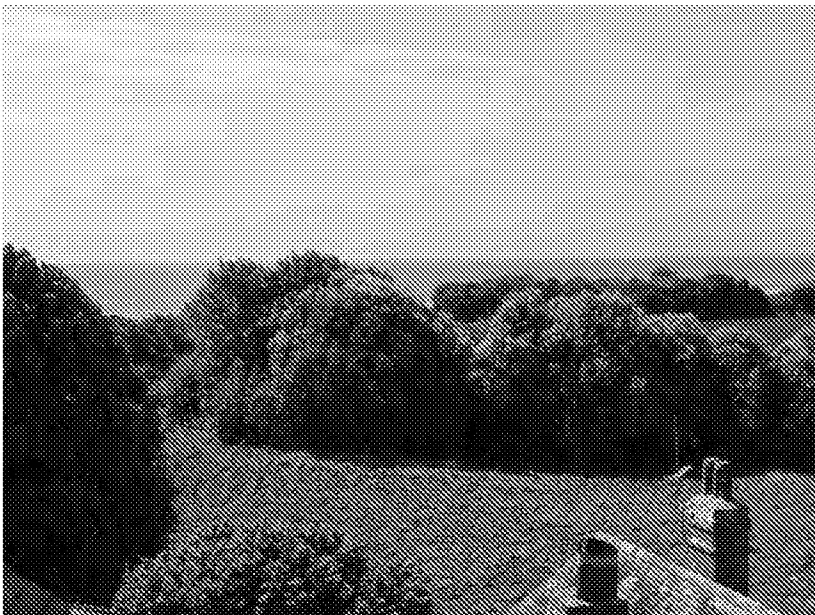
**Fig 50:**

View to south-west; showing structure very exposed to wind driven rain when accessed in accordance with BS 8109: 1990

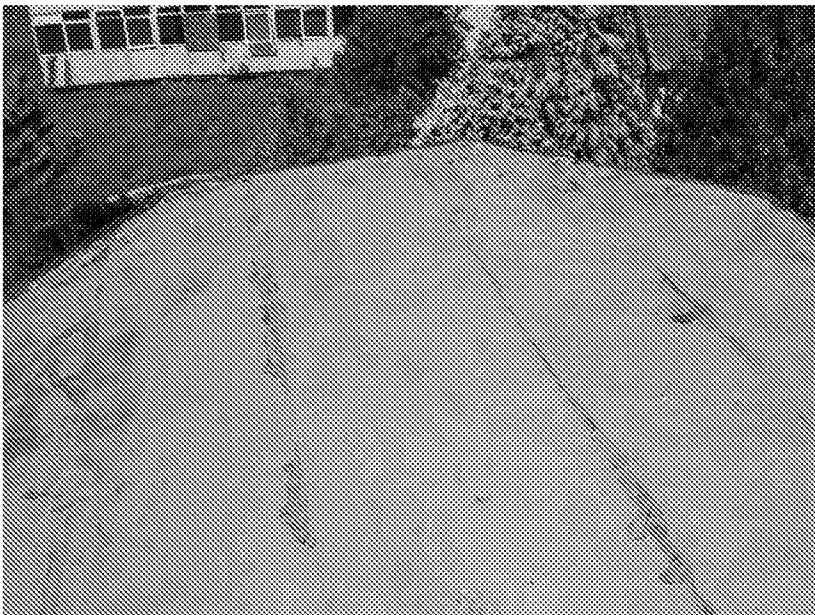
**Fig 52:**

Roof over mill; showing bituminous felt roof surface recently patch repaired but with a limited service life and with no provision for insulation or ventilation

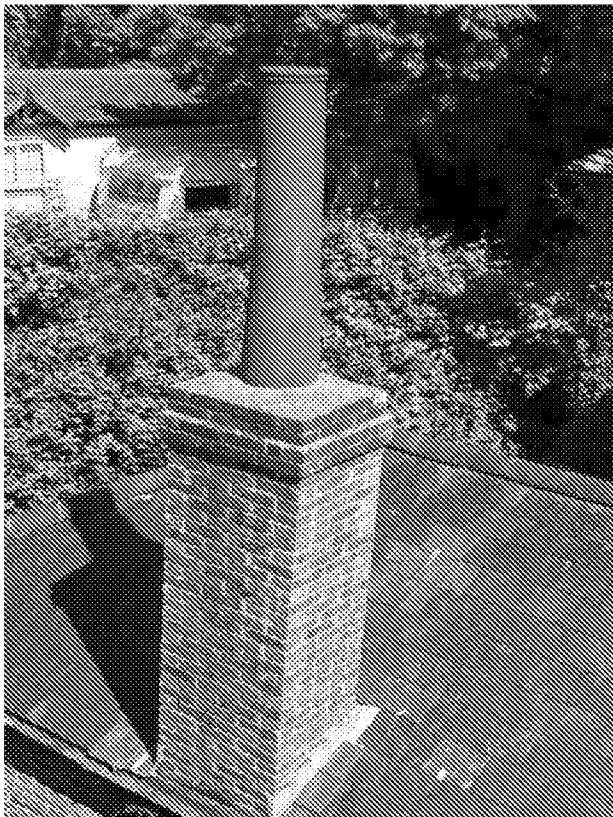
**Fig 54:**

Roof over west ground floor extension; showing chimneystack with tall chimneypot. Note erosion to haunching and pointing. This was likely to allow water penetration but restrict drying

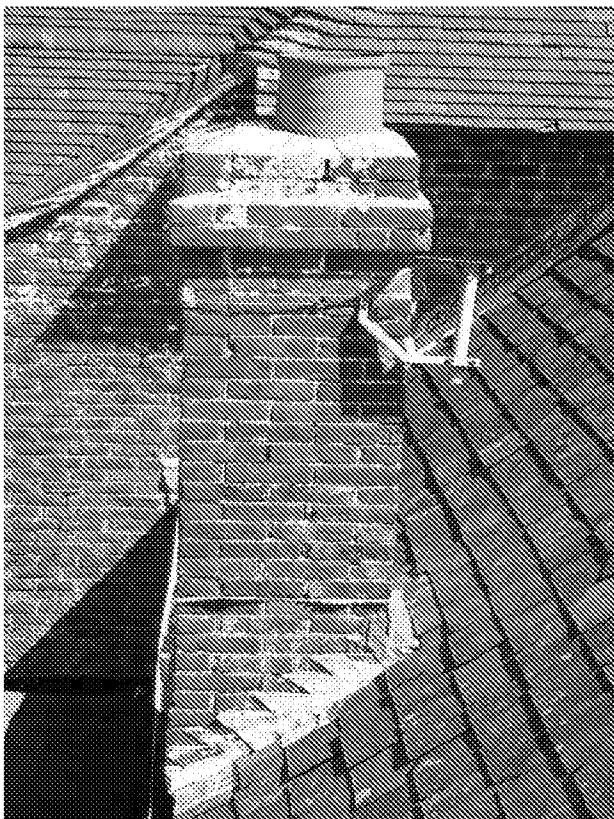
**Fig 56:**

Roof over north side of main building; showing chimneystack with open pots and with haunching and pointing and flashing in poor condition. This was allowing water penetration into the structures beneath providing conditions for damp and decay

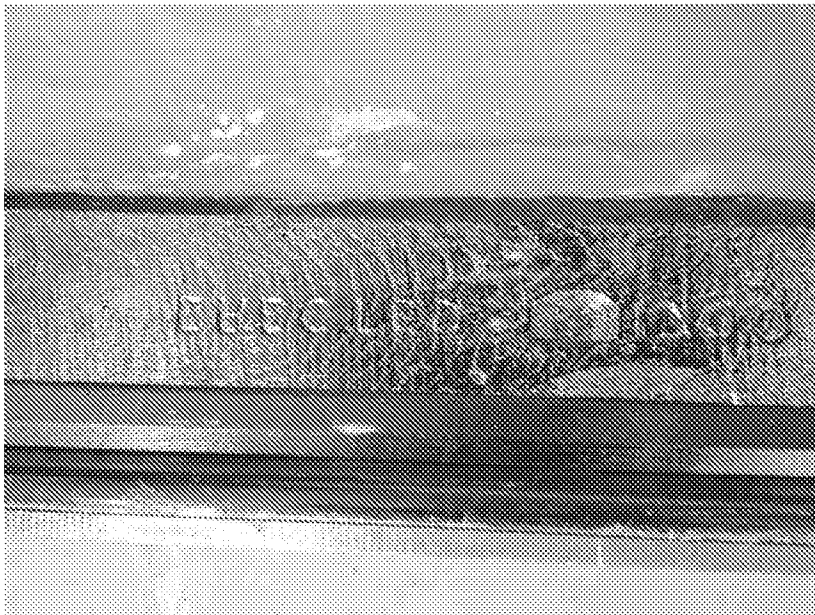
**Fig 58:**

North side of the first floor mill; showing possible date of the construction of the original mill

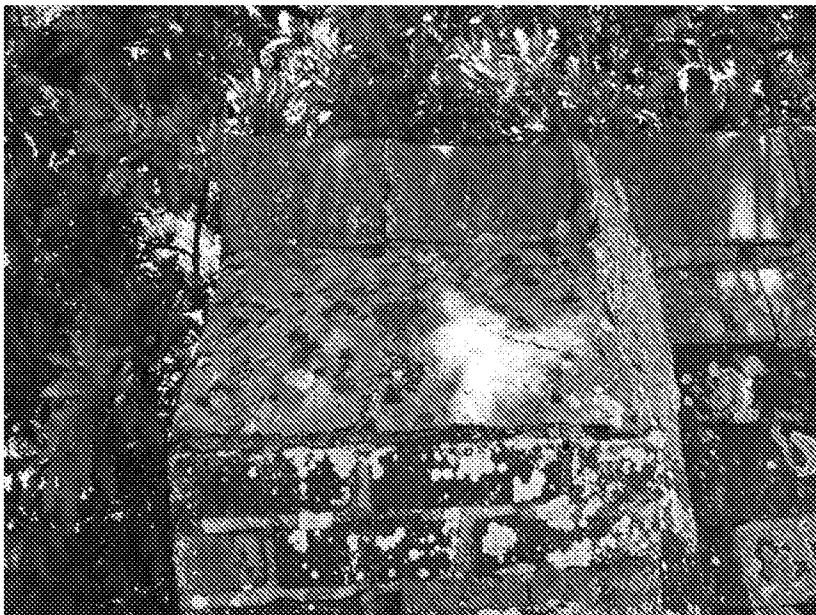
**Fig 60:**

North end of roof over south side of main building; showing original chimney blocked with no provision for ventilation. Note flashing and pointing in poor condition. This was likely to allow water penetration but restrict drying

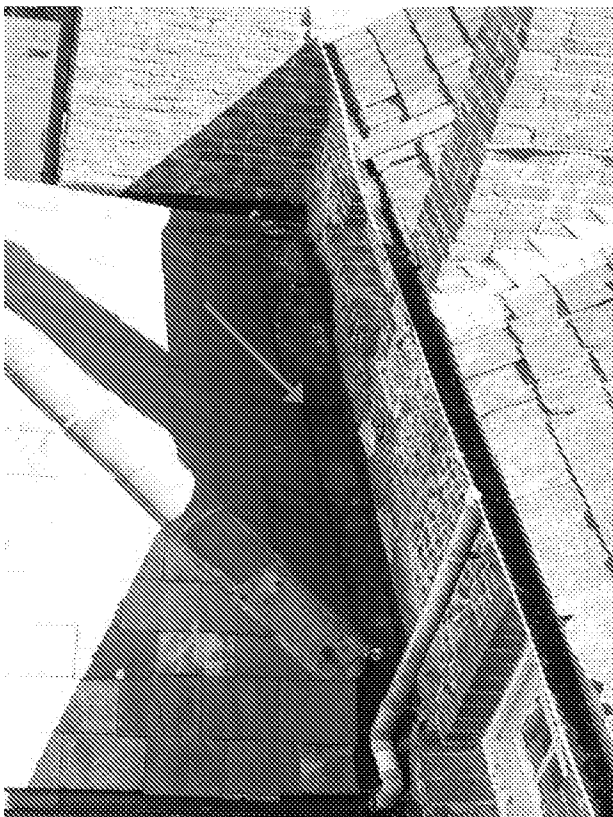
**Fig 64:**

Roof over west ground floor extension; showing valley between pitched roof and main building with roof drainage vulnerable to blockage and overcharging and poorly accessible for inspection and maintenance. This was likely to allow water penetration into the structures beneath providing conditions for damp and decay

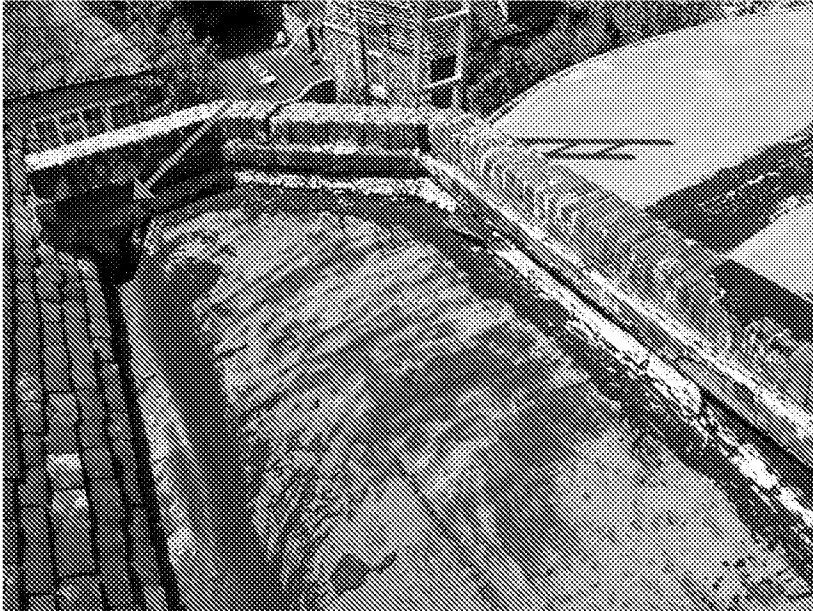
**Fig 65:**

Flat roof over bay at south end of main building; showing bitumen roof surface relatively recently patch repaired but with a very limited service life. Also showing flashing and coping to parapet in poor condition and likely to allow water penetration into the structures beneath providing conditions for damp and decay. Note drain to roof vulnerable to blockage and overcharging

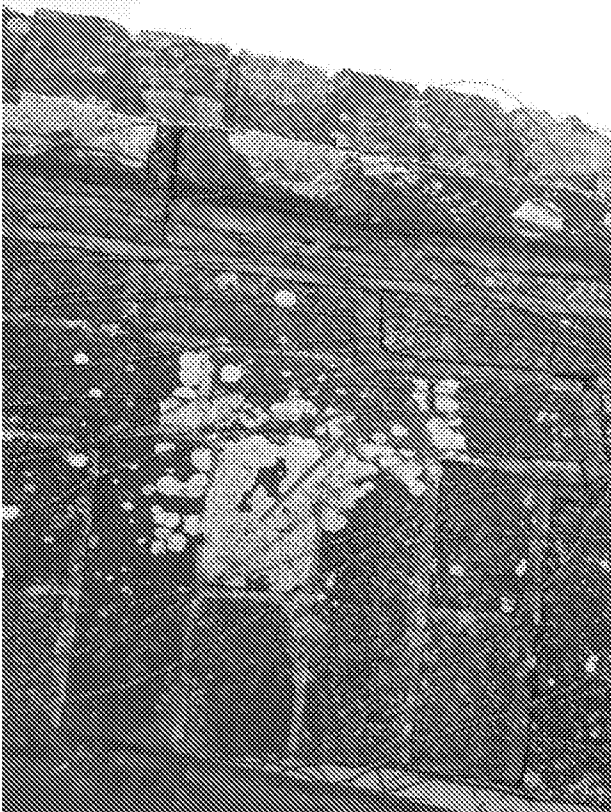
**Fig 66:**

Parapet wall of bay roof at south end of main building; showing erosion to brickwork and pointing with settlement crack. This may be structurally significant as well as allowing water penetration into the structures beneath providing conditions for damp and decay

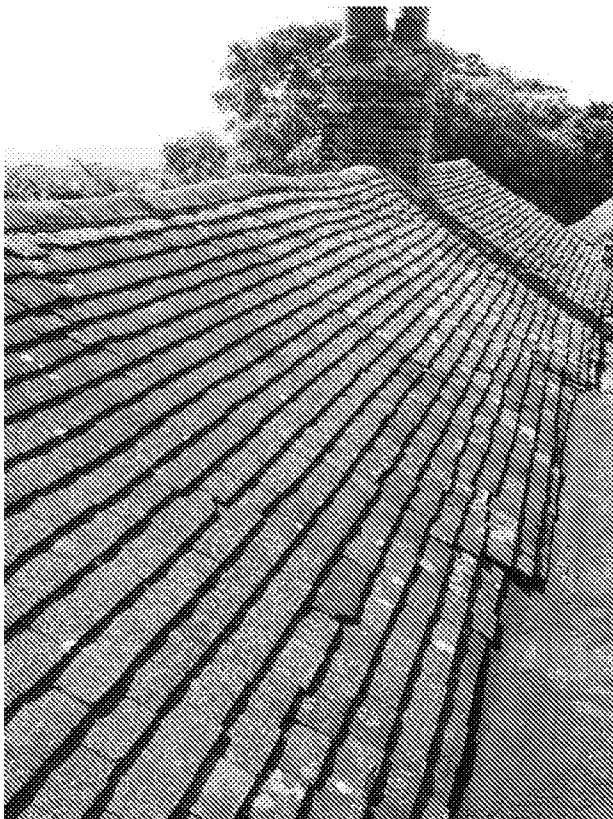
**Fig 70:**

North end of east pitch roof over main building; showing tiles relatively recently re-laid but with a limited service life. Note no special provision for ventilation

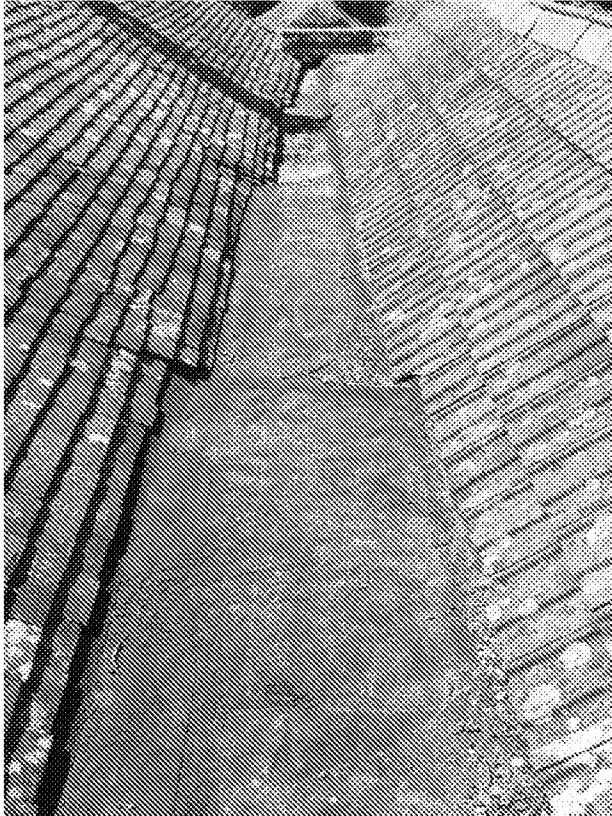
**Fig 71:**

Flat roof at north-east re-entrant corner between main building and north wing; showing lead roof surface with a limited service life. Note no special provision for insulation or ventilation

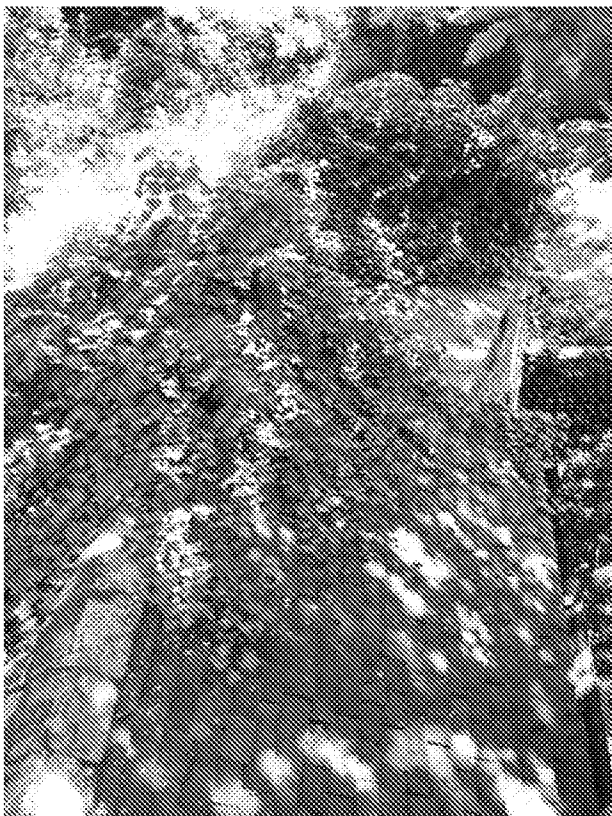
**Fig 72:**

Roofs over east ground floor extensions; showing roof surfaces and roof structures at the end of their useful lives; especially over the larder to the east

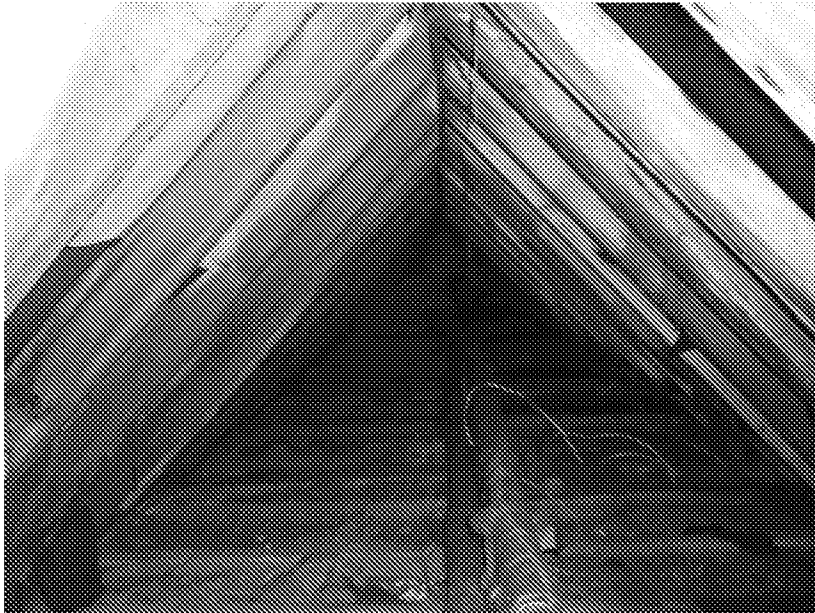
**Fig 73:**

West pitched roof over main building; showing softwood common rafters and ceiling joists acting as collars. Note heavily contaminated debris and mineral fibre quilt insulation and roof re-laid onto impermeable sarking felt to east and more recently onto breather felt to west on previous refurbishments. Generally, inadequate provision had been made for insulation and ventilation and contaminated insulation and debris represented a potential irritant or health hazard during and after refurbishment

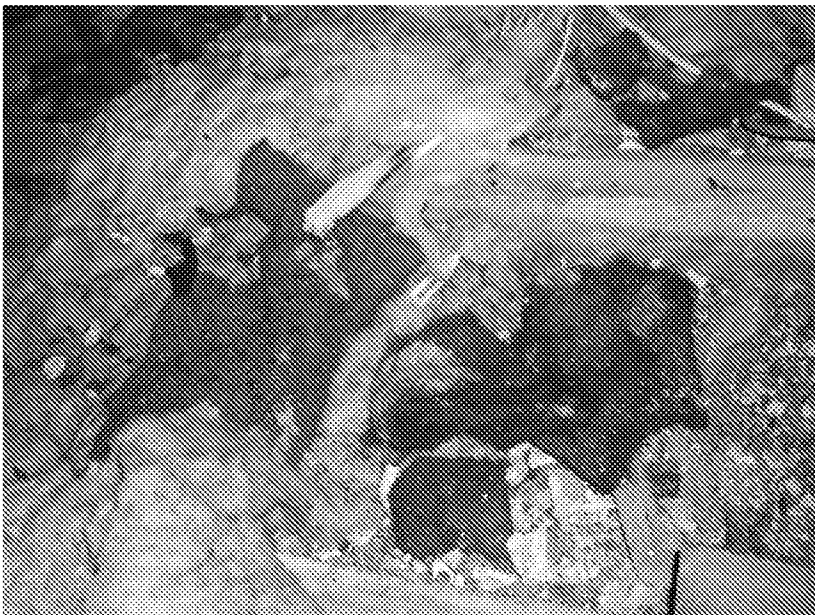
**Fig 74:**

West pitched roof over main building; showing heavily contaminated dust, debris and insulation material. This represented a potential irritant or health hazard during and after refurbishment

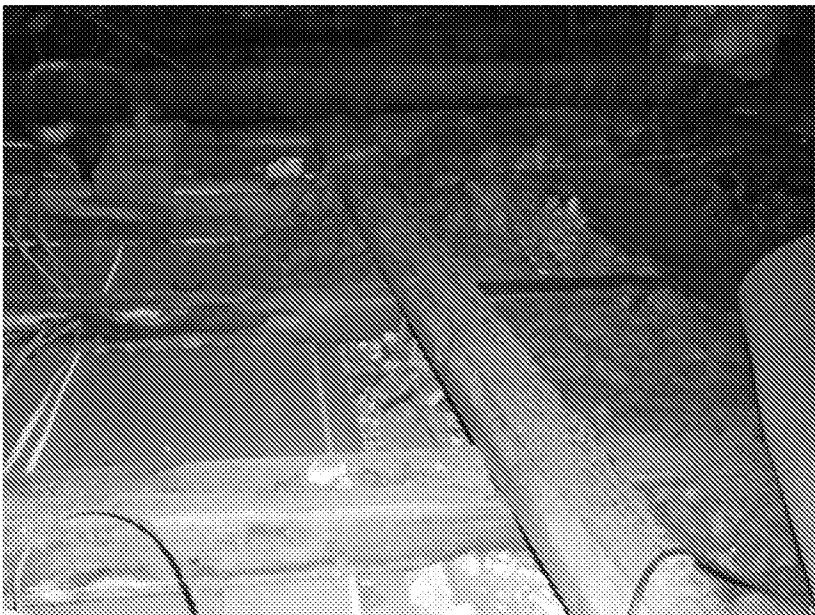
**Fig 76:**

West pitched roof over main building; showing ceiling replaced with plasterboard on previous refurbishments and heavily contaminated debris and mineral fibre quilt insulation. This represented a potential irritant or health hazard during and after refurbishment

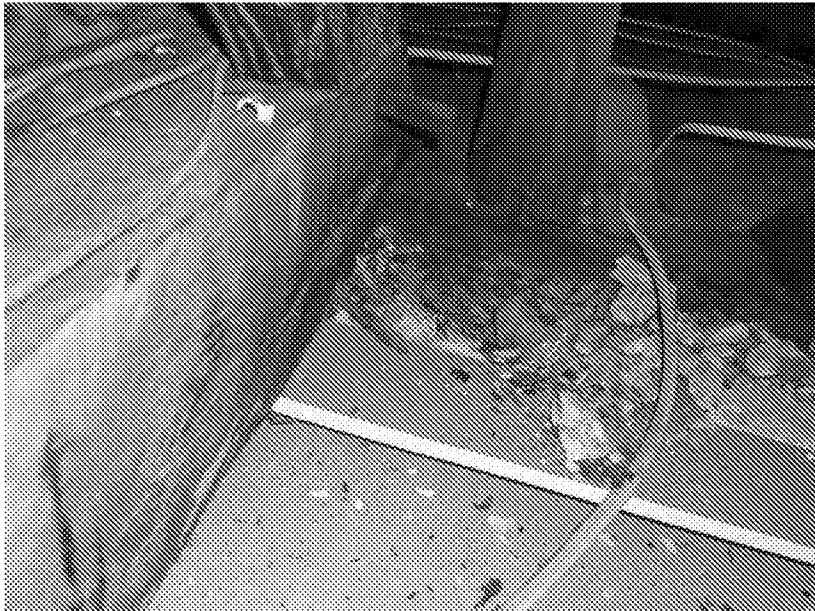
**Fig 77:**

West side of east pitched roof over main building; showing plate beneath valley subject to chronic water penetration in the past and partially decayed by wet rot, although it was too dry for further decay to occur at the time of survey. Also showing bearing of primary ceiling or tie beam

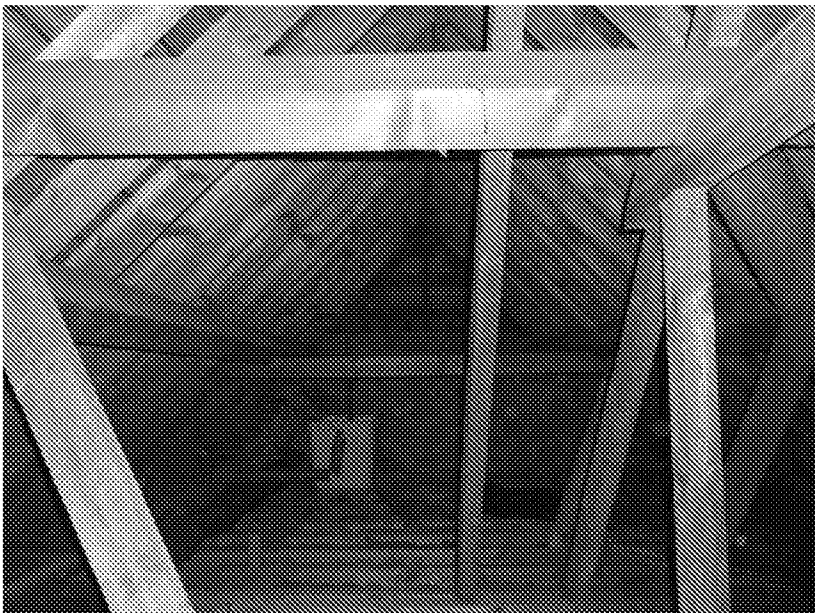
**Fig 78:**

Roof over north wing; showing softwood common rafters and ceiling joists forming lightweight trusses and supported on softwood purlins. Note common rafters overlaid with softwood sarking boards and overlaid with bituminous felt on previous refurbishment with no provision for ventilation. Also showing a thin layer of mineral fibre quilt insulation
