PRELIMINARY INVESTIGATION OF DAMP, DECAY AND RELATED BUILDING DEFECTS SUBSEQUENT TO PURCHASE OF THE MILL, CLIMPING STREET, CLIMPING, LITTLEHAMPTON BN17 5RG FOR 31 MAY–2 JUNE 2017, JOB NO. 147.12A

MR GARY LOVE

**Hutton+Rostron Environmental Investigations Ltd**, Netley House, Gomshall, Surrey, GU5 9QA,

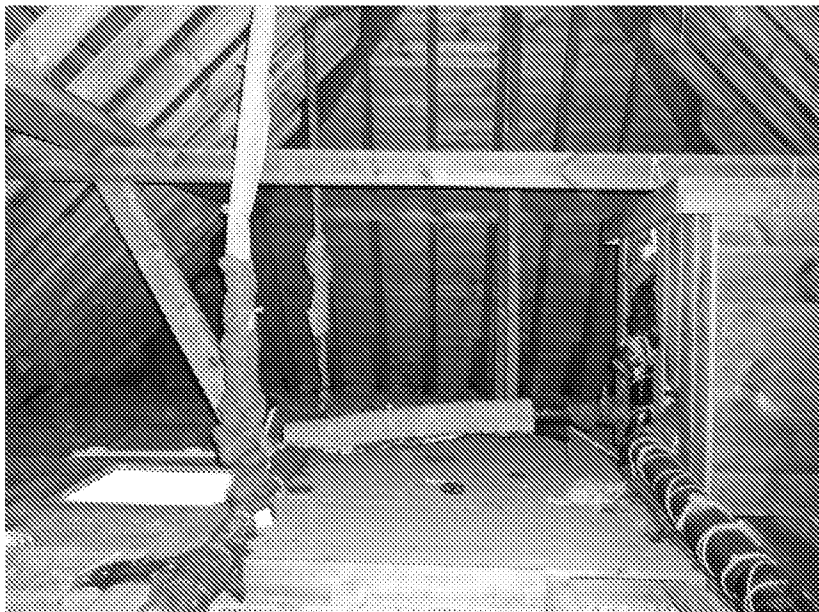
**Fig 79:**

Roof over north wing; showing softwood common rafters and ceiling joists forming lightweight trusses and supported on softwood purlins. Note common rafters overlaid with softwood sarking boards and overlaid with bituminous felt on previous refurbishment with no provision for ventilation. Also showing a thin layer of mineral fibre quilt insulation

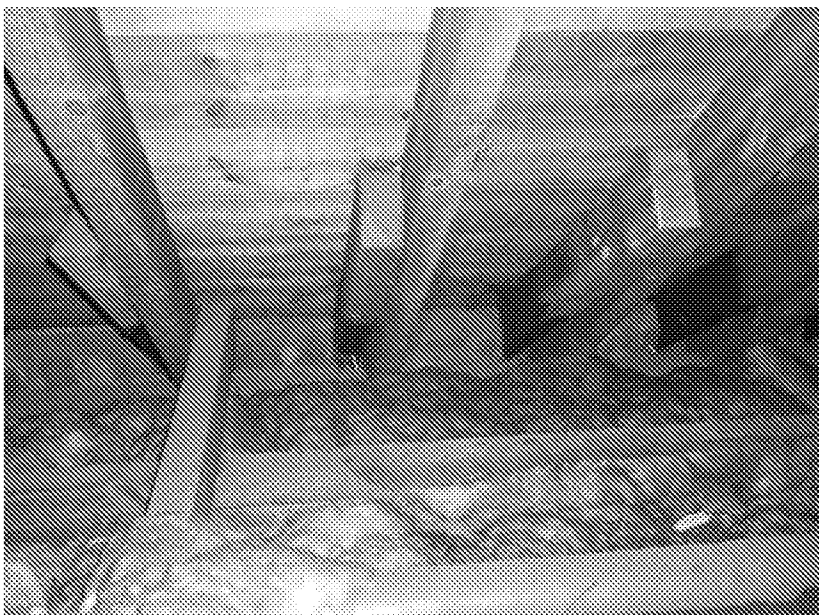
**Fig 80:**

Roof over north wing; showing eaves with no provision for ventilation. Also showing 'sprockets' secured to common rafters and supporting eaves, treated with creosote or bituminous material on original construction and common rafter plate to interior of wall

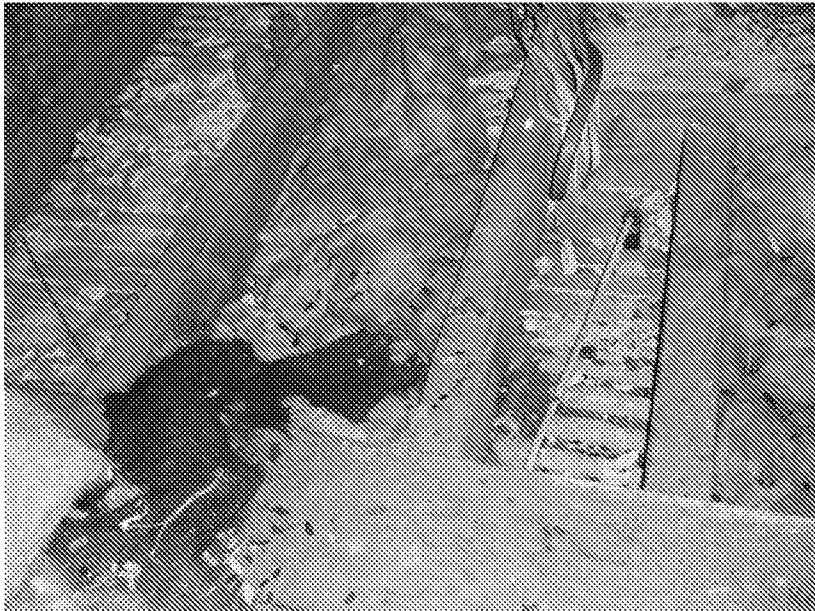
**Fig 81:**

Roof over north wing; showing contaminated insulation dust and debris overlying lath and plaster. Also note some evidence of occupancy by bats in the past

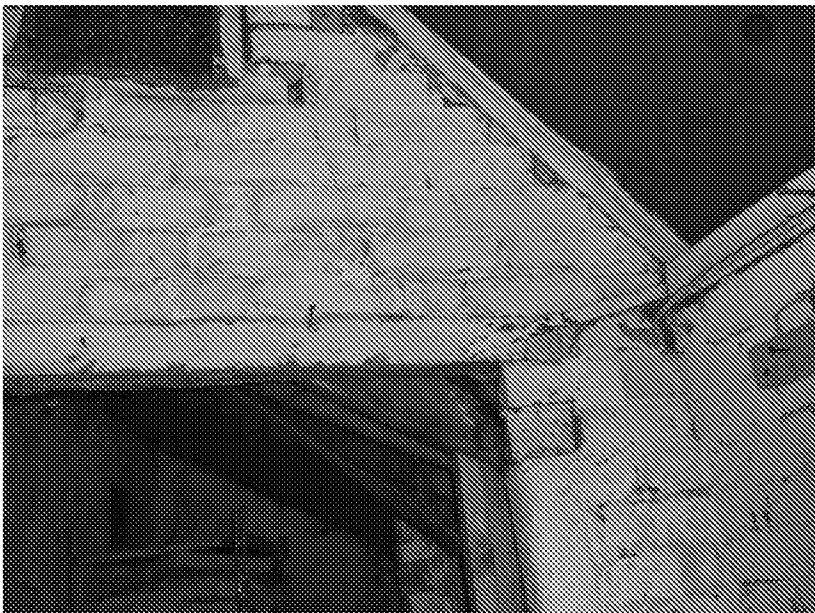
**Fig 82:**

Catslide roof over 'larder' at east end of north-east door of ground floor stores; showing common rafter bearing and an underlying plate decayed by wet rot and wood boring beetle and brickwork at gable end above, poorly supported with settlement cracks. These appear to be structurally significant

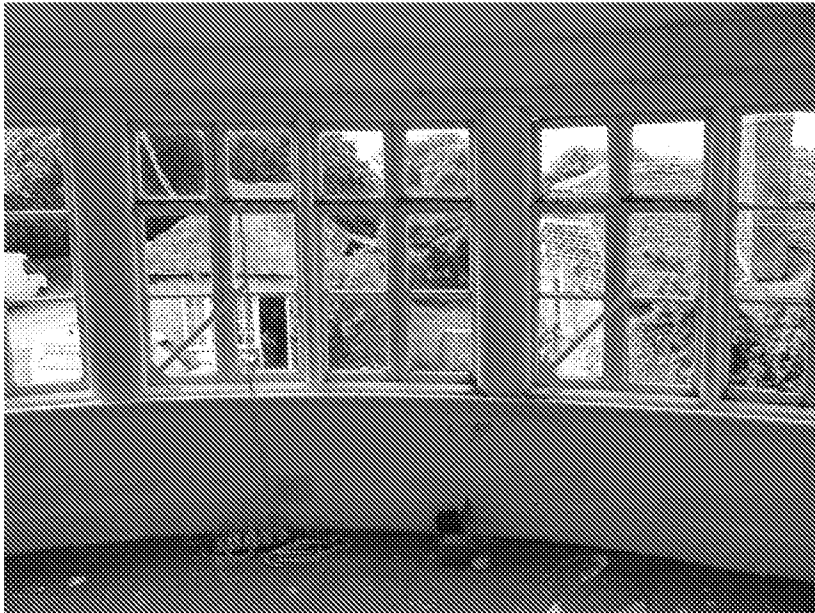
**Fig 83:**

South bay at first floor; showing evidence of chronic water penetration through windows very exposed to wind driven rain

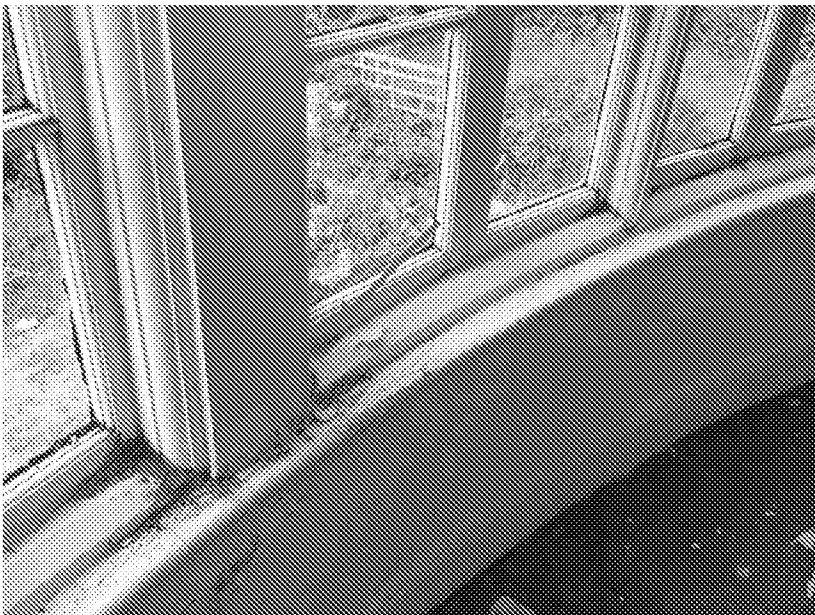
**Fig 84:**

South bay at first floor; showing evidence of chronic water penetration through windows very exposed to wind driven rain

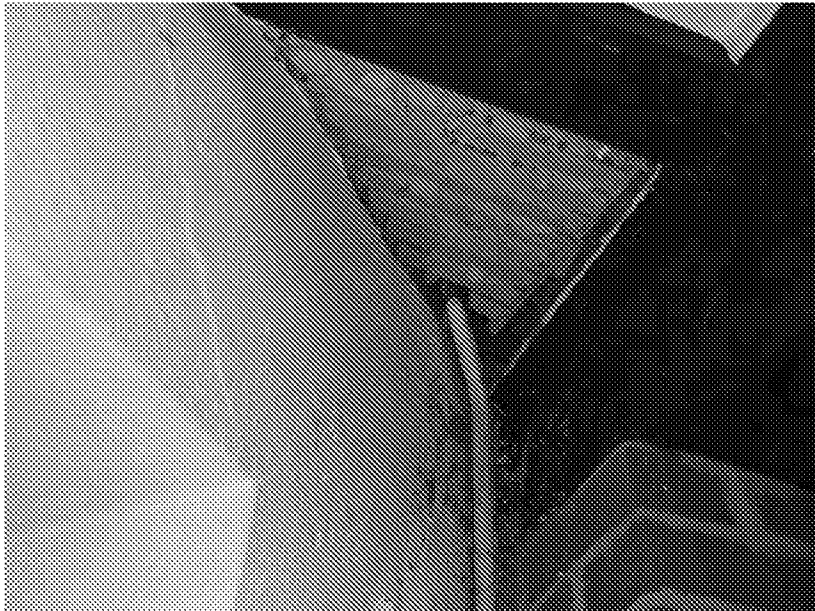
**Fig 85:**

South side of ground floor of windmill; showing ceiling previously repaired with softwood laths and gypsum plaster in area of previous decay to bearing end of primary beam and plates at wall head. Note dust and debris including mineral fibre insulation, possibly containing asbestos mineral fibres

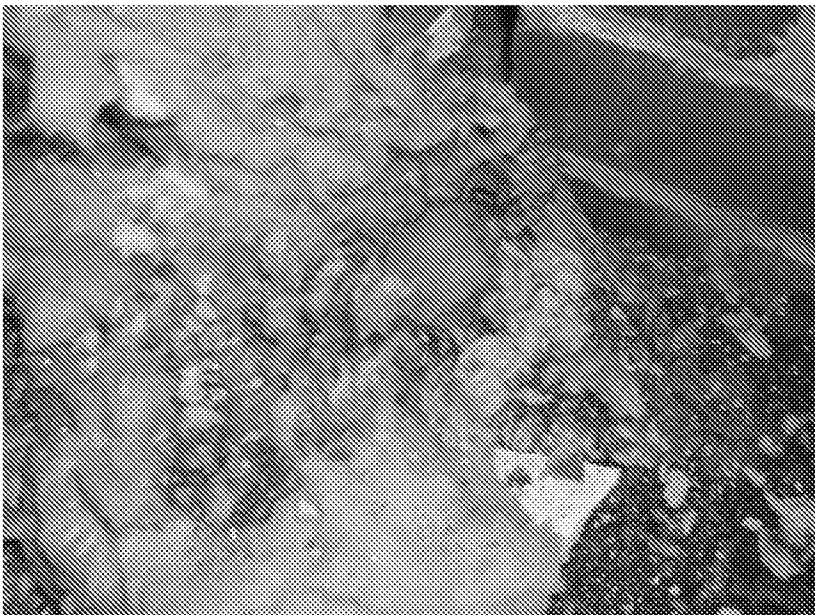
**Fig 86:**

South side of ground floor of windmill; showing ceiling previously repaired with softwood laths and gypsum plaster in area of previous decay to bearing end of primary beam and plates at wall head. Note dust and debris including mineral fibre insulation, possibly containing asbestos mineral fibres

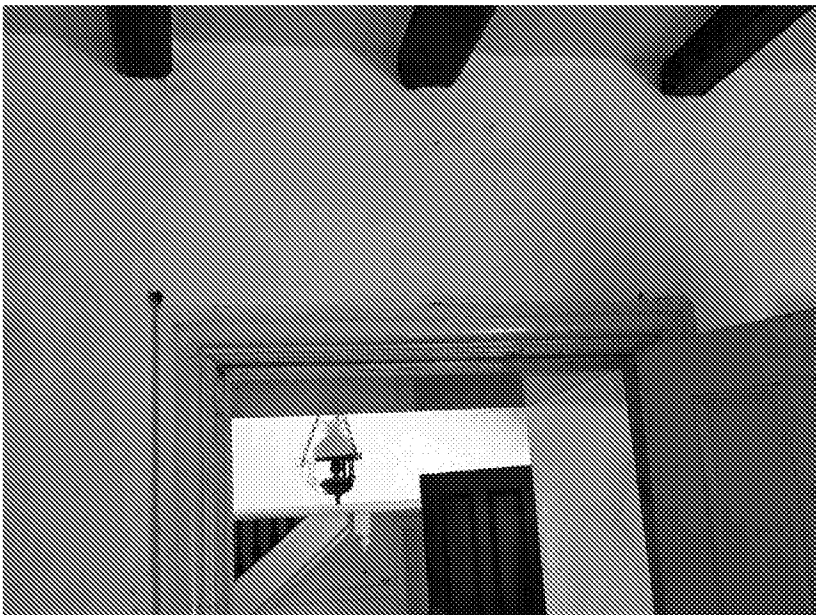
**Fig 88:**

Ground floor room at base of mill;  
showing lintel over door opening to the  
east found to be structurally decayed  
on preliminary drilling

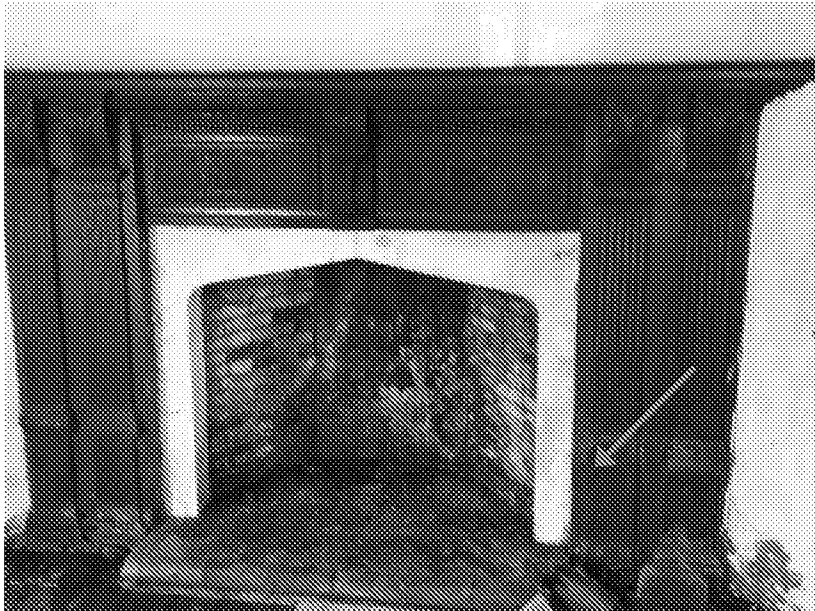
**Fig 89:**

Ground floor room at base of mill; showing decorative timber fire surround partially decayed by wet rot and very vulnerable to further decay due to continuing problems of chronic water penetration

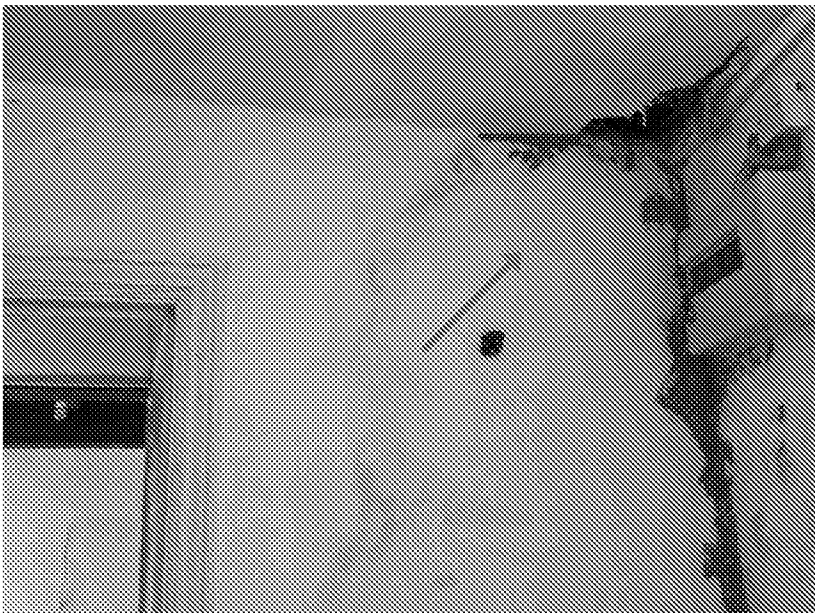
**Fig 90:**

North-west corner of ground floor entrance hall; showing structure subject to chronic water penetration providing conditions for dry rot (*Serpula lacrymans*) infection and decay. Note lintel over door opening to ground floor room at base of mill found to be structurally decayed on preliminary drilling

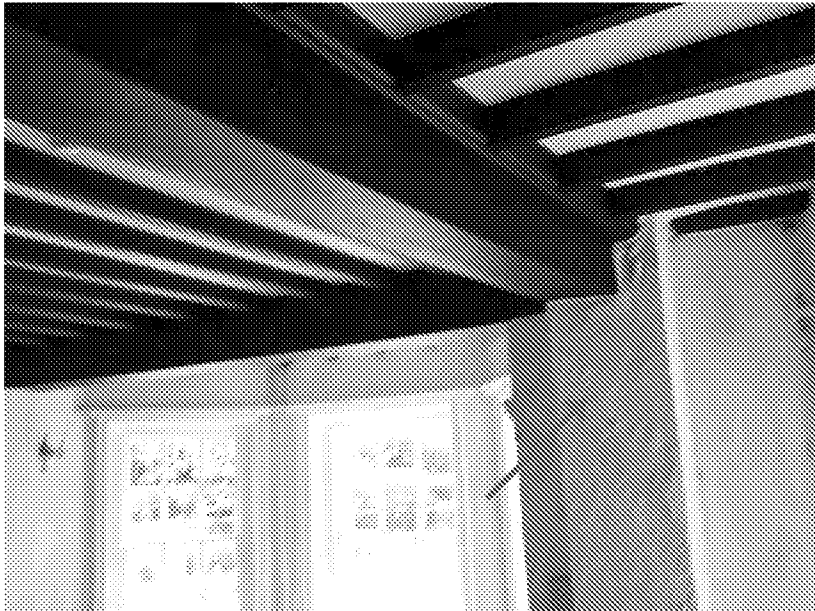
**Fig 91:**

South ground floor room; showing first floor structure above supported on primary beams and joists. Note evidence of chronic water penetration from defective roof drainage at the south-west re-entrant corner of the bay. This was providing conditions for dry rot (*Serpula lacrymans*) infection and decay

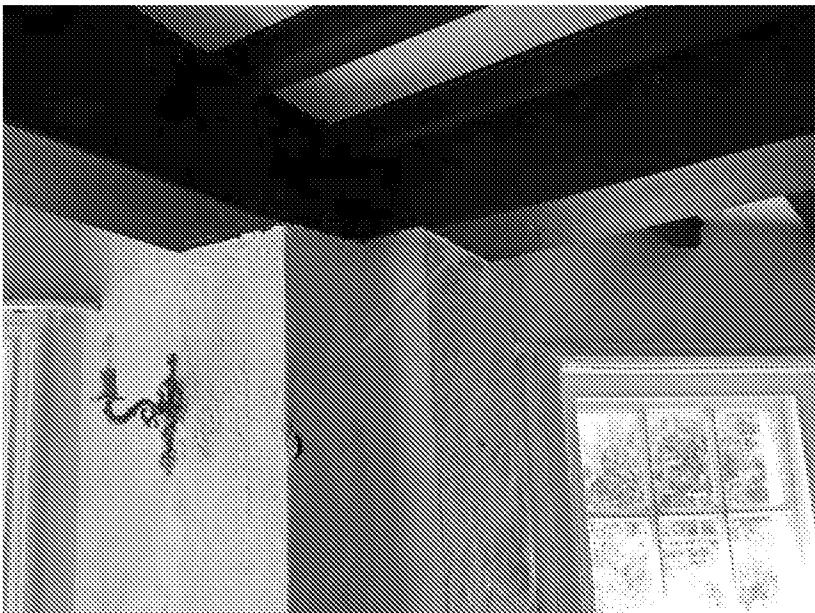
**Fig 92:**

South ground floor room; showing south bearing end of primary beam supporting the first floor above found to be over 50 per cent decayed and very vulnerable to further decay due to continuing problems of water penetration and dry rot (*Serpula lacrymans*) infection

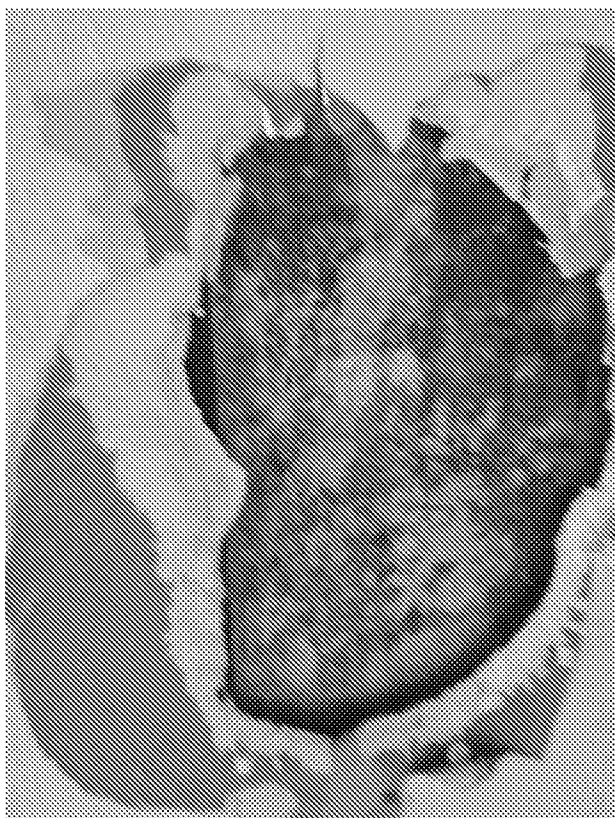
**Fig 94:**

South ground floor room; showing building void behind dry lining heavily contaminated with mould growth. This may represent a potential irritant or health hazard and indicates chronic problems of interstitial condensation due to inadequate provision for ventilation and damp-proofing on previous occupancy

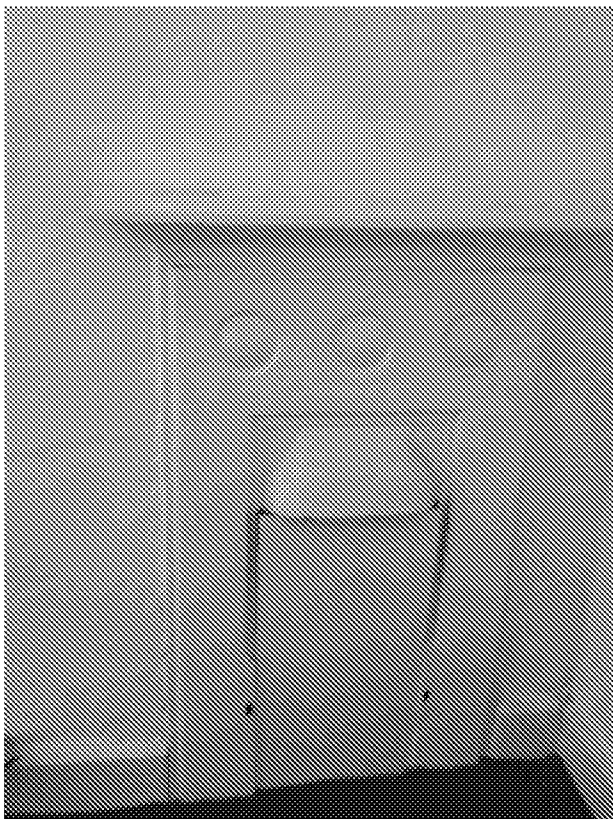
**Fig 96:**

First floor of main building; showing typical fireplace dating from the late 19<sup>th</sup> century blocked preventing ventilation and drying of the chimneystack above

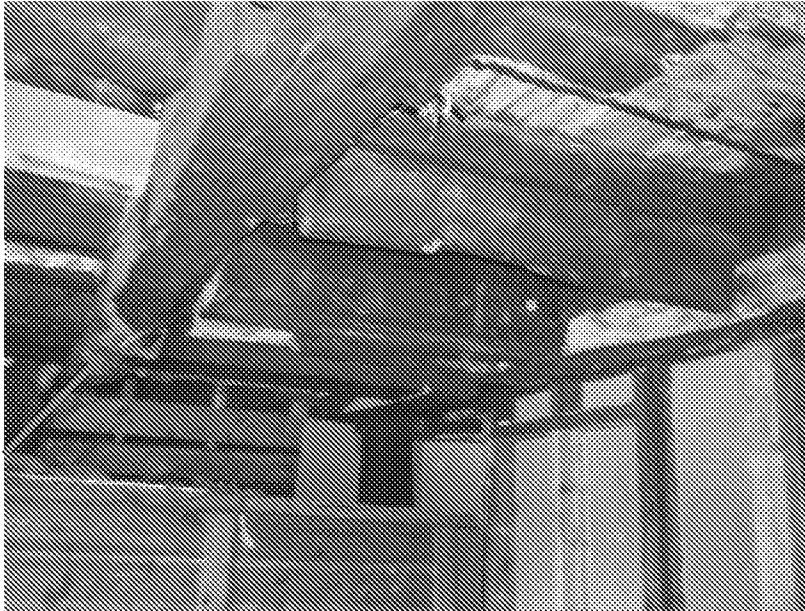
**Fig 97:**

Roof structure of original mill: showing general view of the east main beam of the roof. Note section reduction due to historic decay and beetle attack

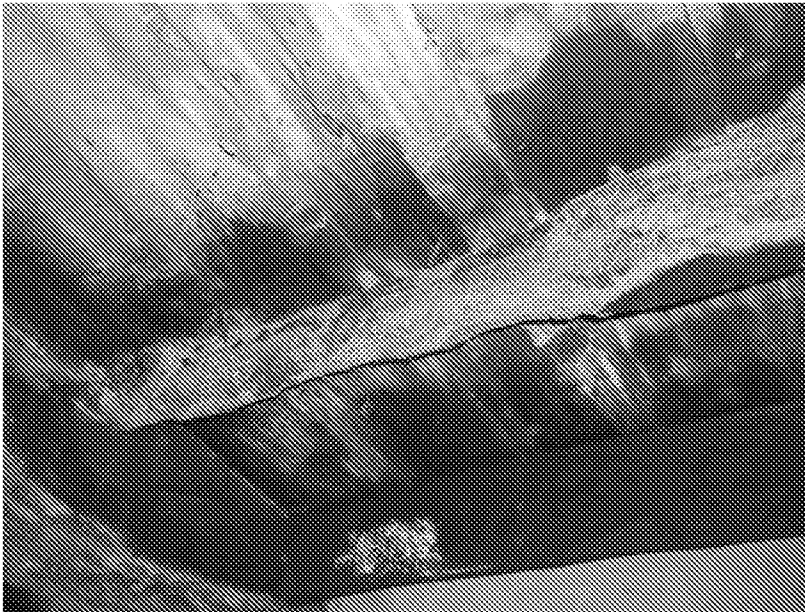
**Fig 98:**

Roof structure of original mill: showing general view of a timber joist, located between main roof beams. Note section reduction to the secondary beam due to historic decay and beetle attack

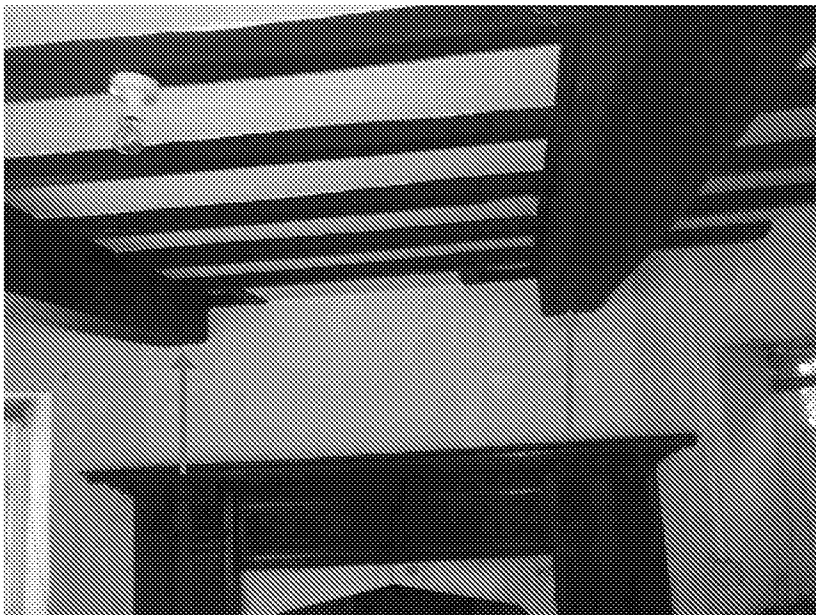
**Fig 100:**

Ground floor of the original mill: showing north bearing ends of the main beam , which had deep moisture content generally above 20 per cent. These elements may be vulnerable to future decay

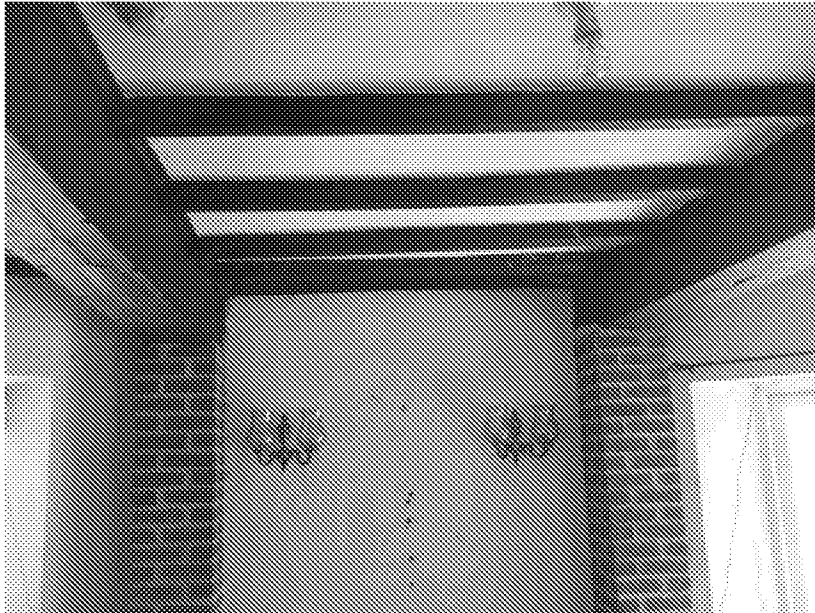
**Fig 101:**

Ground floor of the original mill:  
showing south bearing ends of the  
main beams , which appeared to be in  
good condition and deep moisture  
content generally below 12 per cent

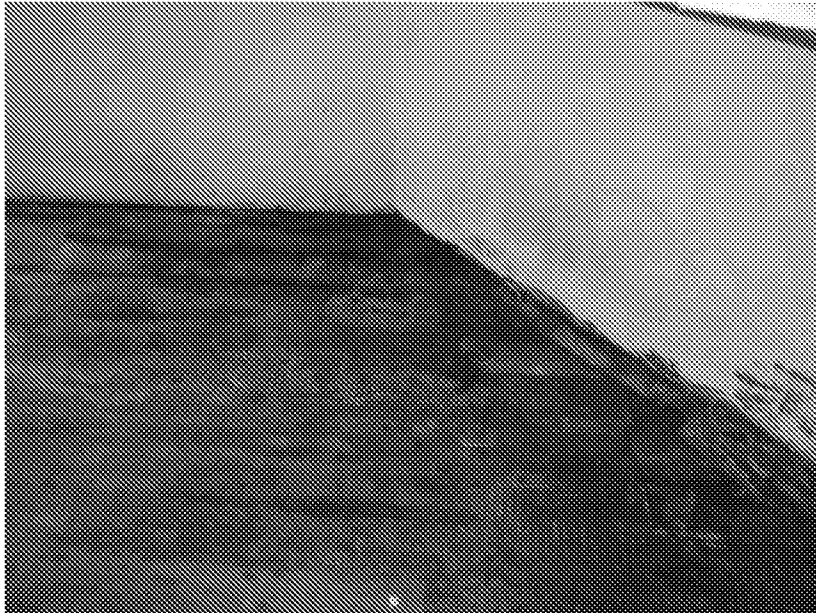
**Fig 103:**

Ground floor room at base of mill;  
showing decayed floorboards due to  
chronic water penetration
