GHA Trees  
5 South Drive  
High Wycombe  
Bucks  
HP13 8JU

22<sup>nd</sup> March 2021

**RE: Trees at Climping Mill, Climping Street, Climping, West Sussex**

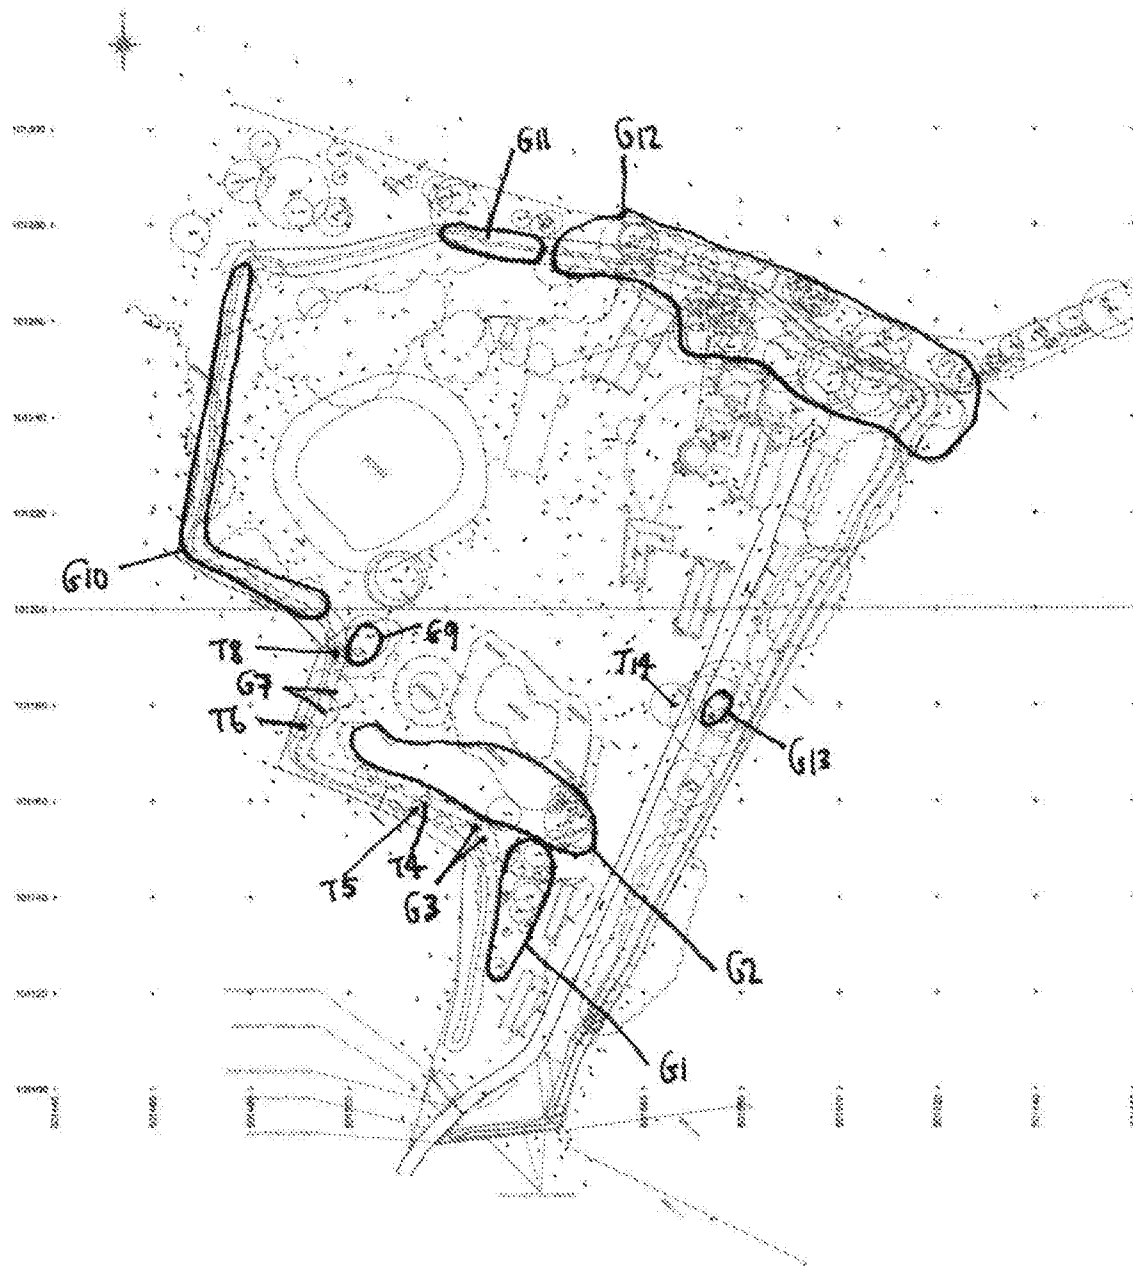
The attached table and site plan outlines the information I recorded. I graded each tree / group in line with BS 5837: 2012 – Trees in relation to design, demolition and construction – recommendation to assess the quality of each tree / group.

- Trees which are unimpacted by the new bund: **G1, G2, G13 and T14**
- Trees which are growing in / near the bund which can be retained but should be coppiced to allow increased bund stability: **T4, G7, T8, G10 and G11**
- Trees which are growing in / near the bund where no work is required at this stage: **T5**
- Trees which are growing in / near the bund where some remedial work is needed to improve their growing conditions: **G12**
- Declining / low value trees which are not worth retaining: **G3, T6 and G9**
