## ARBORICULTURAL REPORT

Reference: 140/OS/18

Site:

Oakside, 1 Old Rectory Drive, Eastergate, West Sussex, PO20 3XH.

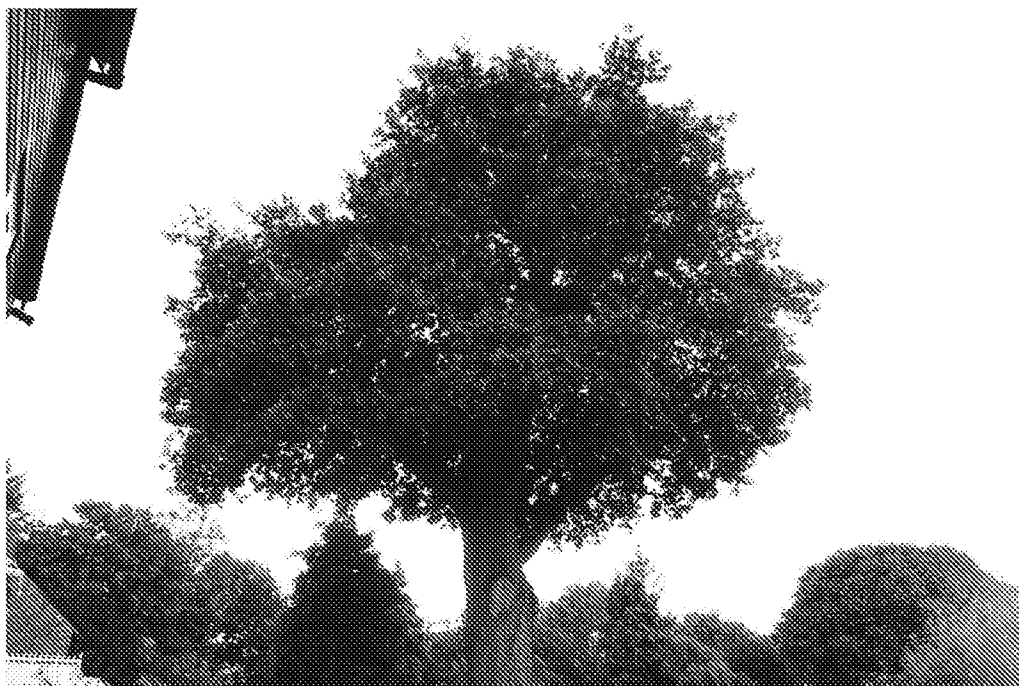
Fig 1 subject tree in rear garden

- 3.2 The subject tree in my opinion is becoming potentially dangerous and needs to be managed to reduce risk of failing in total or part. Removing tree by felling is an option but it can be given more year's life by selective work to reduce risk.

- ✓ There are several old pruning wounds on the stem that have fully occluded and wounds may go back before house was built.
  - ✓ Four fungal brackets around base of tree stem, plus one dead indicating heartwood decay. Buttress roots appear sound using a Thor hammer. I am informed by the tree surgeon Stuart Power who has cared for the tree since the mid-1970s told me that at least one bracket has always been there and now more appearing. These brackets appear at present to be not growing rapidly indicating slow decay.

The tree is now in a condition that requires careful consideration and a decision whether to fell now or manage by pruning by retrenchment. If the tree is to be retained I recommend reducing the crown to previous pruning points to reduce weight. In any event an application will have to be made to Arun District Council. My personal view would be to retain tree and manage until further obvious decline and consider a Picus test but important to make the tree safe.
