ARBORICULTURAL REPORT

LAR2501-ARB-REP-0140

**Land adjoining No. 275 Goring Way
275 Goring Way, Ferring**

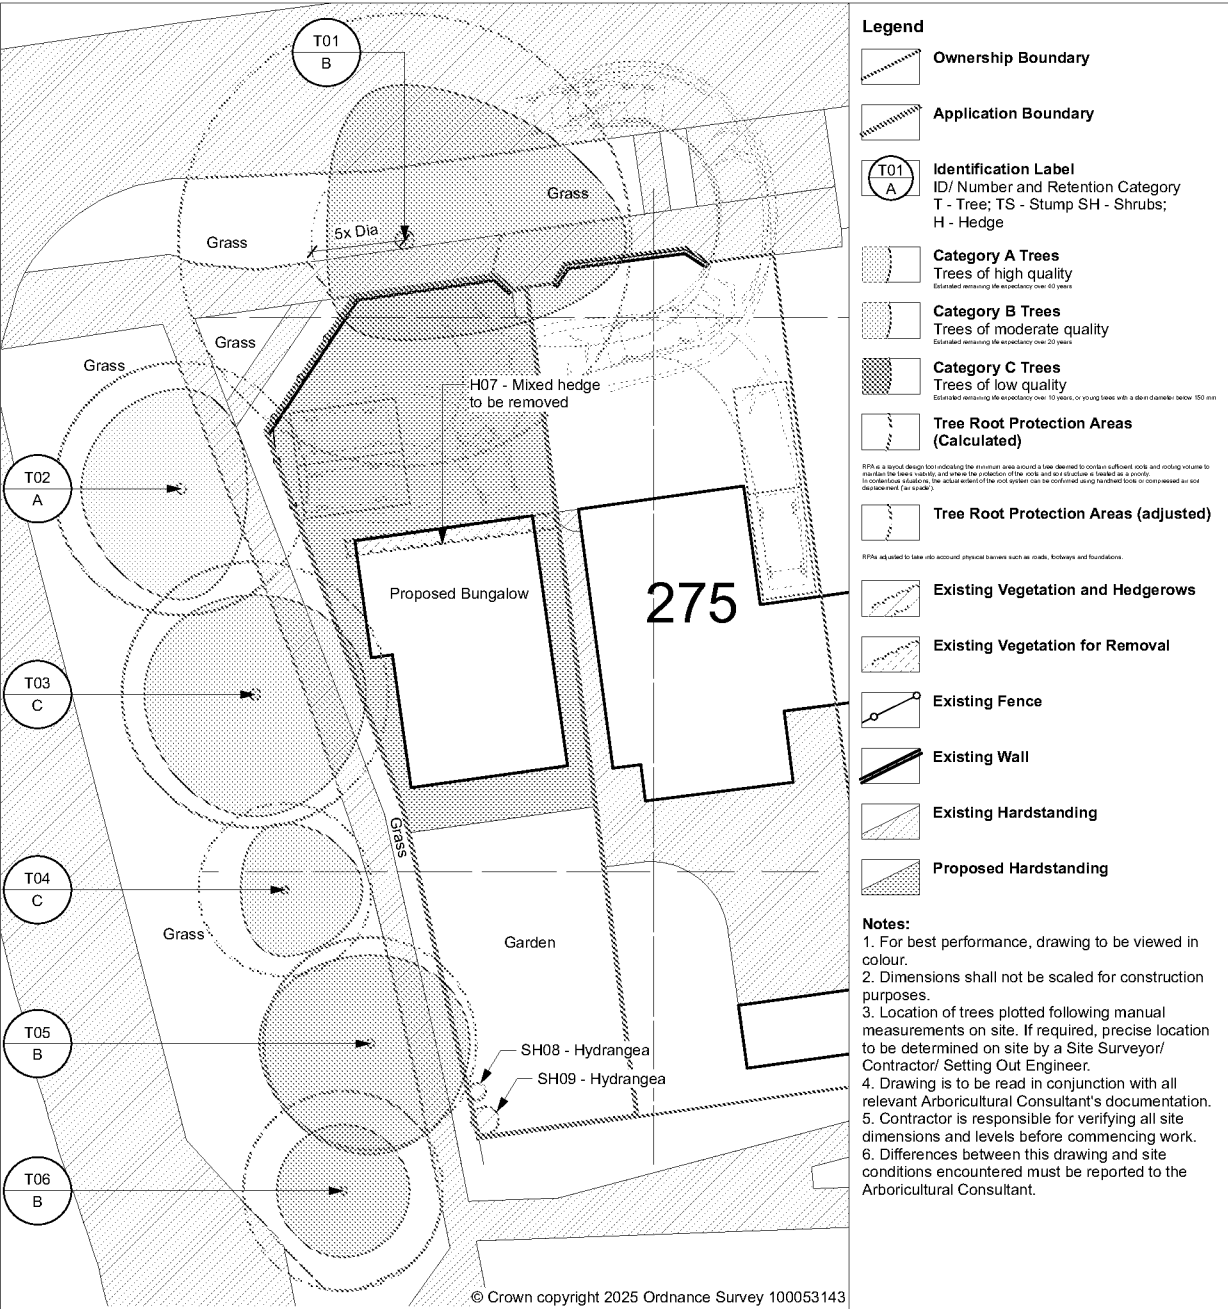
APPENDIX 5. TREE PROTECTION PLAN (EXTRACT)

Where new hardstanding is proposed within the calculated RPAs of the existing trees, it is recommended that construction should proceed with caution, breaking the ground using handheld tools, and under arboricultural supervision, to ensure that no structural roots over 25 mm in diameter are severed if encountered.

It is recommended to limit the extent of the proposed hardstanding to the area required for parking and manoeuvring and develop part of the property frontage as soft landscape.
