## TREE REPORT

### *Little Paddocks Estate, Ferring*

*Professional inspection*

**Bournetrees**  
Consultancy

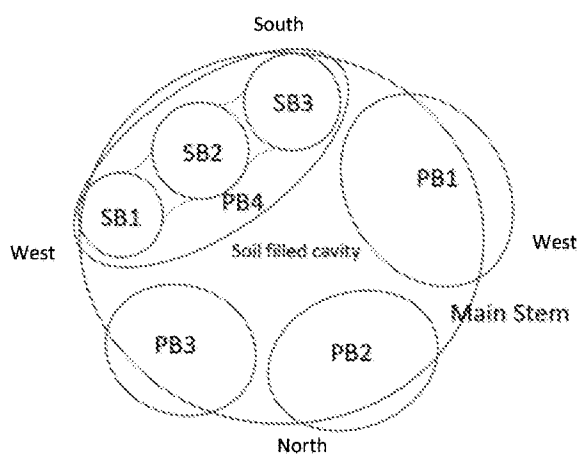
Picture 18, showing location of the major branches emanating from the main stem.

Diagram in Picture 18 above identifies all primary branching structures growing from the single at 1.2m from the main stem, orientated with the top facing south.
