Prepared by David Meagher Environment Consultants for  
AM Design Architects Limited's client - Mr. Michael Roberts

1.0 Summary and recommendations to retain and protect trees during demolition and construction. (following Arboriculture officer's comments).

4.0 Description of the Development: demolition of existing dwelling and construction of two bungalows

This report contains the supporting tree information relating to the study area located at land adjacent to 84 Flansham Lane, Bognor Regis, West Sussex PO22 6AH and the proposal to demolish existing bungalow and replace with two detached residential units.

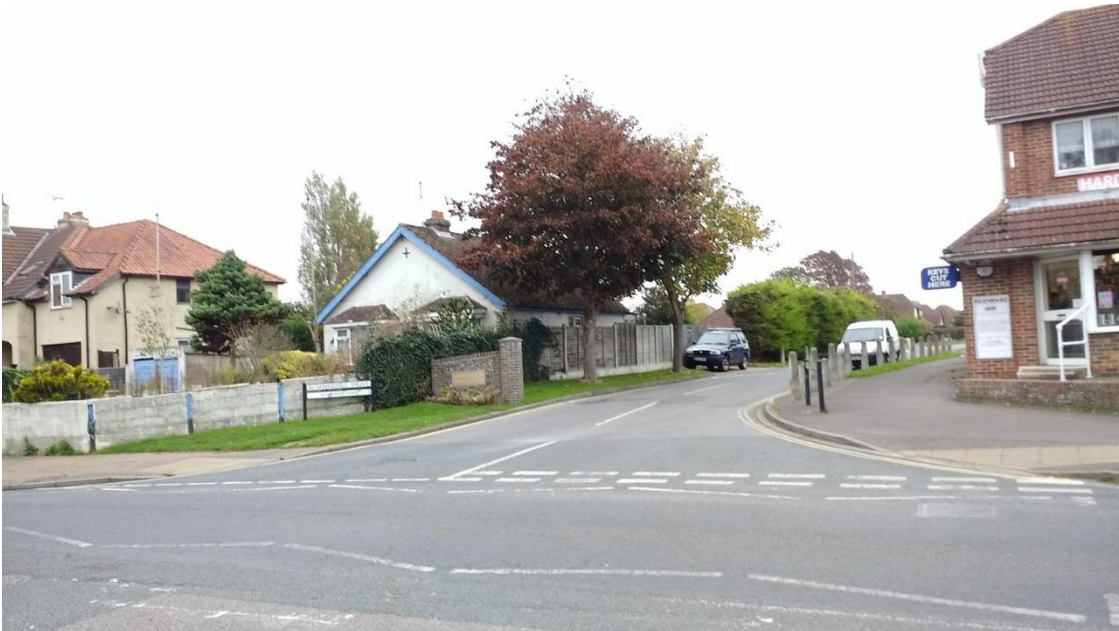
The existing canopies overlap the roof area of the bungalow to be demolished which if continued unheeded could result in damage to the upper parts of the tree. Specific in work (demolition) practices listed in the AMS will prevent damage. There are no apparent overhead services on site which pass through or near the existing trees. This is a private unlit road without street lighting or visible signs of overhead telecommunications cabling.

The existing trees (T1 & T2) require no tree pruning work as care in the demolition phase as outlined in the method statement should prevent possible damage.

The tree survey has established a root protection area suggesting that roots intrude under the bungalow which requires demolition. The extent to which to roots penetrate beneath the derelict bungalow is unknown. Damage below ground due to demolition is a high likelihood, for this reason measures need to be taken to prevent this happening. This is outlined in the AMS.

Above: T1 & T2 Norway Maple Subject Trees
