**Barratt Homes****Felpham**

**Inspection Date:** 10 Apr 2013

**Inspection Type:** Post Install Inspection

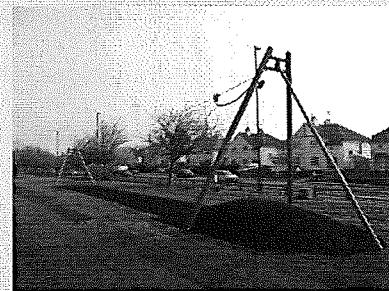
### Aerial Runway

- ❖ Standards Compliance – Yes
- ❖ Surfacing Area Compliance – Yes
- ❖ Surfacing Type – Grass Mats
- ❖ Manufacturer - Lappset
- ❖ Defects/Issues - Yes

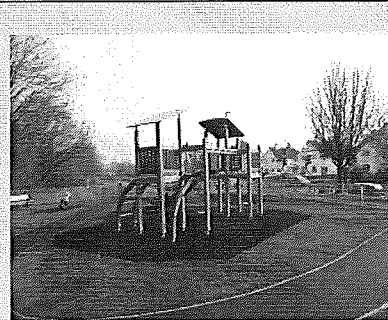
### Multi Play Unit

- ❖ Standards Compliance – Yes
- ❖ Surfacing Area Compliance – Yes
- ❖ Surfacing Type – Grass Mats
- ❖ Manufacturer – Lappset
- ❖ Defects/Issues - Yes

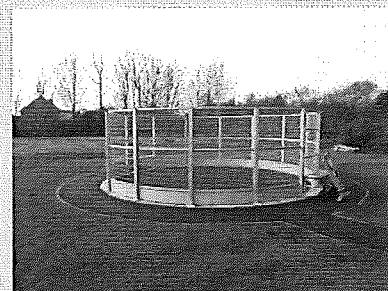
### PANNA

- ❖ Standards Compliance – N/A
- ❖ Surfacing Area Compliance – N/A
- ❖ Surfacing Type – Tarmac
- ❖ Manufacturer - Lappset
- ❖ Defects/Issues - Yes

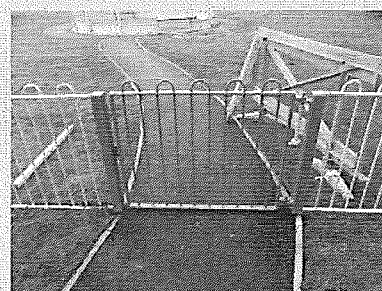
### Single Gate x 3

- ❖ Standards Compliance – N/A
- ❖ Surfacing Area Compliance – N/A
- ❖ Surfacing Type – N/A
- ❖ Manufacturer - Steelway Fensecure
- ❖ Defects/Issues - Yes
