## Post Installation Report

Barratt Southampton

Blakes Mead

Post Installation Report - 21 July 2017 at 09:40 Inspector: Chris Buss RPII Annual Inspector

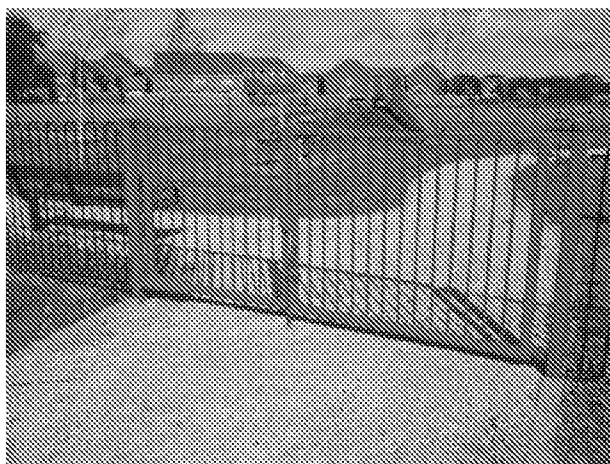
**Item:** Ancillary Items - Gate - Combination  
**Manufacturer:** Not Identified  
**Surface Type:** Compacted Stone  
**Equipment Compliance:** N/A  
**Surface Area Compliance:** N/A  
**Ref/Part Number:**  
**Total Findings:** 2

There is no padlock on the maintenance gate - Provide a padlock to secure the gate

The locking pin socket is silted up - Clean and maintain

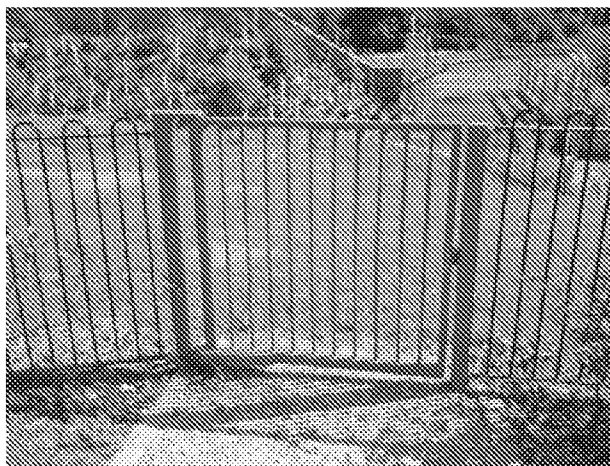
**Item:** Ancillary Items - Gate - Self Closing  
**Manufacturer:** Not Identified  
**Surface Type:** Compacted Stone  
**Equipment Compliance:** N/A  
**Surface Area Compliance:** N/A  
**Ref/Part Number:**  
**Total Findings:** 1

This item is satisfactory - no work required

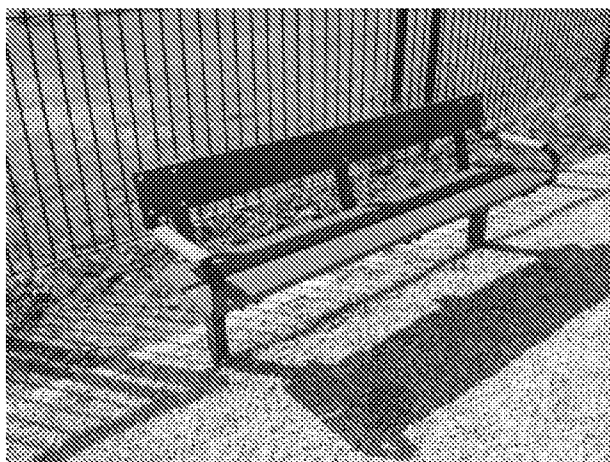
**Item:** Ancillary Items - Bench  
**Manufacturer:** Not Identified  
**Surface Type:** Compacted Stone  
**Equipment Compliance:** N/A  
**Surface Area Compliance:** N/A  
**Ref/Part Number:**  
**Total Findings:** 1

Parts of the timber are rough or splintered - Remove all rough or sharp edges

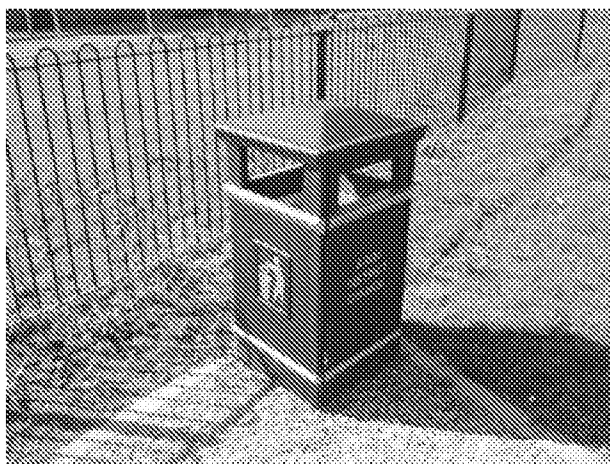
**Item:** Ancillary Items - Litter Bin  
**Manufacturer:** Wybone  
**Surface Type:** Compacted Stone  
**Equipment Compliance:** N/A  
**Surface Area Compliance:** N/A  
**Ref/Part Number:**  
**Total Findings:** 1

This item is satisfactory - no work required

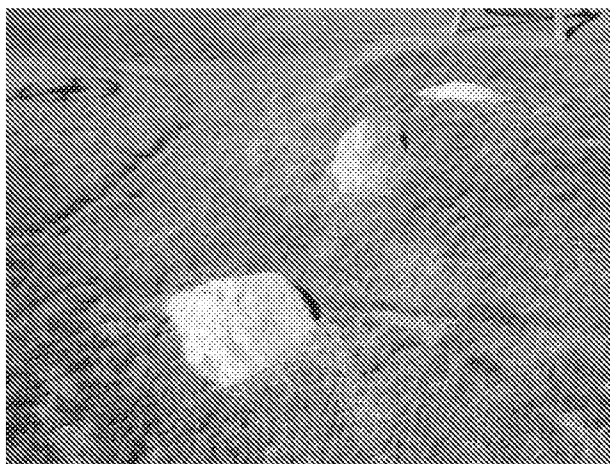
**Item:** Ancillary Items - Boulders  
**Manufacturer:** Not Applicable  
**Surface Type:** Grass  
**Equipment Compliance:** N/A  
**Surface Area Compliance:** N/A  
**Ref/Part Number:**  
**Total Findings:** 1

The use of boulders in the play area presents a risk to users of falling onto hard objects - Monitor use

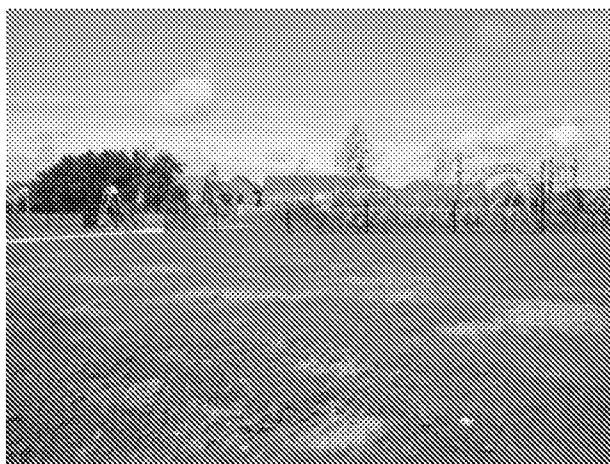
**Item:** Ancillary Items - Site General  
**Manufacturer:** Not Applicable  
**Surface Type:** N/A  
**Equipment Compliance:** N/A  
**Surface Area Compliance:** N/A  
**Ref/Part Number:**  
**Total Findings:** 3

There are ongoing works to the surrounding landscaping - Complete installation

The landscaping on site is not fully established and has deteriorated since the initial completion of the site - Reinststate/make good the landscaping on site

There are small holes in the riding surface in places and some minor damage to the surface around site - Monitor for any further deterioration and repair as required

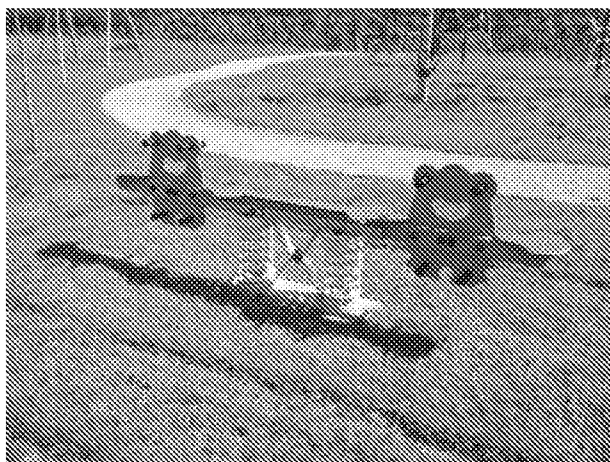
**Item:** Rocking Equipment - Spring See-Saw  
**Manufacturer:** Proludic  
**Surface Type:** Grass Matrix Tiles  
**Equipment Compliance:** Yes  
**Surface Area Compliance:** Yes  
**Ref/Part Number:**  
**Total Findings:** 1

This item is satisfactory - no work required

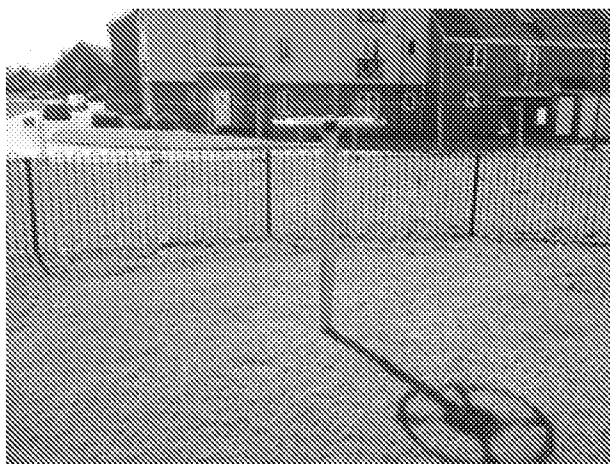
**Item:** Rotor Play - Overhead Rotator  
**Manufacturer:** Proludic  
**Surface Type:** Grass Matrix Tiles  
**Equipment Compliance:** Yes  
**Surface Area Compliance:** Yes  
**Ref/Part Number:**  
**Total Findings:** 1

There is no identification label affixed to the equipment - Provide an identification label

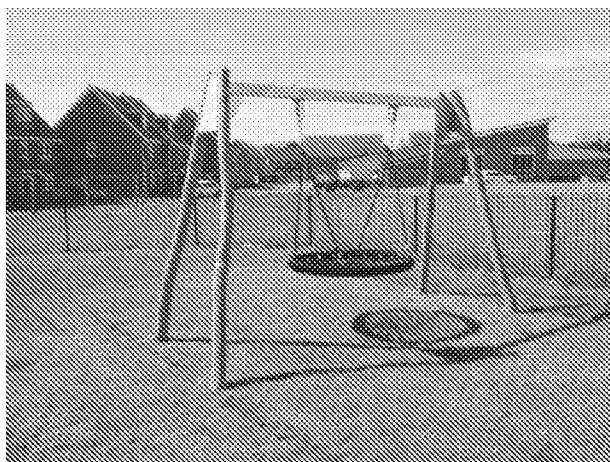
**Item:** Swings - Basket Swing - Type 1  
**Manufacturer:** Norleg  
**Surface Type:** Grass Matrix Tiles  
**Equipment Compliance:** Yes  
**Surface Area Compliance:** Yes  
**Ref/Part Number:**  
**Total Findings:** 1

This item is satisfactory - no work required

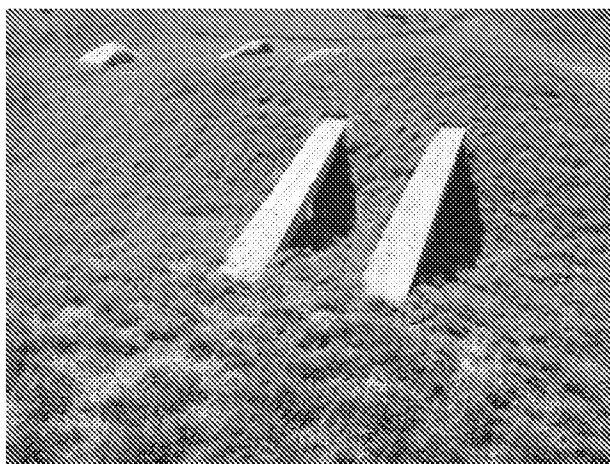
**Item:** Activity Equipment - Balance Beam  
**Manufacturer:** Not Identified  
**Surface Type:** Grass  
**Equipment Compliance:** Yes  
**Surface Area Compliance:** Yes  
**Ref/Part Number:**  
**Total Findings:** 2

Parts of the timber are rough or splintered - Remove all rough or sharp edges

The ground fixings are working loose on one beam - Secure

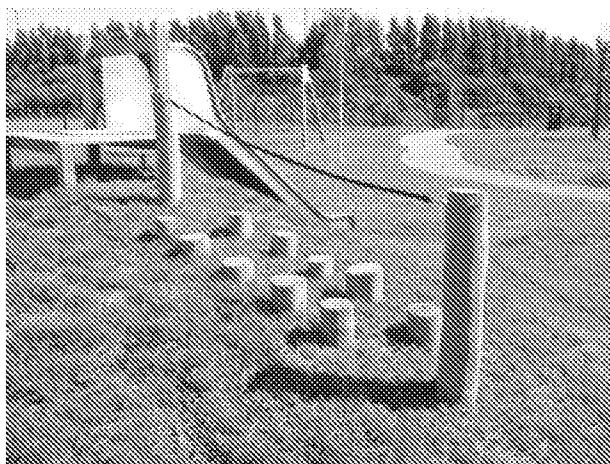
**Item:** Activity Equipment - Rope Walk  
**Manufacturer:** Norleg  
**Surface Type:** Grass Matrix Tiles  
**Equipment Compliance:** Yes  
**Surface Area Compliance:** Yes  
**Ref/Part Number:**  
**Total Findings:** 1

The step between the stepping stones and the slide platform is quite large and users may not be able to complete the step without touching ground, the items could therefore be considered to be within the falling space of each other, however the intention of the play activity continuity is easily apparent and foreseeable to the user (stepping stone to platform 1.15m) - Monitor use

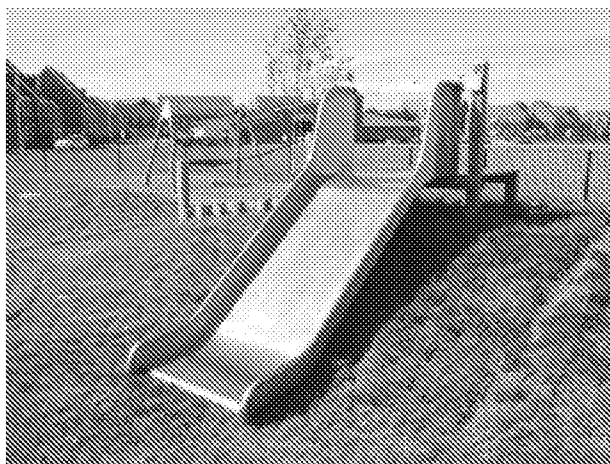
**Item:** Other - Embankment Slide  
**Manufacturer:** Norleg  
**Surface Type:** Grass Matrix Tiles  
**Equipment Compliance:** No  
**Surface Area Compliance:** Yes  
**Ref/Part Number:**  
**Total Findings:** 5

Fixing Pins have been installed in the impact areas of the grass mats - Remove pins from impact areas

The identification label is loose and damaged - Repair

There is a finger entrapment in one opening at the top of the slide and the item fails to meet the requirements of BS EN 1176:2008 Part 1 4.2.7.6 Entrapment of fingers - Refer to the manufacturer

The step between the slide platform and rope pull is quite large and users may not be able to complete the step without touching ground, the items could therefore be considered to be within the falling space of each other, however the intention of the play activity continuity is easily apparent and foreseeable to the user (platform to post 600mm) - Monitor use

Parts of the timber are rough or splintered - Remove all rough or sharp edges

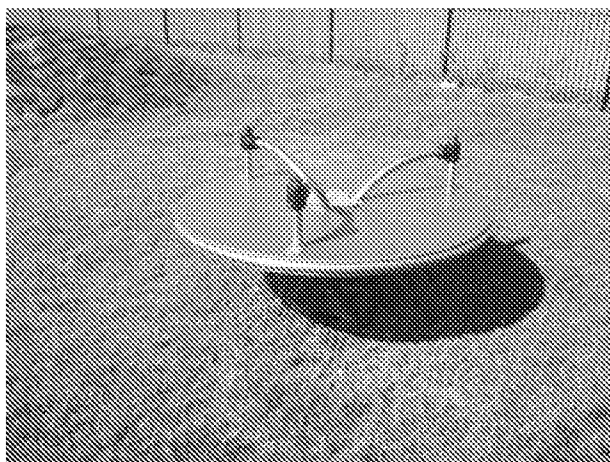
**Item:** Rotor Play - Roundabout  
**Manufacturer:** Proludic  
**Surface Type:** Grass Matrix Tiles  
**Equipment Compliance:** No  
**Surface Area Compliance:** Yes  
**Ref/Part Number:**  
**Total Findings:** 4

There is offensive graffiti present - Remove as soon as practicable

The base is loose in the ground - Secure

There is/are bolt cap covers missing or damaged on the item - Replace missing or damaged bolt cap covers

The height of the roundabout platform is less than 400mm (385mm) and fails the requirements of BS EN 1176 Part 5 (this is due to the base being loose and the item leaning) - Refer to the manufacturer

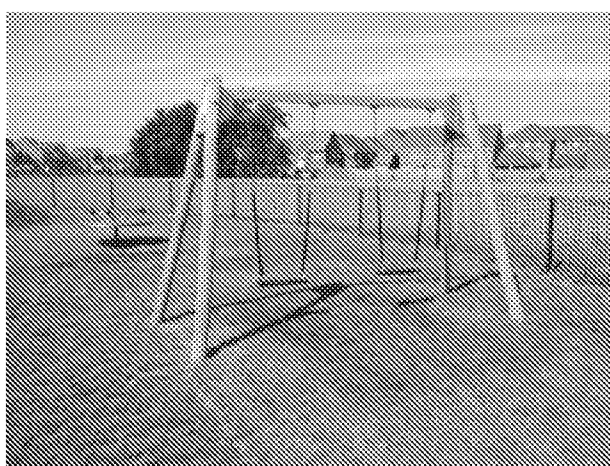
**Item:** Swings - 1 Bay 2 Seat (Flat)  
**Manufacturer:** Norleg  
**Surface Type:** Grass Matrix Tiles  
**Equipment Compliance:** Yes  
**Surface Area Compliance:** Yes  
**Ref/Part Number:**  
**Total Findings:** 1

This item is satisfactory - no work required

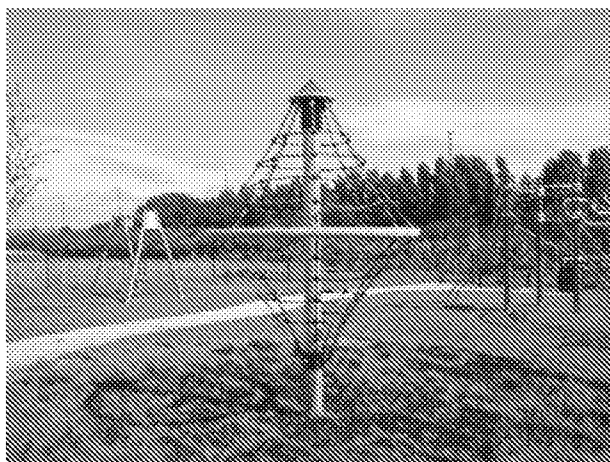
**Item:** Rotor Play - Rotating Net  
**Manufacturer:** Huck Nets (UK) Ltd  
**Surface Type:** Grass Matrix Tiles  
**Equipment Compliance:** Yes  
**Surface Area Compliance:** Yes  
**Ref/Part Number:**  
**Total Findings:** 1

There are unused fixing points on the post cap that create potential finger entrapments - Provide inserts

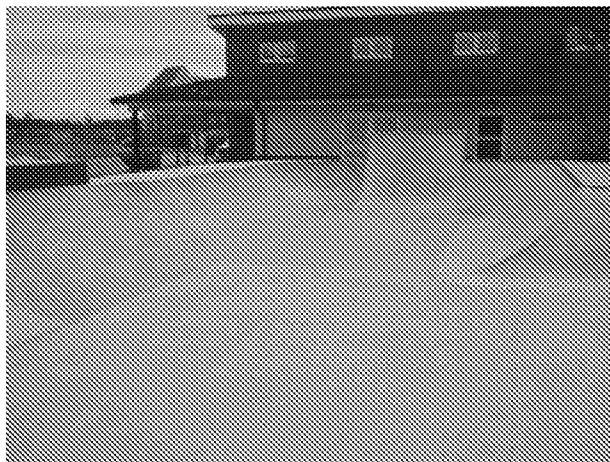
**Item:** Wheeled Sports - Concrete Bowl  
**Manufacturer:** Not Identified  
**Surface Type:** Concrete  
**Equipment Compliance:** No  
**Surface Area Compliance:** Yes  
**Ref/Part Number:**  
**Total Findings:** 2

The foliage is growing into the 2.0m safety zone - Cut back and maintain

There is some damage to the concrete riding surface adjacent to the copings - Monitor for any further deterioration and repair as required

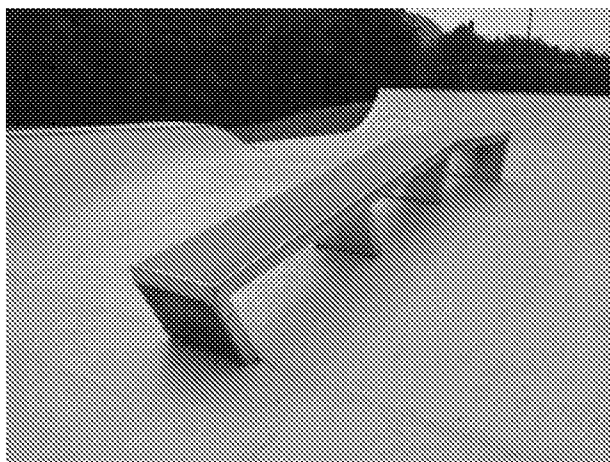
**Item:** Wheeled Sports - Grind Bench  
**Manufacturer:** Not Identified  
**Surface Type:** Concrete  
**Equipment Compliance:** Yes  
**Surface Area Compliance:** Yes  
**Ref/Part Number:**  
**Total Findings:** 1

There are sharp edges along the sides of the riding surface - Rub down to remove sharp edges

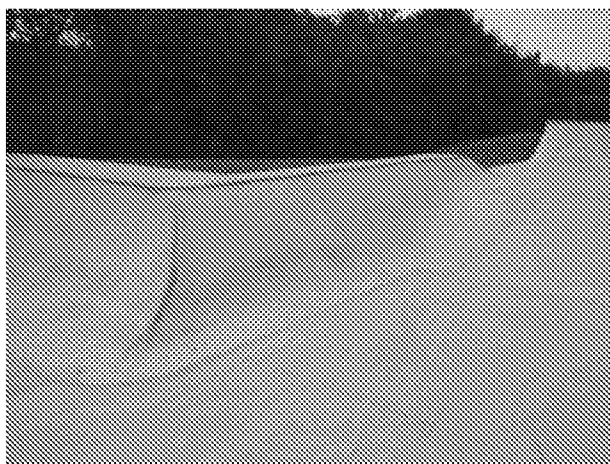
**Item:** Wheeled Sports - Concrete Ramp  
**Manufacturer:** Not Identified  
**Surface Type:** Concrete  
**Equipment Compliance:** Yes  
**Surface Area Compliance:** Yes  
**Ref/Part Number:**  
**Total Findings:** 1

This item is satisfactory - no work required

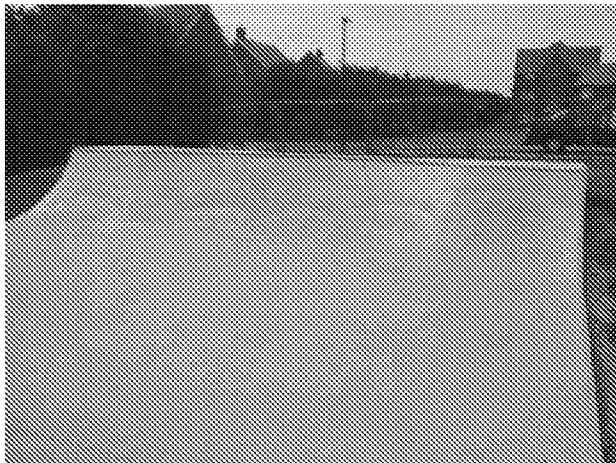
| 4 - Very Low Risk | |
|---|---|
| <b>Item:</b> | Wheeled Sports - Curved Start Ramp |

| Finding 1 |
|---|
| This item is satisfactory - no work required |

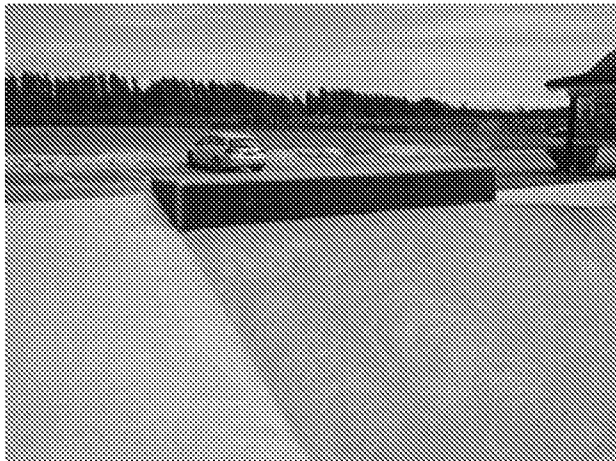
| 4 - Very Low Risk | |
|---|---|
| <b>Item:</b> | Wheeled Sports - Ledge |

| Finding 1 |
|---|
| This item is satisfactory - no work required |

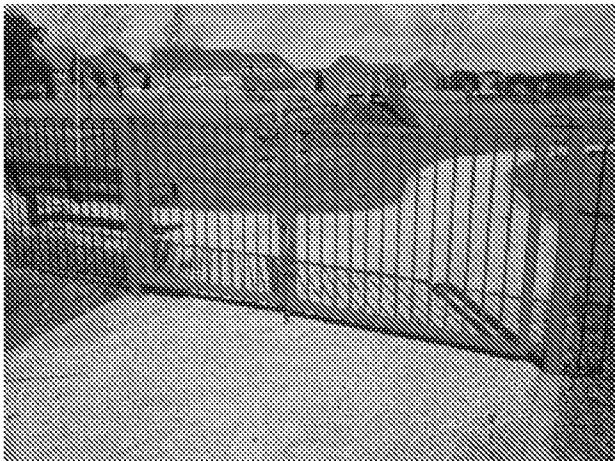
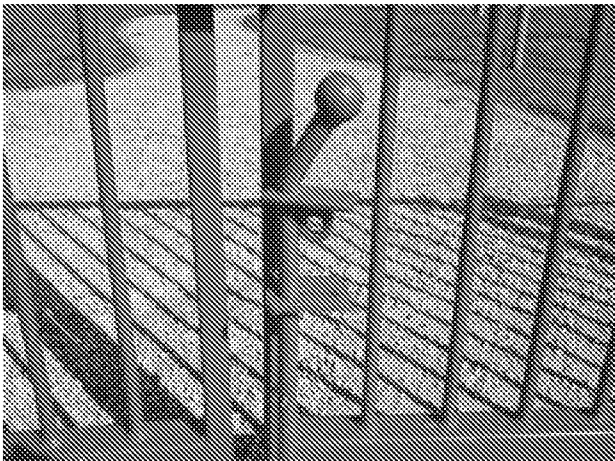
| 6 - Low Risk (Finding 1) | | | |
|---|---|---|---|
| <b>Finding:</b> | There is no padlock on the maintenance gate | | <b>Action:</b> Provide a padlock to secure the gate |

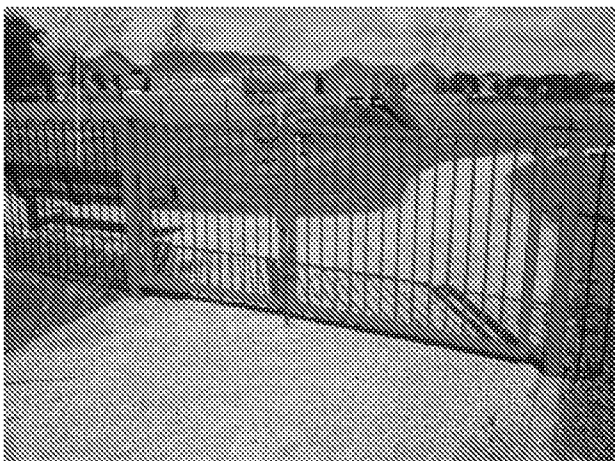
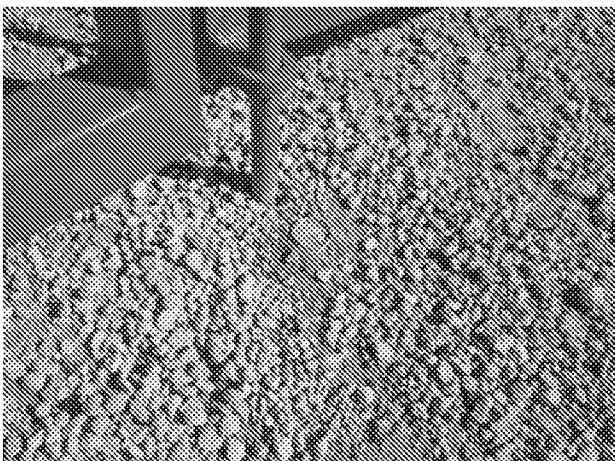
| 6 - Low Risk (Finding 2) | | | |
|---|---|---|---|
| <b>Finding:</b> | The locking pin socket is silted up | | <b>Action:</b> Clean and maintain |

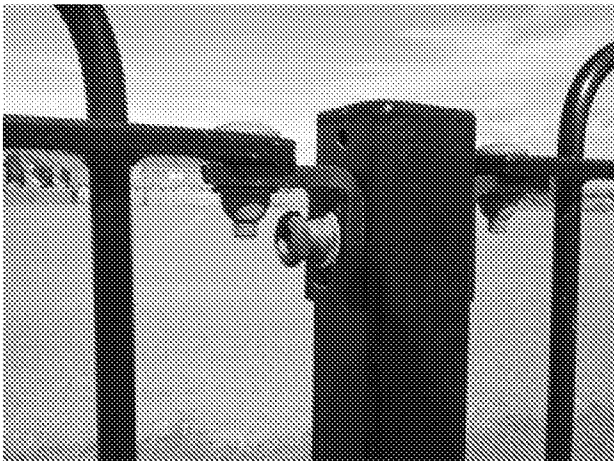
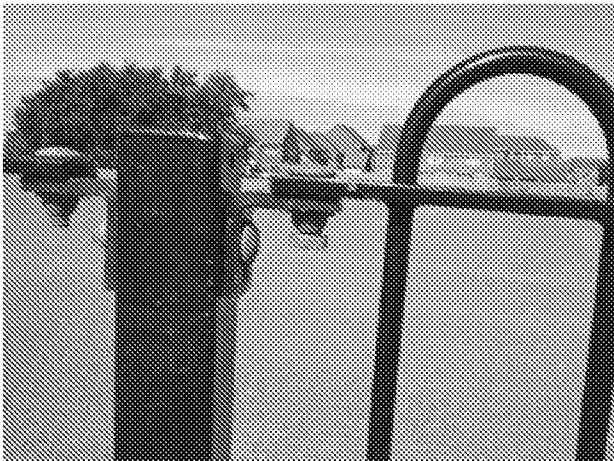
| 4 - Very Low Risk (Finding 4) | | | |
|---|---|---|---|
| <b>Finding:</b> | There are incomplete shear nut fixings | | <b>Action:</b> Complete installation |

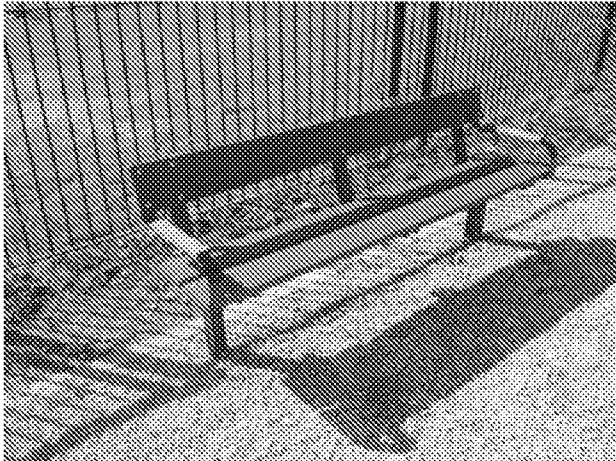
| <b>B - Low Risk (Finding 1)</b> | | | |
|---|---|---|---|
| <b>Finding:</b> | Parts of the timber are rough or splintered | | <b>Action:</b> Remove all rough or sharp edges |

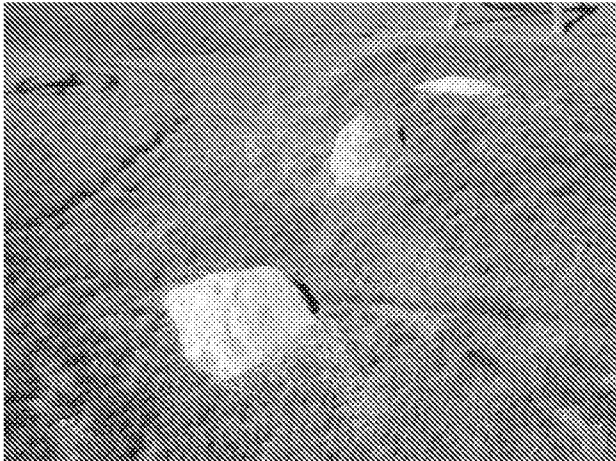
| <b>5 - Very Low Risk (Finding 1)</b> | | | |
|---|---|---|---|
| <b>Finding:</b> | The use of boulders in the play area presents a risk to users of falling onto hard objects | | <b>Action:</b> Monitor use |

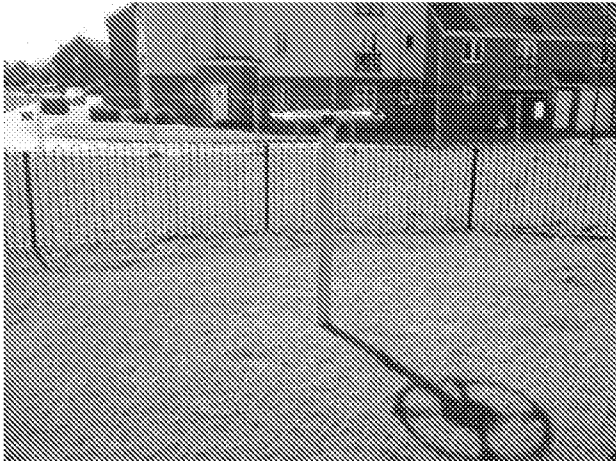
| 4 - Very Low Risk (Finding 1) | | | |
|---|---|---|---|
| <b>Finding:</b> | There is no identification label affixed to the equipment | | <b>Action:</b> Provide an identification label |

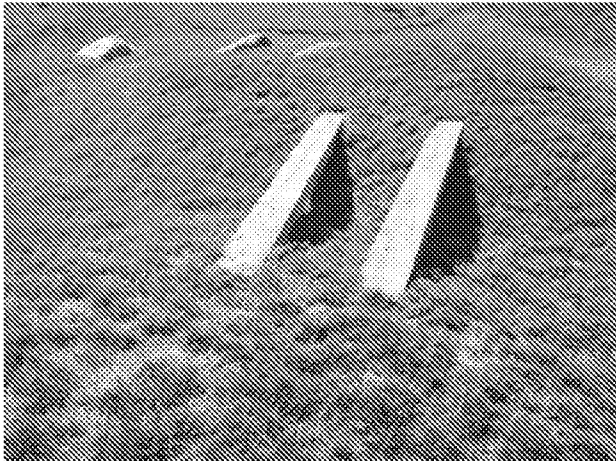
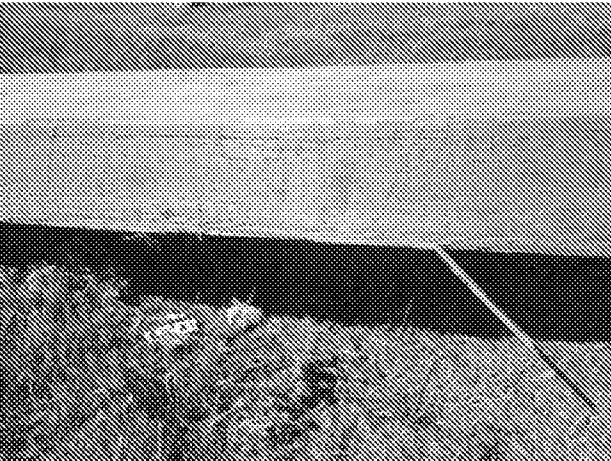
| 6 - Low Risk (Finding 1) | | | |
|---|---|---|---|
| <b>Finding:</b> | Parts of the timber are rough or splintered | | <b>Action:</b> Remove all rough or sharp edges |

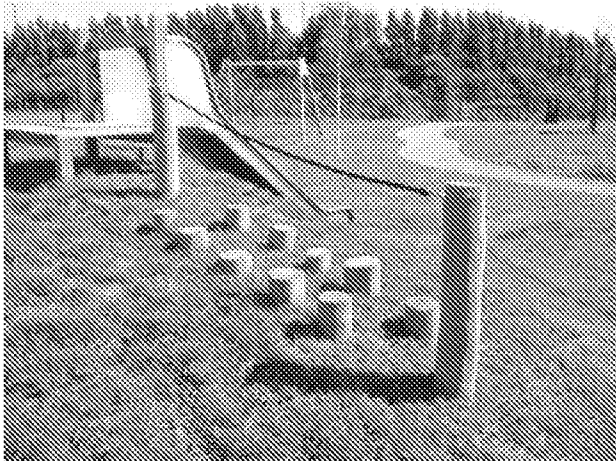
| <b>4 - Very Low Risk (Finding 1)</b> | | | |
|---|---|---|---|
| <b>Finding:</b> | The step between the stepping stones and the slide platform is quite large and users may not be able to complete the step without touching ground, the items could therefore be considered to be within the falling space of each other, however the intention of the play activity continuity is easily apparent and foreseeable to the user (stepping stone to platform 1.15m) | | <b>Action:</b> Monitor use |

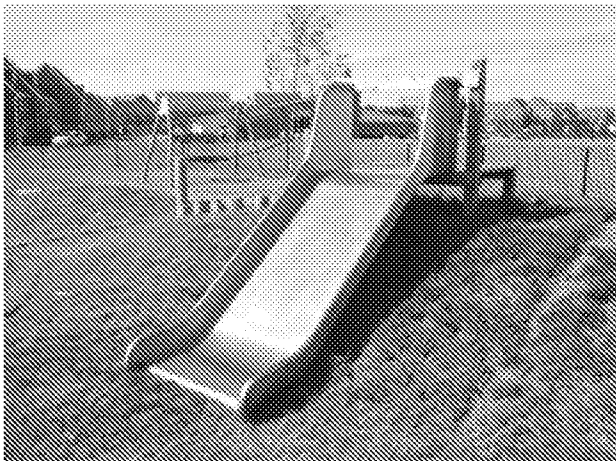
| <b>4 - Very Low Risk (Finding 4)</b> | | | |
|---|---|---|---|
| <b>Finding:</b> | The step between the slide platform and rope pull is quite large and users may not be able to complete the step without touching ground, the items could therefore be considered to be within the falling space of each other, however the intention of the play activity continuity is easily apparent and foreseeable to the user (platform to post 600mm) | | <b>Action:</b> Monitor use |

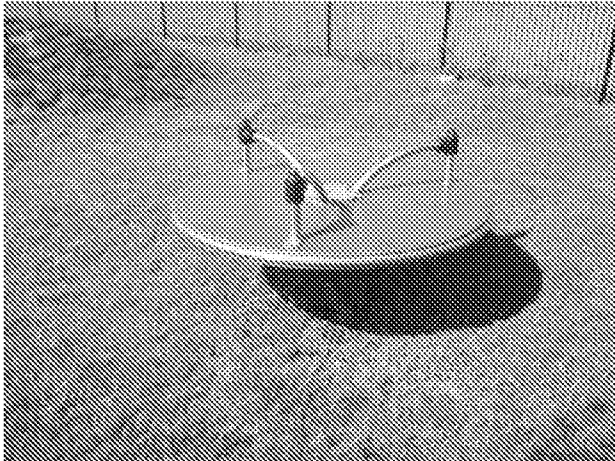
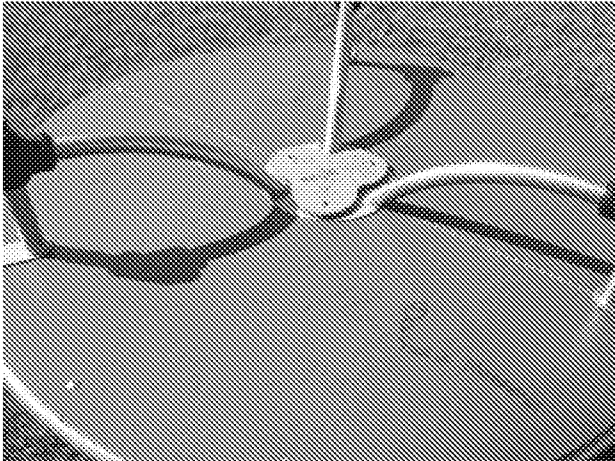
| <b>2 - Very Low Risk (Finding 1)</b> | | | |
|---|---|---|---|
| <b>Finding:</b> | There is offensive graffiti present | | <b>Action:</b> Remove as soon as practicable |

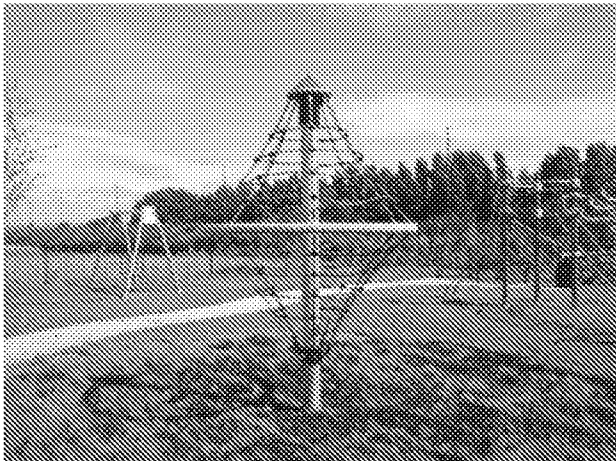
| <b>5 - Very Low Risk (Finding 1)</b> | | | |
|---|---|---|---|
| <b>Finding:</b> | There are unused fixing points on the post cap that create potential finger entrapments | | <b>Action:</b> Provide inserts |

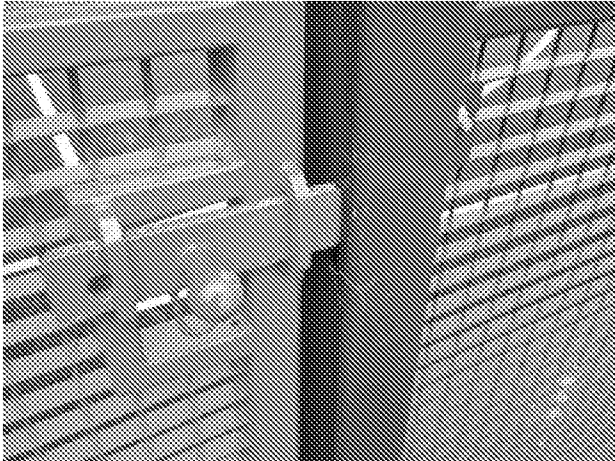
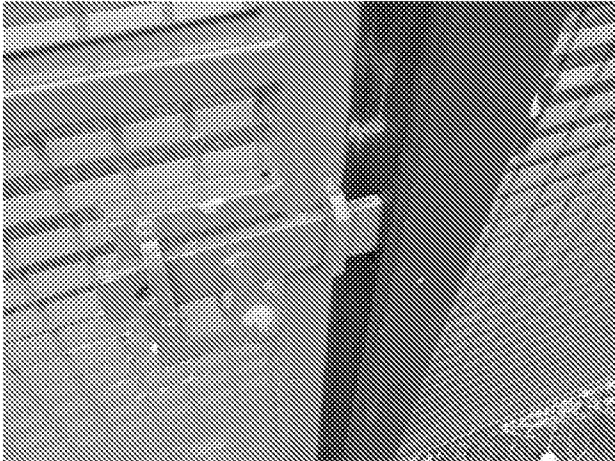
| <b>B - Low Risk (Finding 3)</b> | | | |
|---|---|---|---|
| <b>Finding:</b> | The gate latches are stiff or not closing | | <b>Action:</b> Adjust |

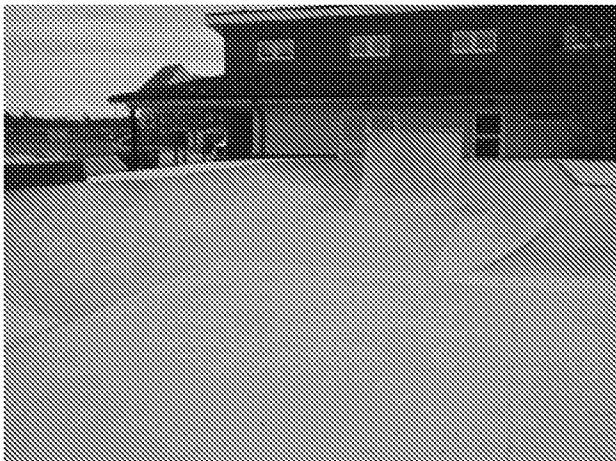
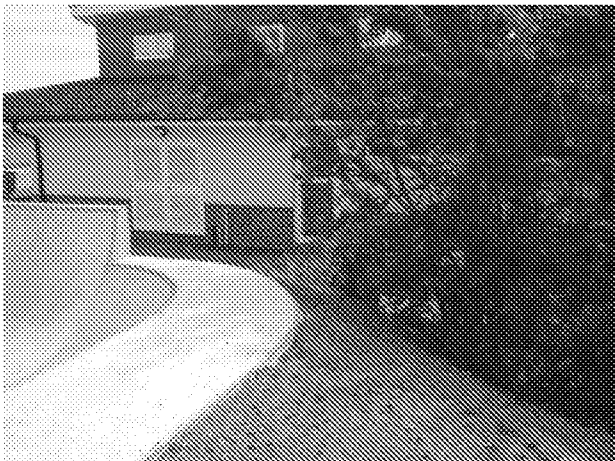
| B - Low Risk (Finding 1) | | | |
|---|---|---|---|
| <b>Item:</b> | Wheeled Sports - Concrete Bowl | <b>Risk Level:</b> | L - Low Risk |

| B - Low Risk (Finding 1) | | | |
|---|---|---|---|
| <b>Finding:</b> | The foliage is growing into the 2.0m safety zone | | <b>Action:</b> Cut back and maintain |

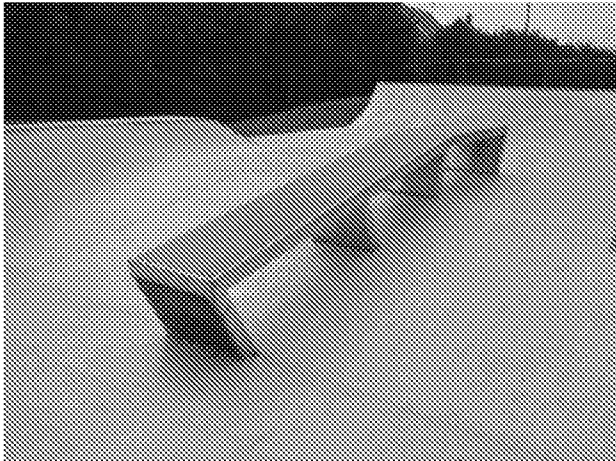
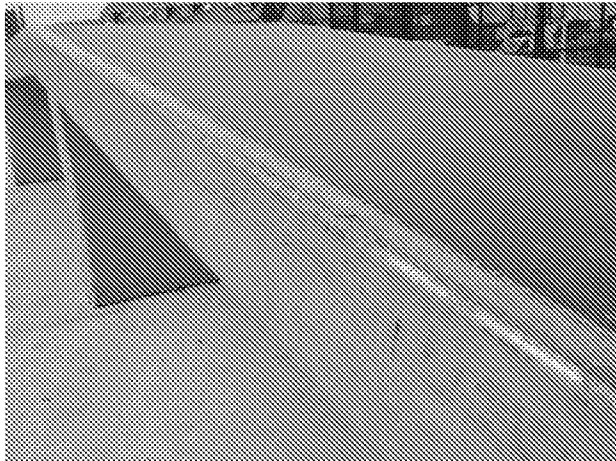
| <b>B - Low Risk (Finding 1)</b> | | | |
|---|---|---|---|
| <b>Finding:</b> | There are sharp edges along the sides of the riding surface | | <b>Action:</b> Rub down to remove sharp edges |
