## Post Installation Report

Barratt Southampton

Blakes Mead

Post Installation Report - 15 December 2016 at 12:28 Inspector: Robert Baldock (RPII Annual Inspector)

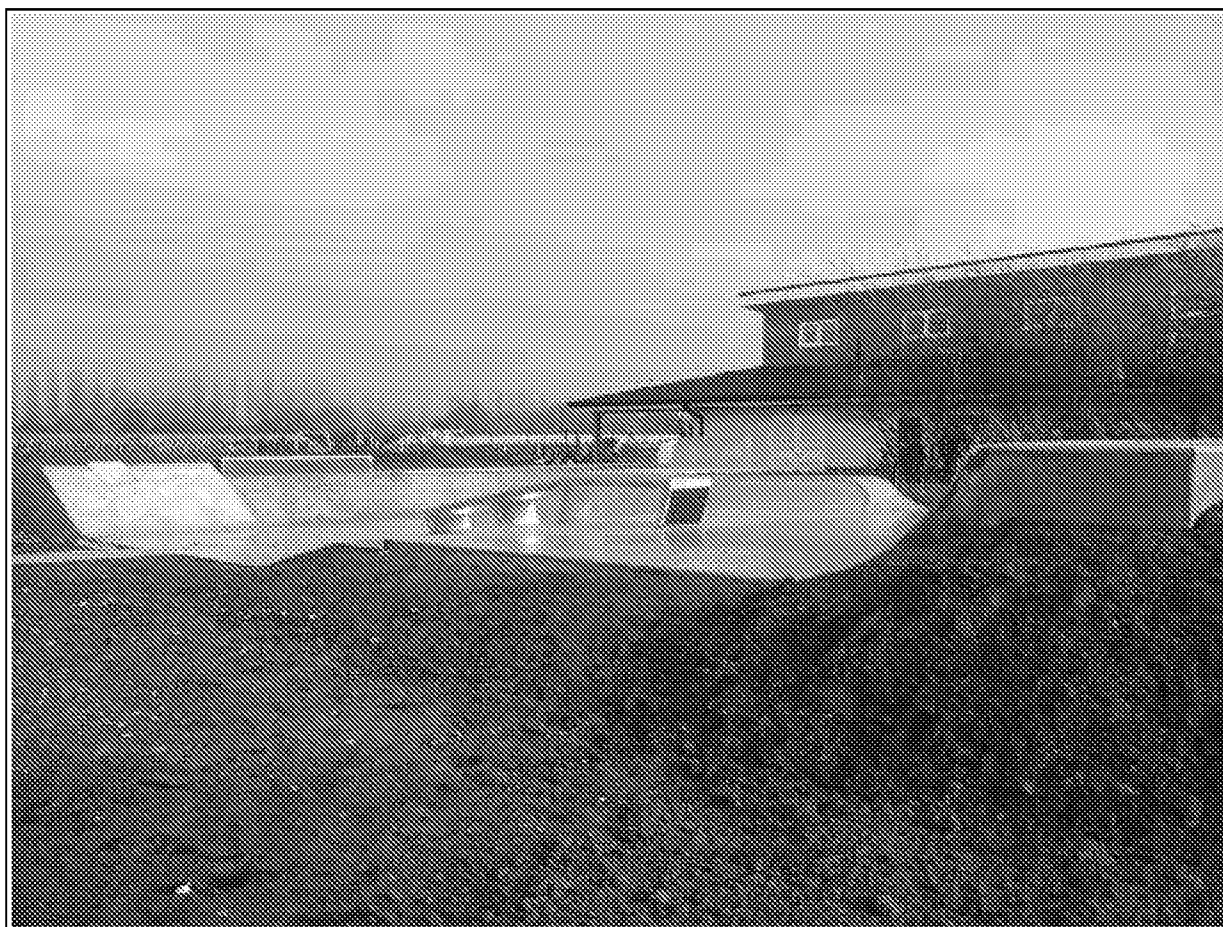
Risk Assessment: 12 - Moderate Risk

**Location:** The site is partially overlooked by properties in the local community

**Disabled Access:** Some accessible features; an area that presents difficulties to the majority of people with disabilities but in favourable circumstances and certainly in partnership can be accessed.
