## Post Installation Report

Barratt Southampton

Blakes Mead Play Area 2

Inspection Ref: 638829

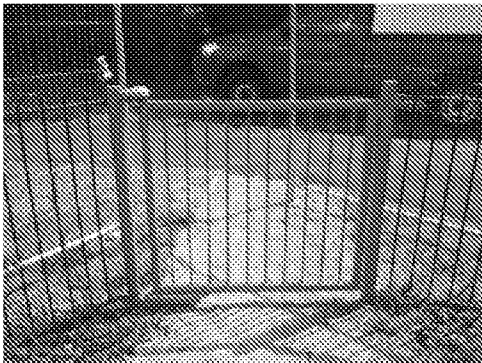
| 4 - Very Low Risk | |
|---|---|
| Item: | Gate - Self Closing |

| 4 - Very Low Risk | |
|---|---|
| This item is satisfactory - no work required | |

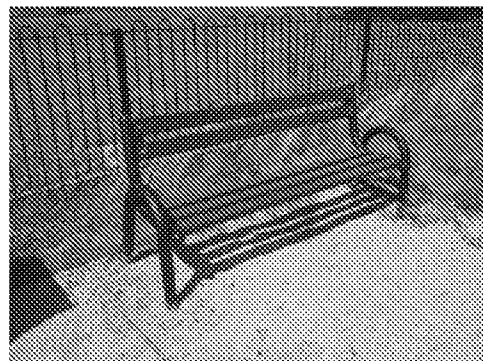
**Item:** Bench  
**Manufacturer:** Not Identified  
**Surface Type:** N/A  
**Equipment Compliance:** N/A  
**Surface Area Compliance:** N/A

This item is satisfactory - no work required

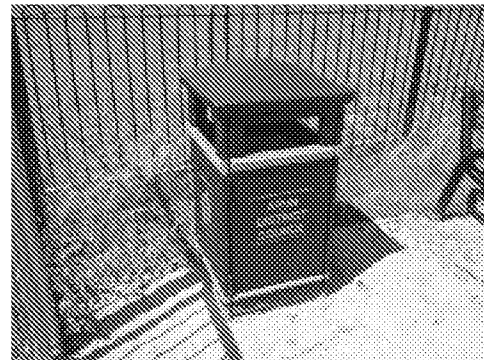
**Item:** Litter Bin  
**Manufacturer:** Not Identified  
**Surface Type:** N/A  
**Equipment Compliance:** N/A  
**Surface Area Compliance:** N/A

This item is satisfactory - no work required

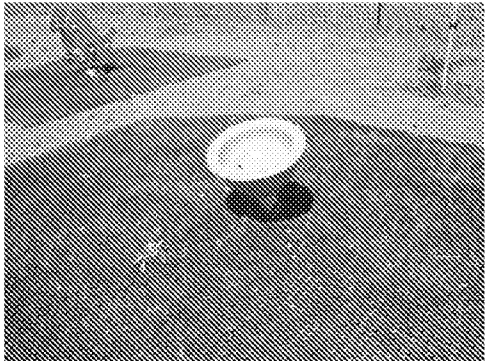
| 4 - Very Low Risk | |
|---|---|
| <b>Item:</b> | Spinner Bowl |

| 4 - Very Low Risk | |
|---|---|
| This item is satisfactory - no work required | |

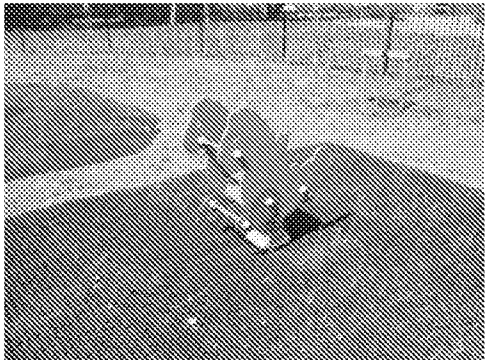
| 4 - Very Low Risk | |
|---|---|
| <b>Item:</b> | Spring Dino |

| 4 - Very Low Risk | |
|---|---|
| This item is satisfactory - no work required | |

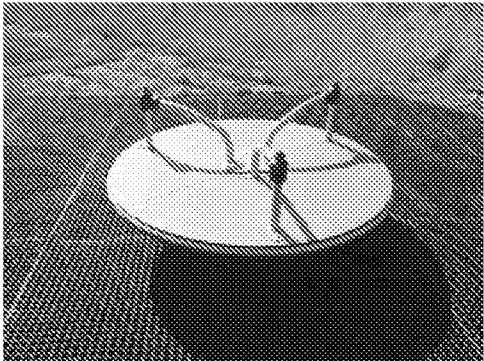
| 4 - Very Low Risk | |
|---|---|
| <b>Item:</b> | Roundabout |

| 4 - Very Low Risk | |
|---|---|
| This item is satisfactory - no work required | |

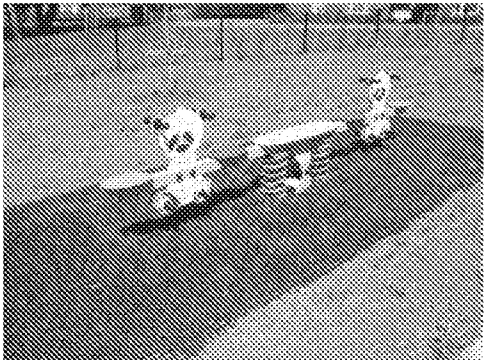
| 4 - Very Low Risk | |
|---|---|
| <b>Item:</b> | Spring See-Saw |

| 4 - Very Low Risk | |
|---|---|
| This item is satisfactory - no work required | |

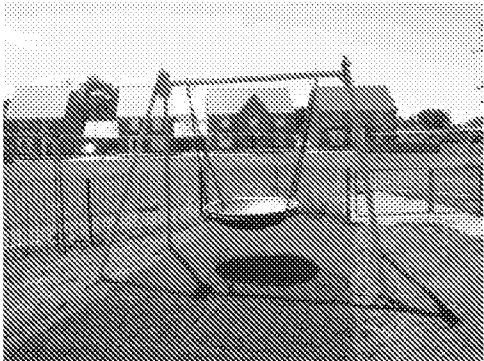
| 4 - Very Low Risk | |
|---|---|
| <b>Item:</b> | Basket Swing - Type 1 |

| 4 - Very Low Risk | |
|---|---|
| This item is satisfactory - no work required | |

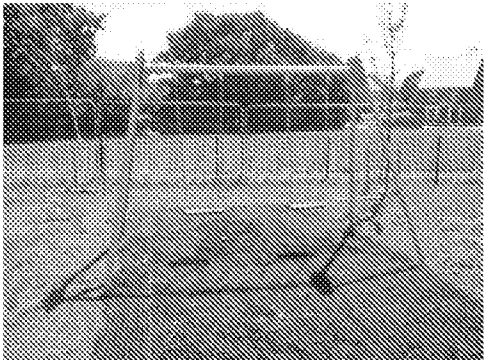
| 4 - Very Low Risk | |
|---|---|
| <b>Item:</b> | 1 Bay 2 Seat (Flat) |

| 4 - Very Low Risk | |
|---|---|
| This item is satisfactory - no work required | |

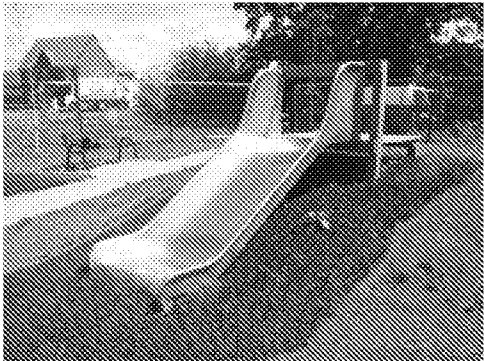
This item is satisfactory - no work required
