**RJS6308**

Ford AirField  
Arundel  
West Sussex  
BN18 0DD

The survey was conducted to establish the presence of asbestos containing materials in the areas noted below:  
**Demolition Survey to Bleach Warehouse, adjacent Barn Storage and Old Hangar**

#### Demolition

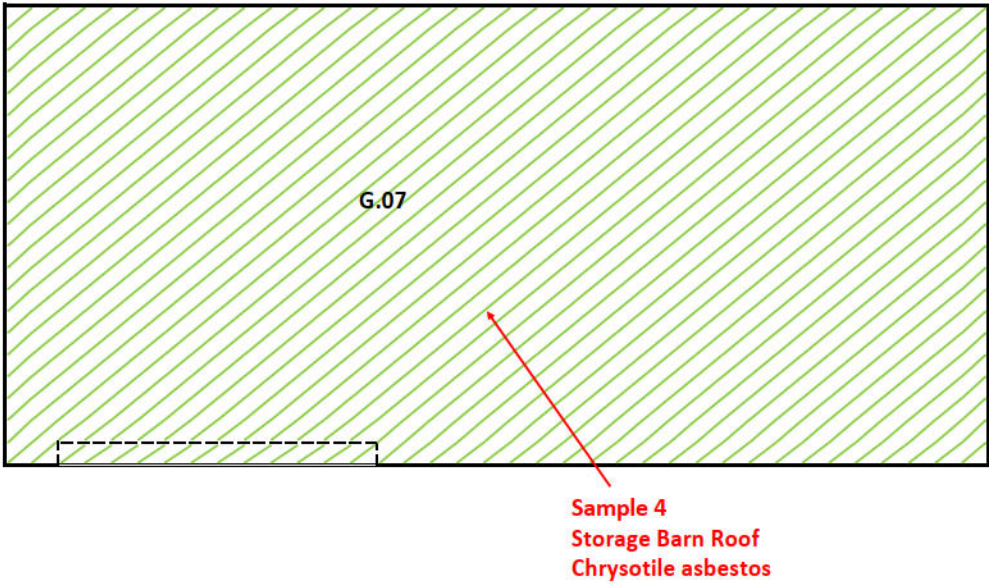
Storage Barn

| Building: <b>Main</b> | | | | |
|---|---|---|---|---|
| G.07 - Storage area<br>Cement sheeting to roof | 04 | 04 | Was found to contain<br>Chrysotile (White Asbestos) | Remove |
