## **Condition Report Following Water Damage**

**Property Address: 9 South Terrace,  
Littlehampton BN17 5NZ**

**Inspection Dates: 31<sup>st</sup> January 2020 and 07<sup>th</sup> February 2020**

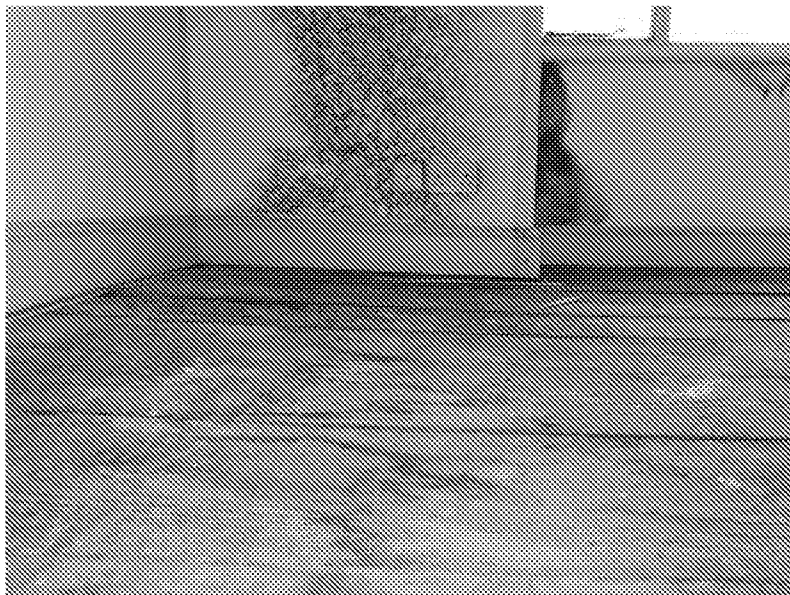
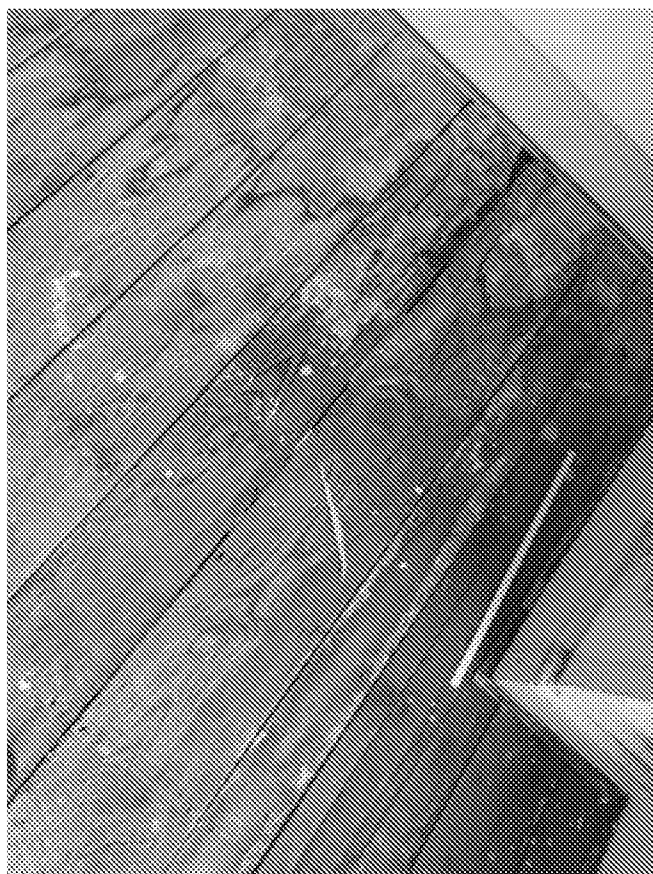
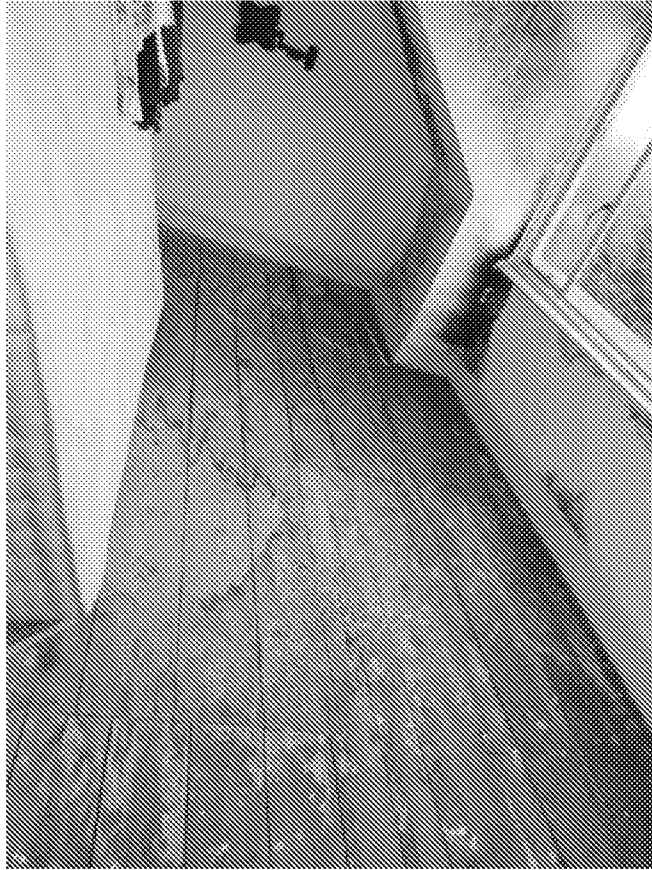
2<sup>nd</sup> Floor boarding and walls

Much of the boarding, especially around the areas where water has penetrated from the Spine wall, are badly stained, damaged and will require removal and repair or replacement.

Floor undulating and water stained
