# **A1 – A5 Viability Report**

**2 - 13 Duke Street**

**Littlehampton**

**09 March 2017**

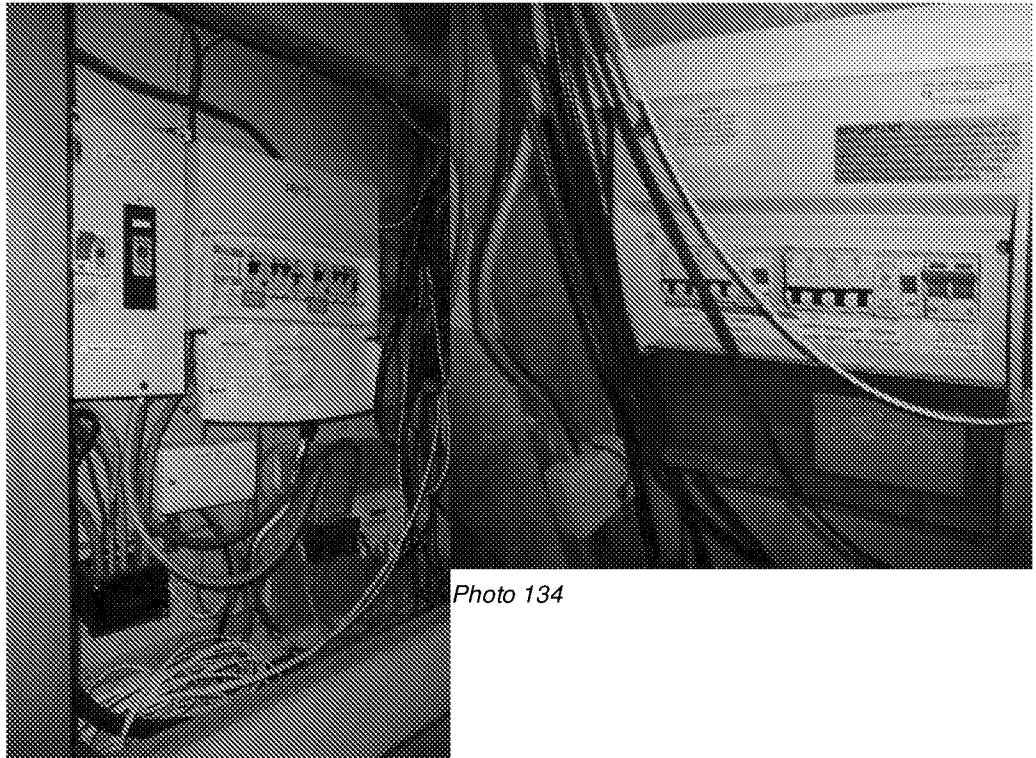
Photo 134

There is an off peak supply meter and modern consumer unit with miniature circuit breakers located on North wall in the Brewery area. It was observed that the cover to the electrical junction box is detached and repair is advised.

There are exposed and loose electrical cables.

A comprehensive test of the electrics was outside the scope of the inspection. Due to the apparent ongoing removal of fixtures, fittings and equipment within the premises, the electrics throughout should be considered to be unsafe until tested by a competent electrician.

A specialist test of the electrics is advised, to fully understand the condition and operational adequacy of the system.

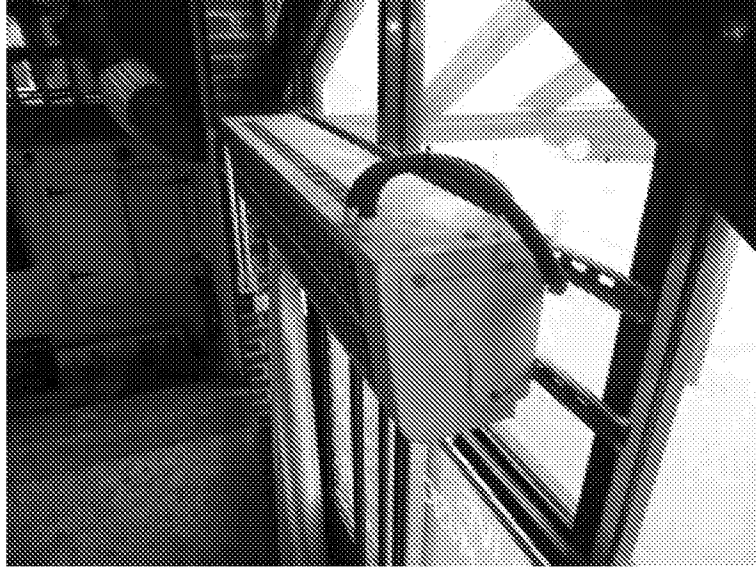
*Photo 141*

Various individual electric panel heaters were observed within the premises, which were not tested.

There is also a heater unit above the doors at the North entrance, which was not tested.

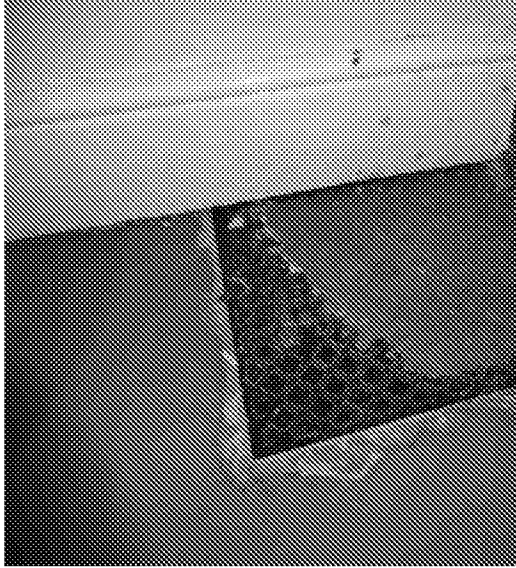
Photo 144

Internal recessed manholes were found to the floors in the Female Toilet, Bar area and the Brewery Store. The manhole covers within the Female Toilet and Brewery Store could not be lifted. The manhole cover within the Bar area could only be partially lifted. The inspection chambers were not observed. A strong odour was noted from the manhole chamber in the Bar area and there was cause to suspect blockage of the foul drainage.

A full drainage survey at the property is advised to ascertain the exact routing and condition of the drainage systems.

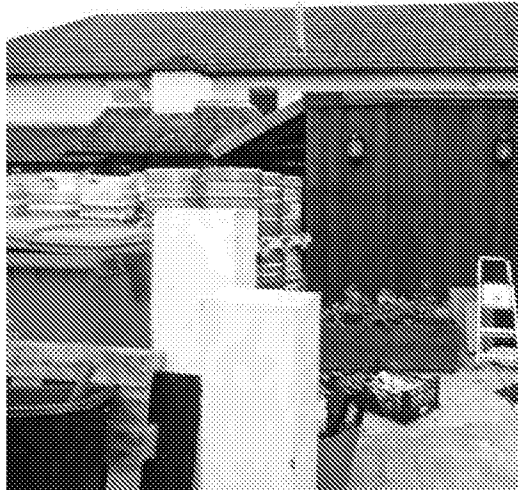
Photo 151

1). There is a timber framed and clad shed structure to the West side of the building which houses commercial walk-in chillers. The shed is open sided to South side. The shed appears to be in fair condition generally, however could not be fully observed due to stored items.

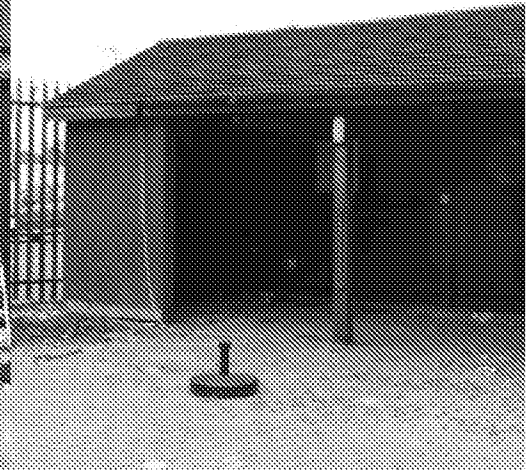
Photo 152

2). There is a timber framed and clad barn structure to the North West corner of the grounds. The barn is open sided to South side. The barn has a pitched roof with concrete tile coverings. The barn is in fair condition generally. There is a wood burning stove installed within the barn, which was not tested.
