## Preliminary Roost Assessment

57 River Road, Littlehampton, West Sussex, BN17 5BF

Partial demolition of the existing structure, and external and internal alterations to the remainder. Redevelopment into six apartments with amenity space, parking and cycle storage.

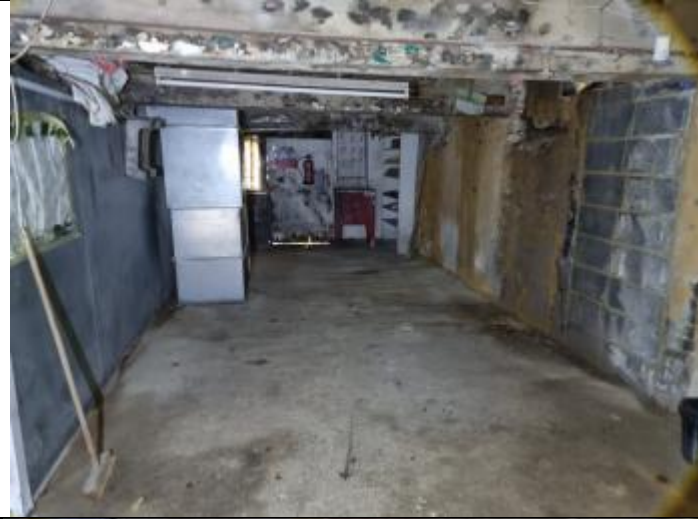
Bottom floor

The ground floor is comprised of a large L-shaped room with a separate sealed room in the crook of the “L”. A door on the south-west elevation leads out into the extension and car port. There are large cross-beams supporting the structure and a stone floor. No evidence of bat or rodent usage was found.

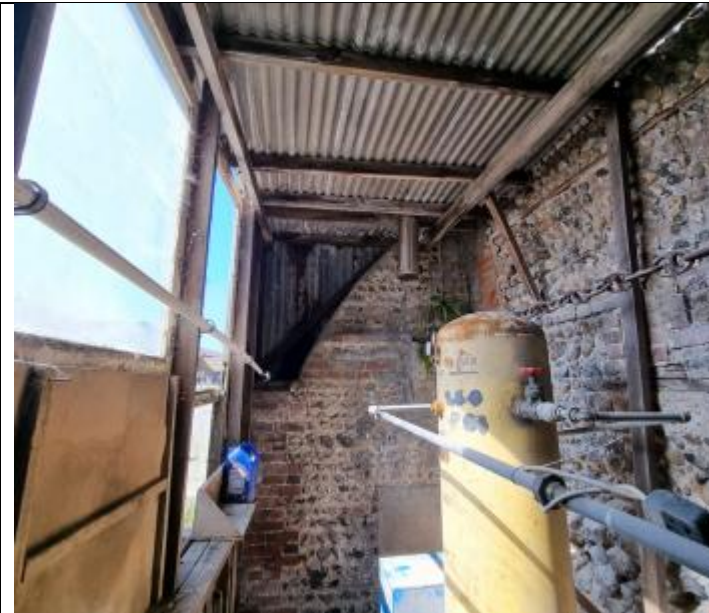
Inside of extension

The extension is made from bricks to a height of approximately 3 feet, and the remainder is made from single wood panels and corrugated sheeting. There is a large open door on the south-east side allowing light ingress and access. The attached car port is made from steel sheeting and wood with a largely missing wooden panel roof. It is completely open on two sides. No evidence of bat usage was found within the extension or the car port.

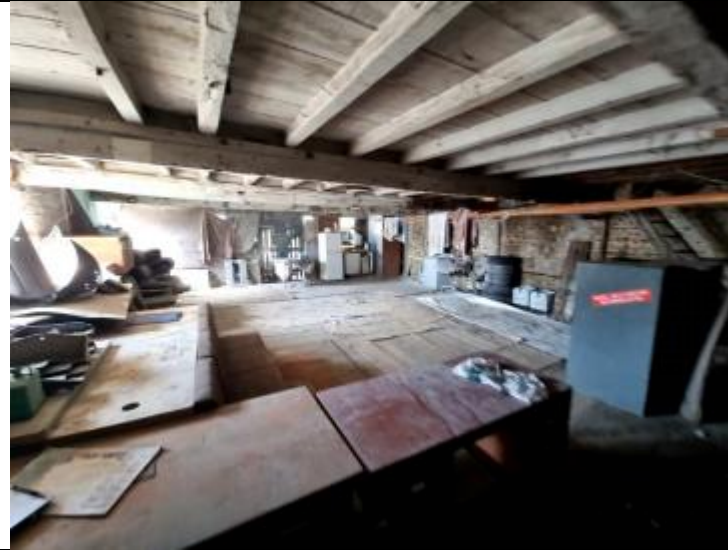
Middle floor

The middle floor is one large open space. There are light-coloured dusty carpets and sheeting on the floors which would show any evidence of bat or rodent usage for example droppings and feeding remains, however no such evidence was present (which indicates a lack of void dwelling bat presence but does not indicate an absence of crevice dwelling). This floor was very bright, having several uncovered windows. There are many gaps, primarily along the south-western elevation, and a portion of the window on that elevation is broken.

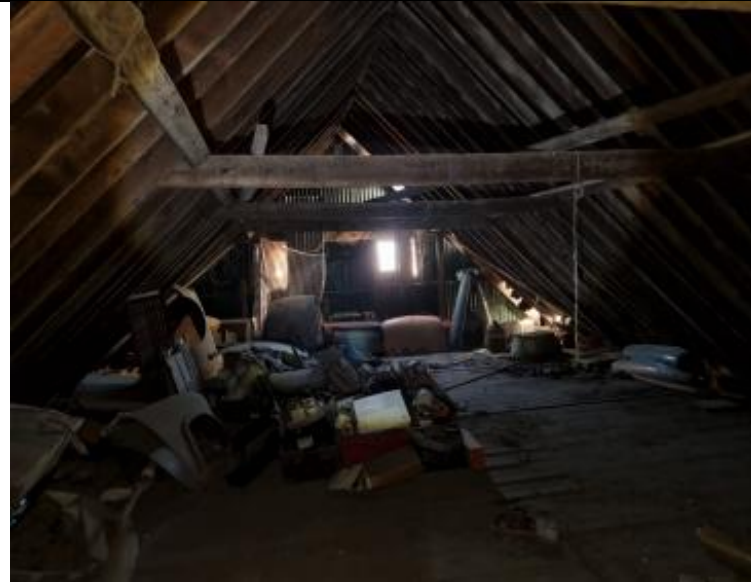
Top floor

The top floor (approximately 12m(L) x 7.5m(W) x 6m(H)) is also one large open space. There is a broken window on the south-western elevation, and a large portion of the roof slates are missing above it at the western corner of the building, allowing light into the floor. The second storey of the entire south-western wall is made from wooden boards clad in corrugated iron, and the third storey just single sheet corrugated iron. The ridge and gables are well sealed and the bitumen lining is in good condition apart from the holes mentioned. No bat droppings or feeding remains were observed, nor any rodent droppings. There were large amounts of bird droppings under each gable end. Remains of a dead pigeon was found in the centre of the floor, and there were cat and fox footprints in the dust throughout the entire floor suggesting frequent use by predatory animals.

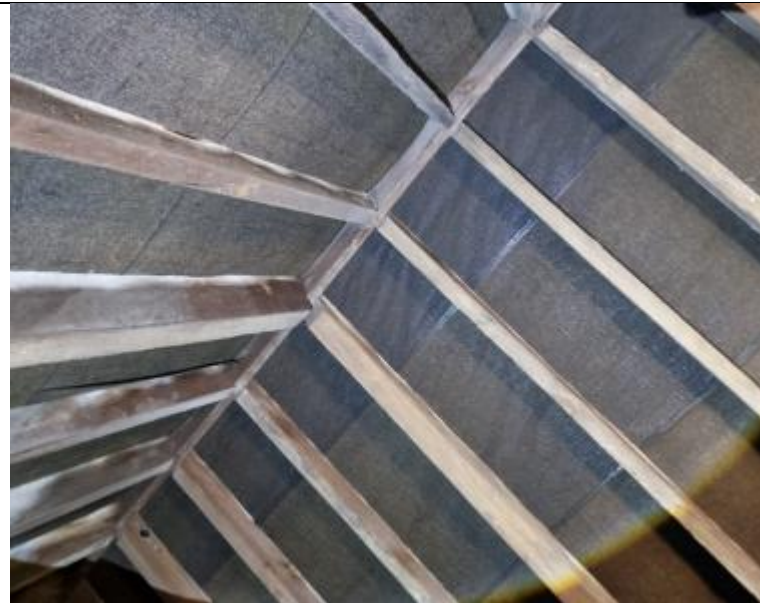
Top floor ridge and lining

The roof is covered with slate tiles. There are several raised slates which provide gaps and access to space between the tiles and lining which could be used by crevice dwelling bats, and any droppings would be trapped within and not visible. There are large open portions of roof at the western corner allowing access into the loft and into the roof between the slates and lining. The ridge-line is well sealed and there is no mortar missing along the length.

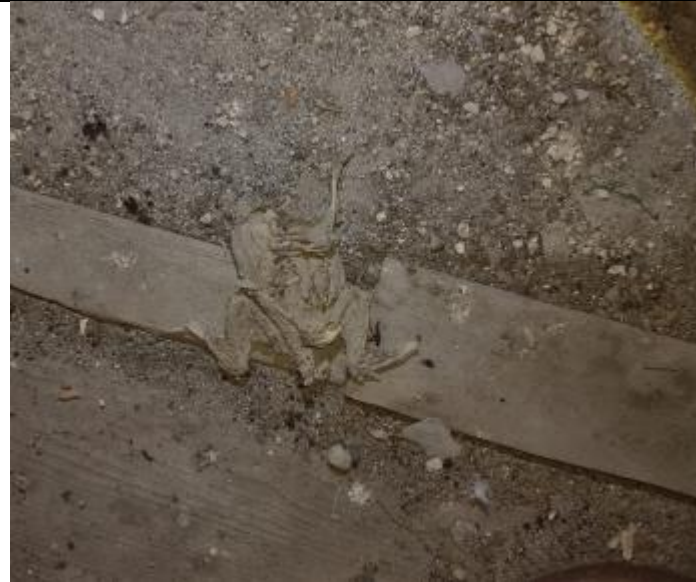
Pigeon remains

| Summary of Survey Findings | A nesting pigeon was observed in the inner stonework at the north-east gable. Bird droppings indicate pigeons have been nesting at both internal gables. | | |

| Recommendations | Any works to B1 should be undertaken outside the period 1st March to 31st August. Regardless of the time of year, because pigeons can nest all year round a close inspection of the building should be undertaken immediately prior to the start of works by a qualified ecologist. All active nests will need to be retained with a 5m buffer until the young have fledged. | | |

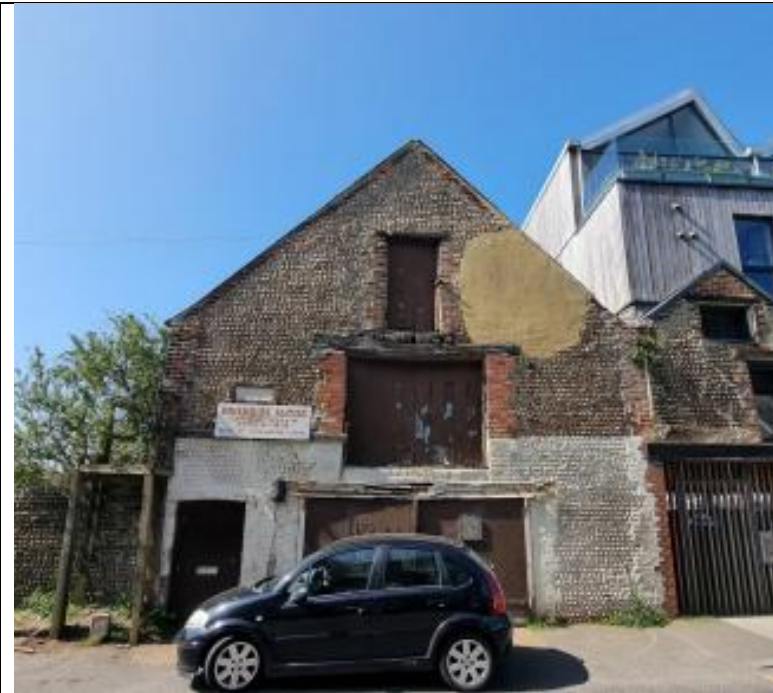
Full elevations (north-east)

The wall of the north-east elevation itself is well sealed, however there are multiple gaps around the first and second floor doors, in particular above the wooden lintel that separates them where several bricks are missing.

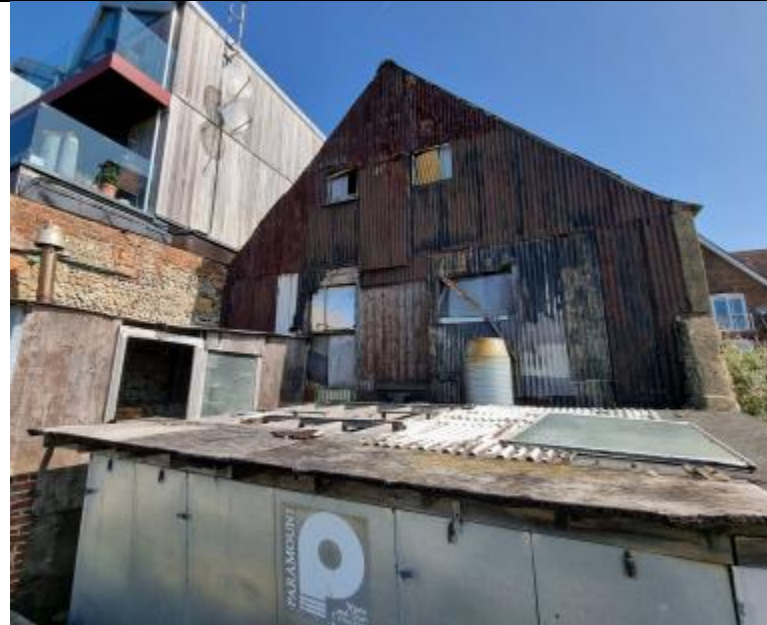
Full elevations (south-west)

The verges of the south-western elevation are missing large sections of mortar, allowing access to the space between the tiles and lining.
