**ALL HOURS PLUMBING**

| Project Name:<br><b>468</b> | Contract Number: | Contact:<br><b>Parchow Groundworks</b> | Date:<br><b>05/05/2026</b> |

Client: **Parchow Groundworks**  
Contact:  
Position:  
Road: **Widley Farm, New Down Lane**  
Town: **Purbrook**  
Post Code: **PO7 5SE**  
County: **Hampshire**  
Telephone:

Inspection Report

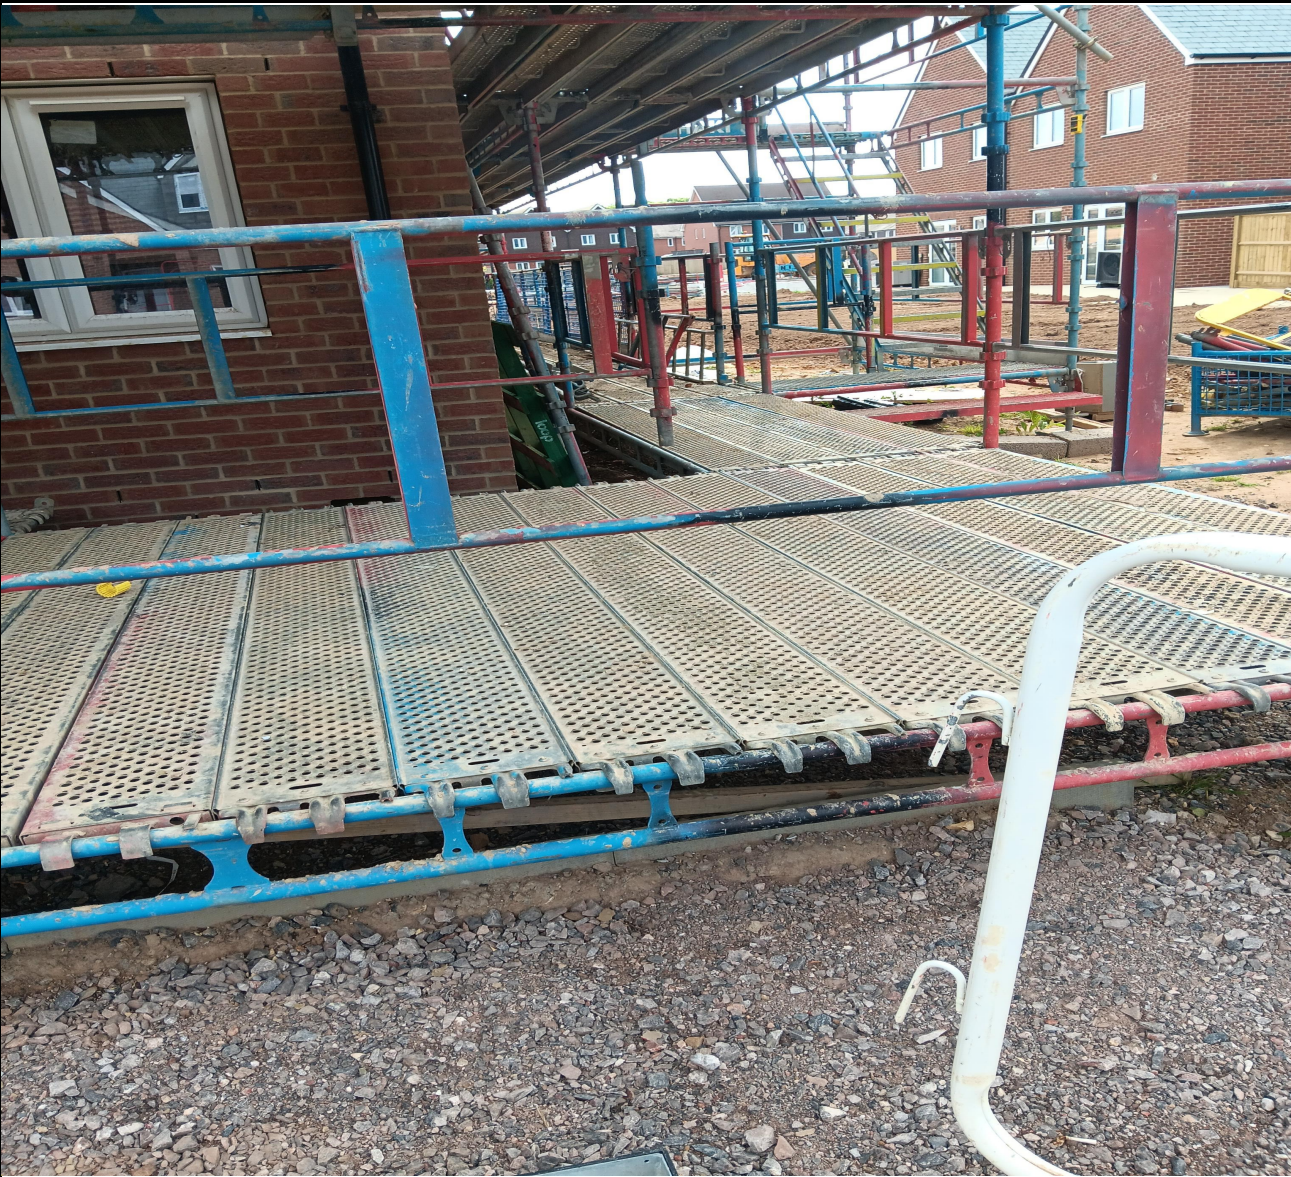
MANHOLE PPCP 6  
UNDER SCAFFOLD
