**12 River Road**  
**Littlehampton**  
**West Sussex**

**Existing Floor Plans**

| <b>19072</b> | <b>01</b> | <b>-</b> |

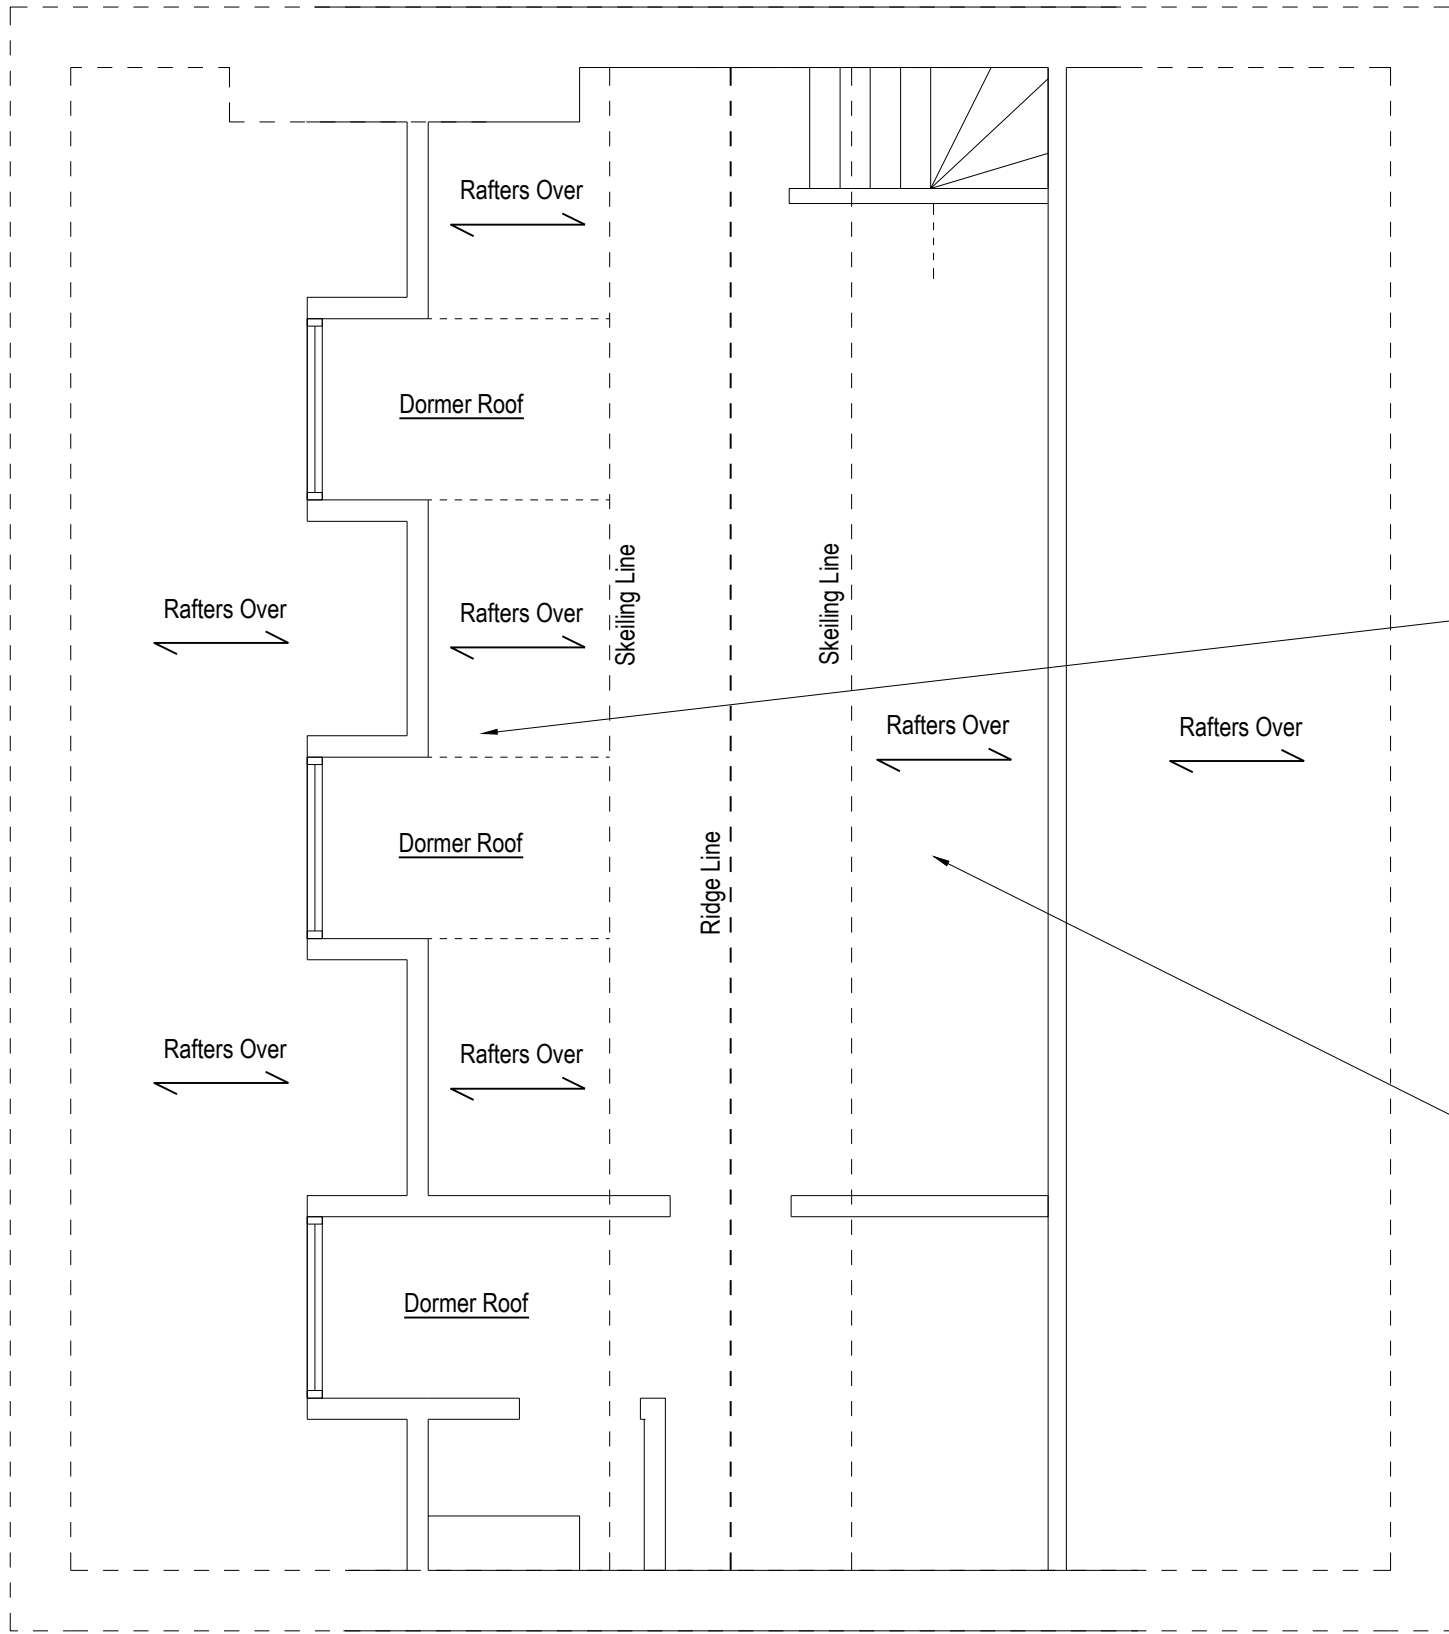
**Existing Attic Floor Plan.**  
(Showing current layout - from planning records)  
(1:50)

It appeared that the original roof of the property may have fallen towards the rear. The joists visible in the loft space appeared to be firings to provide a level attic floor at a later date **THIS HAS NOT BEEN CONFIRMED!**

Dotted line indicates approximate position of studwork wall removed by others in 2017/2018. Wall was considered to be non-load bearing by others.

The Contractor has advised that cracking appeared in the attic upon removal of the wall and that gaps appeared between the skirting boards to the dormers and the knee walls and the floor boards, suggesting that the structure had dropped. This has not been independently verified. The purpose of the works is to resupport the attic floor joists and original roof elements along the line of the wall to prevent further movement occurring.

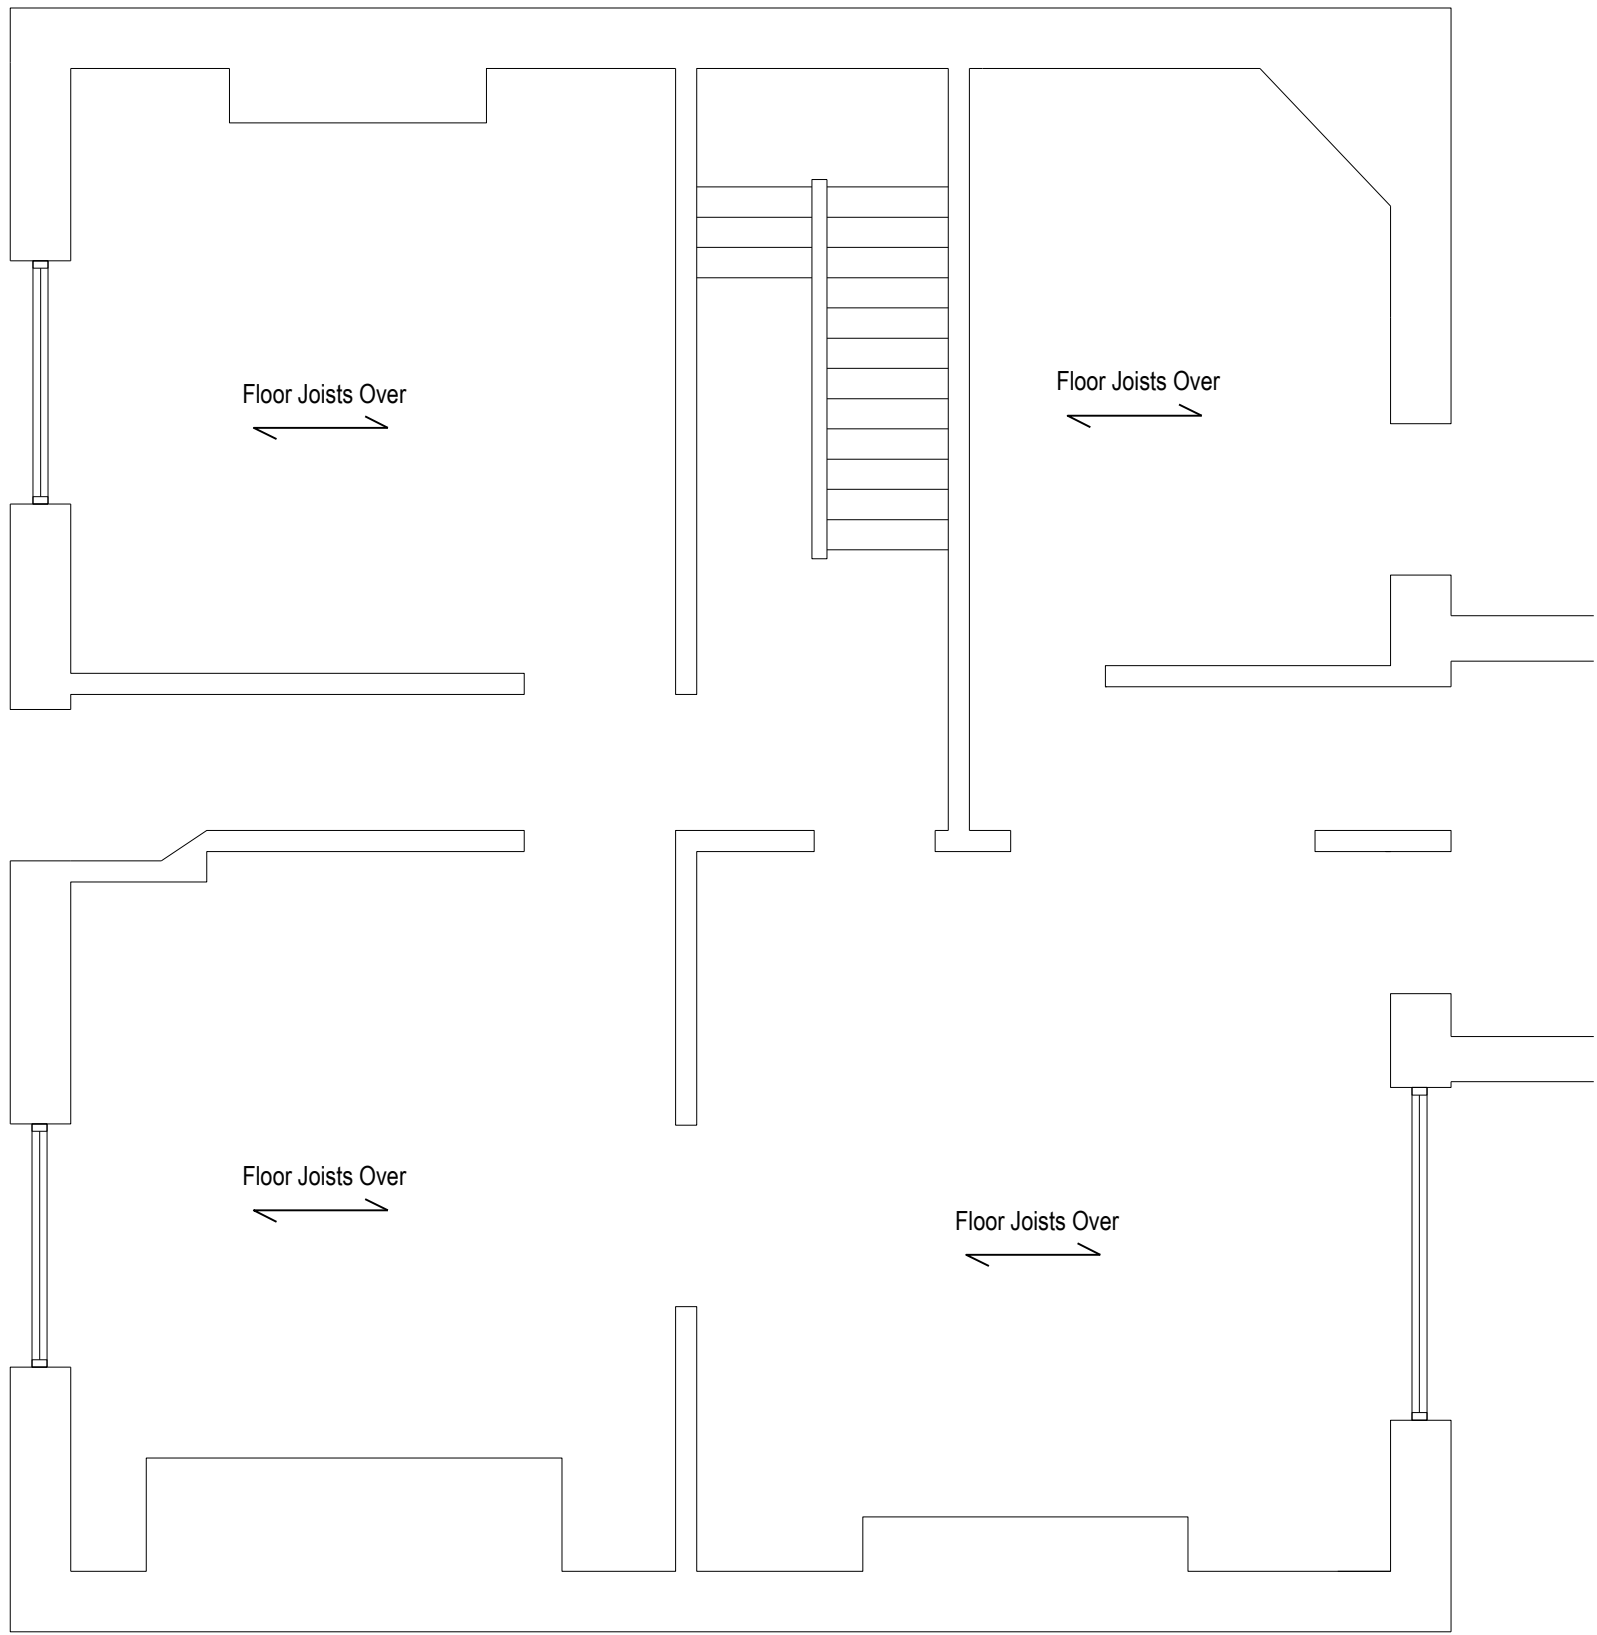
**Existing Ground Floor Plan.**  
(Showing current layout - from planning records)  
(1:50)

The Contractor has advised that the joists over Sitting Room spanned in the direction shown. The Contractor advised that the joists were in a single length across top of wall. **Joists were hidden and not visible at time of inspection. It has not been confirmed that this is correct!**
