## Post Installation Report

Proludic Ltd

Hampton Park - Littlehampton

Inspection Ref: 1339409

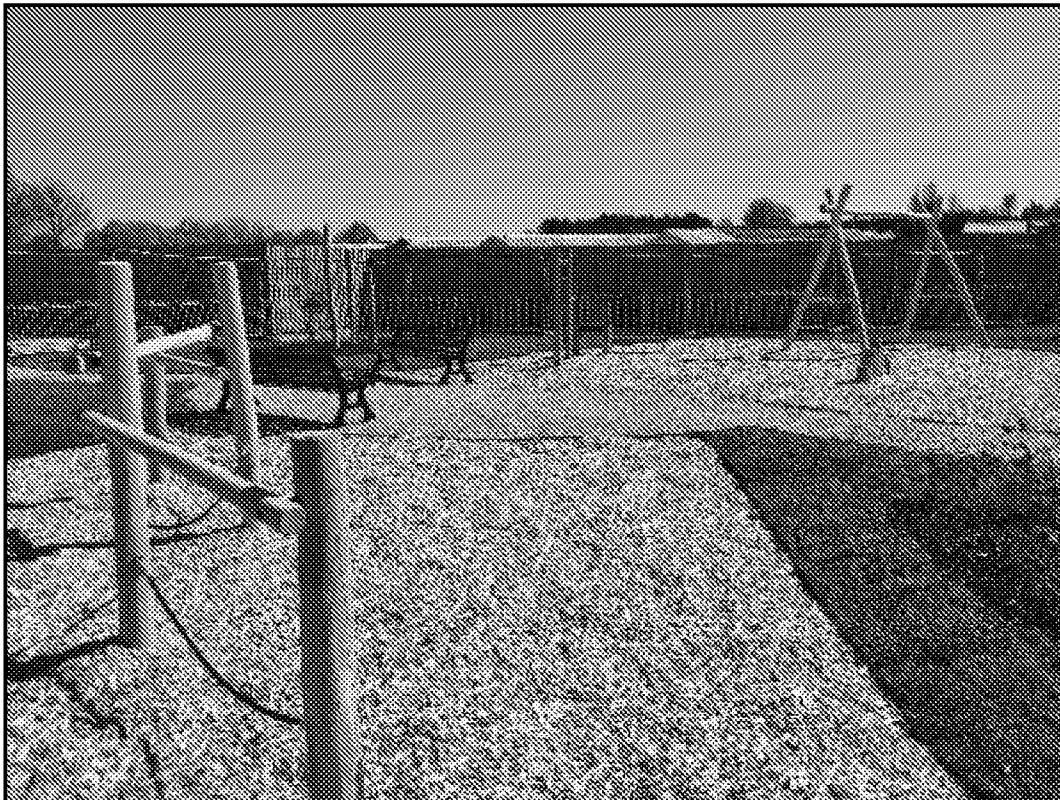
Risk Assessment: 9 Low Risk

**Location:**

The site is located in an area of public open space and is overlooked by a number of properties in the local community.
