# **A1 – A5 Viability Report**

**2 - 13 Duke Street**

**Littlehampton**

## **The condition report**

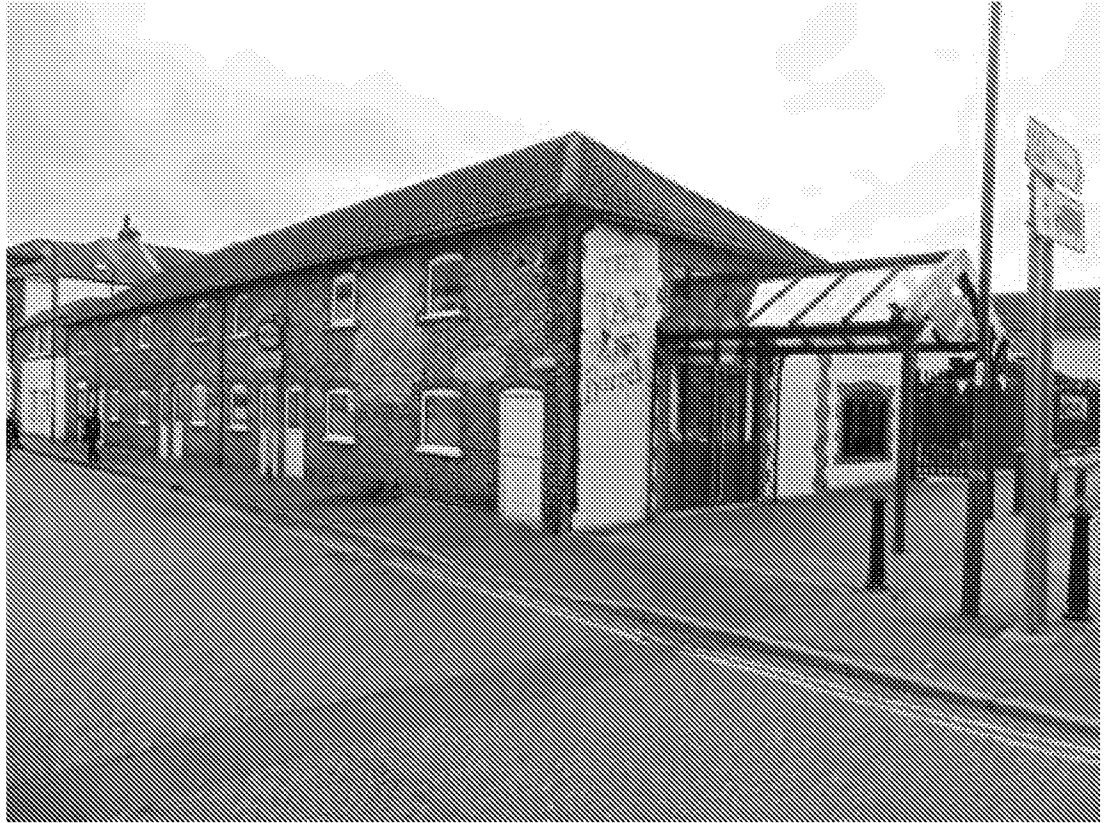
Photo 2

The property, 2 - 13 Duke Street, is currently a licensed premises. The building was formerly a terrace of 2-storey residential properties originating from the 19th Century, which are believed to have been converted into a single business premises in the 1970's.

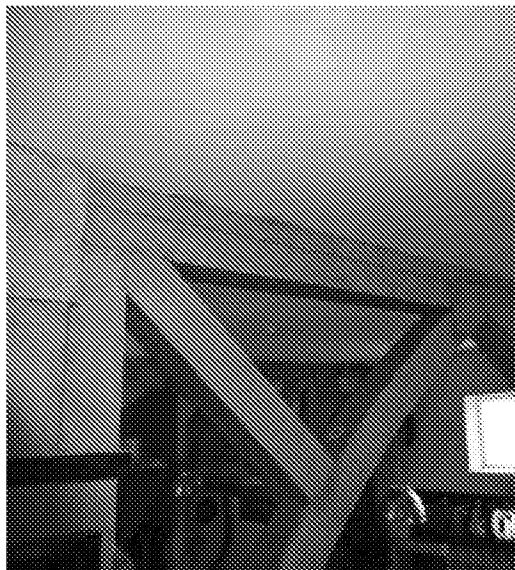
Photo 81

The ceilings are likely to be of plasterboard and have textured decorated plaster finishes throughout that are generally in fair condition. There are cover battens to the board joints.

Note: The textured 'Artex' finish to the textured ceilings may contain asbestos fibres, which is of little consequence unless the finishes are disturbed (by removal, sanding, scraping or cutting holes for lights – creation of dust). A specialist contractor should deal with alterations to the textured ceilings.

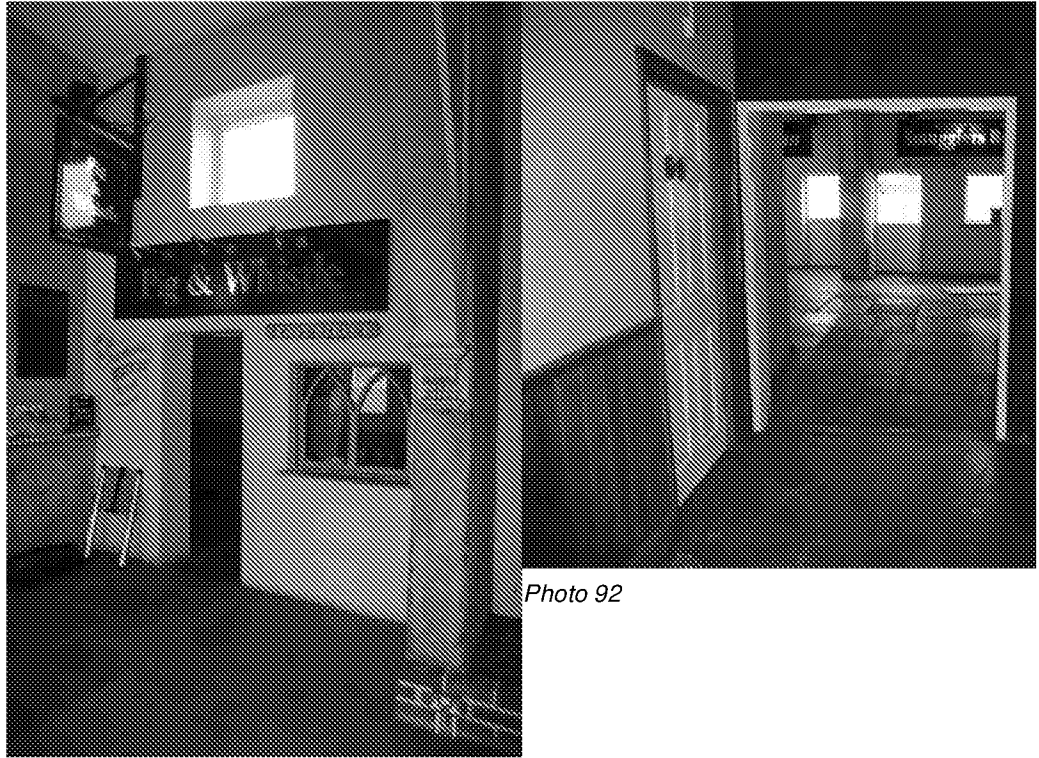
Photo 92

The external walls and internal partitions have a mixture of undecorated plasterboard linings and decorated lining panels, which are in fair condition generally, although with minor damage and blemishes throughout.

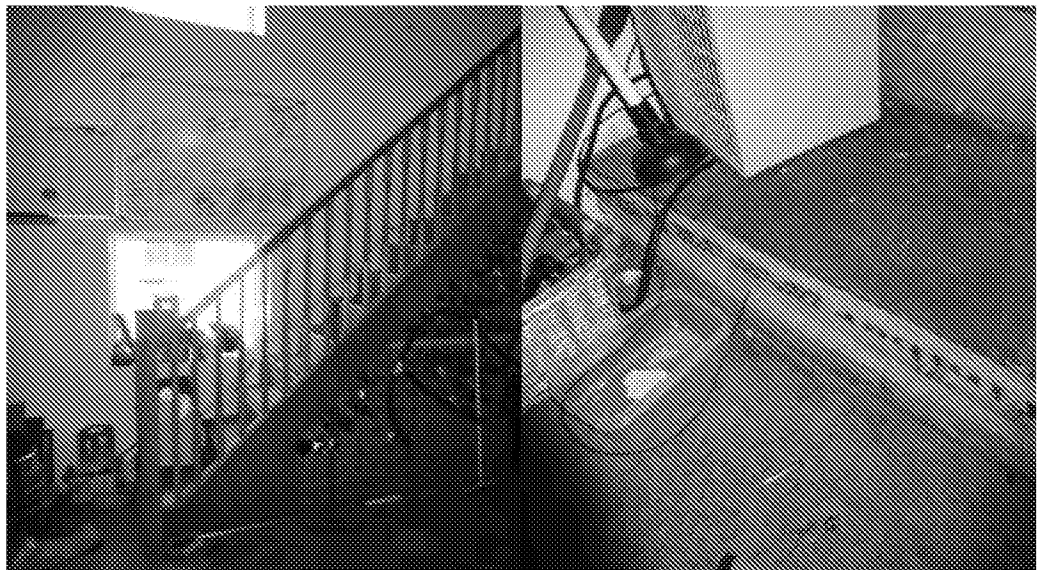
Photo 120

3). There are decorated sill boards to the windows that are in fair condition generally.

4). There are cantilevered timber balcony features at high level to the external walls within the Bar and Brewery areas and a timber balustrade at floor level within the Bar area which are all decorative pub-theme features and were not inspected.

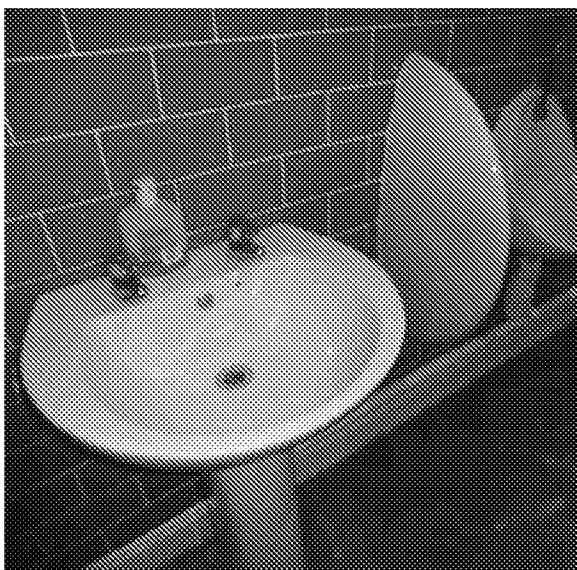
Photo 127

There is ceramic tiling to the walls which is in fair condition generally..

There is a separate disabled toilet accessed from the Entrance Lobby which was locked and not accessible at time of survey.

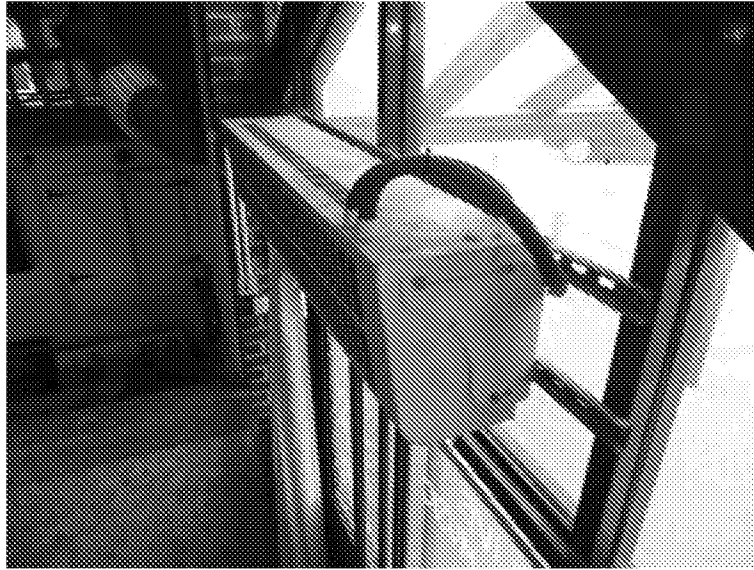
*Photo 141*

Various individual electric panel heaters were observed within the premises, which were not tested.

There is also a heater unit above the doors at the North entrance, which was not tested.

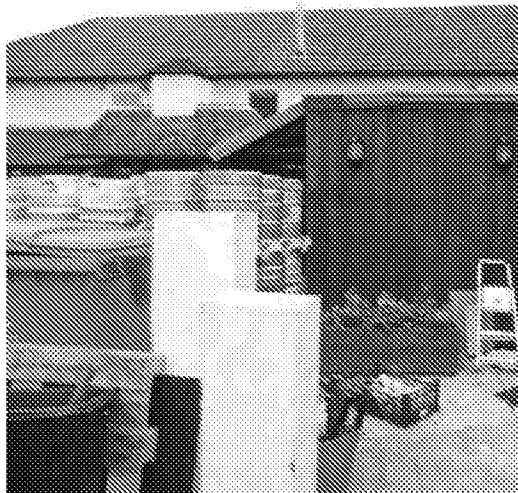
Photo 151

1). There is a timber framed and clad shed structure to the West side of the building which houses commercial walk-in chillers. The shed is open sided to South side. The shed appears to be in fair condition generally, however could not be fully observed due to stored items.

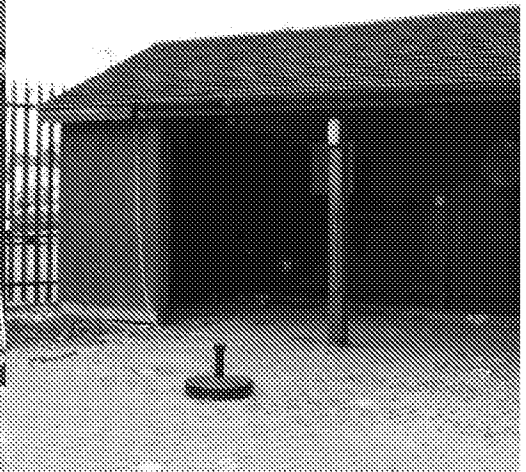
Photo 152

2). There is a timber framed and clad barn structure to the North West corner of the grounds. The barn is open sided to South side. The barn has a pitched roof with concrete tile coverings. The barn is in fair condition generally. There is a wood burning stove installed within the barn, which was not tested.

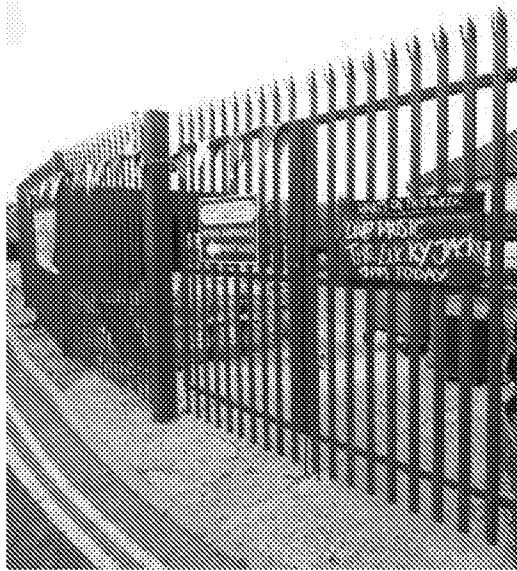
Photo 154

3). There is decorated steel palisade fencing to yard, which is in sound condition generally, although there are some damaged pales to the fence on the West side. There are double gates to the West and North sides which are fitted with a sliding bolts with padlock apertures and drop bolts. The gates are in sound condition generally. The gate gates to West side operates correctly, although there are no ground pockets for the drop bolts. The gates to North side were locked at time of survey and the operation of the gates could not be checked.

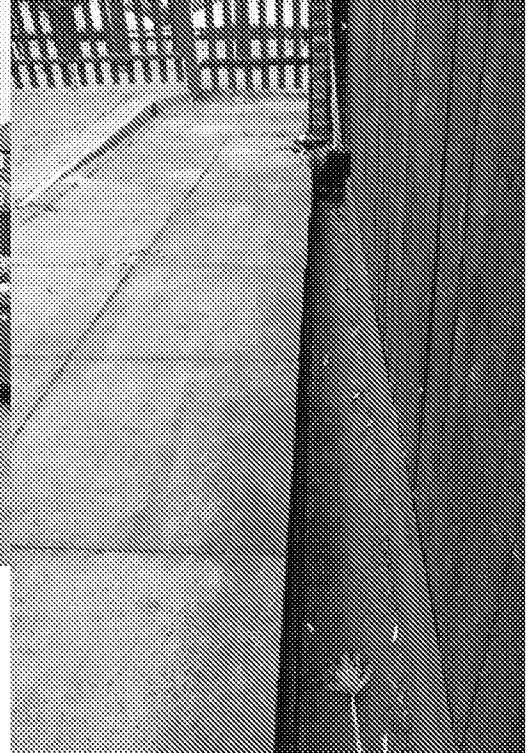
Photo 159

- H3 General There is a margin between the subject property and adjoining property to the South side which is paved with concrete. Ownership of this margin was not known at time of survey, however it should be noted that there are locked security gates at both ends, with the gate frames fixed into the wall of the subject property, an air conditioning unit installed at low level on the wall of the neighbouring property obstructs the path and the paving to the margin is in deteriorating condition.
