# BS 5837:2012 Arboricultural Survey

DBN3 Norway Lane, Littlehampton

Presented to Gleave Partnership

Delta-Simons Project No. 19-0138.02

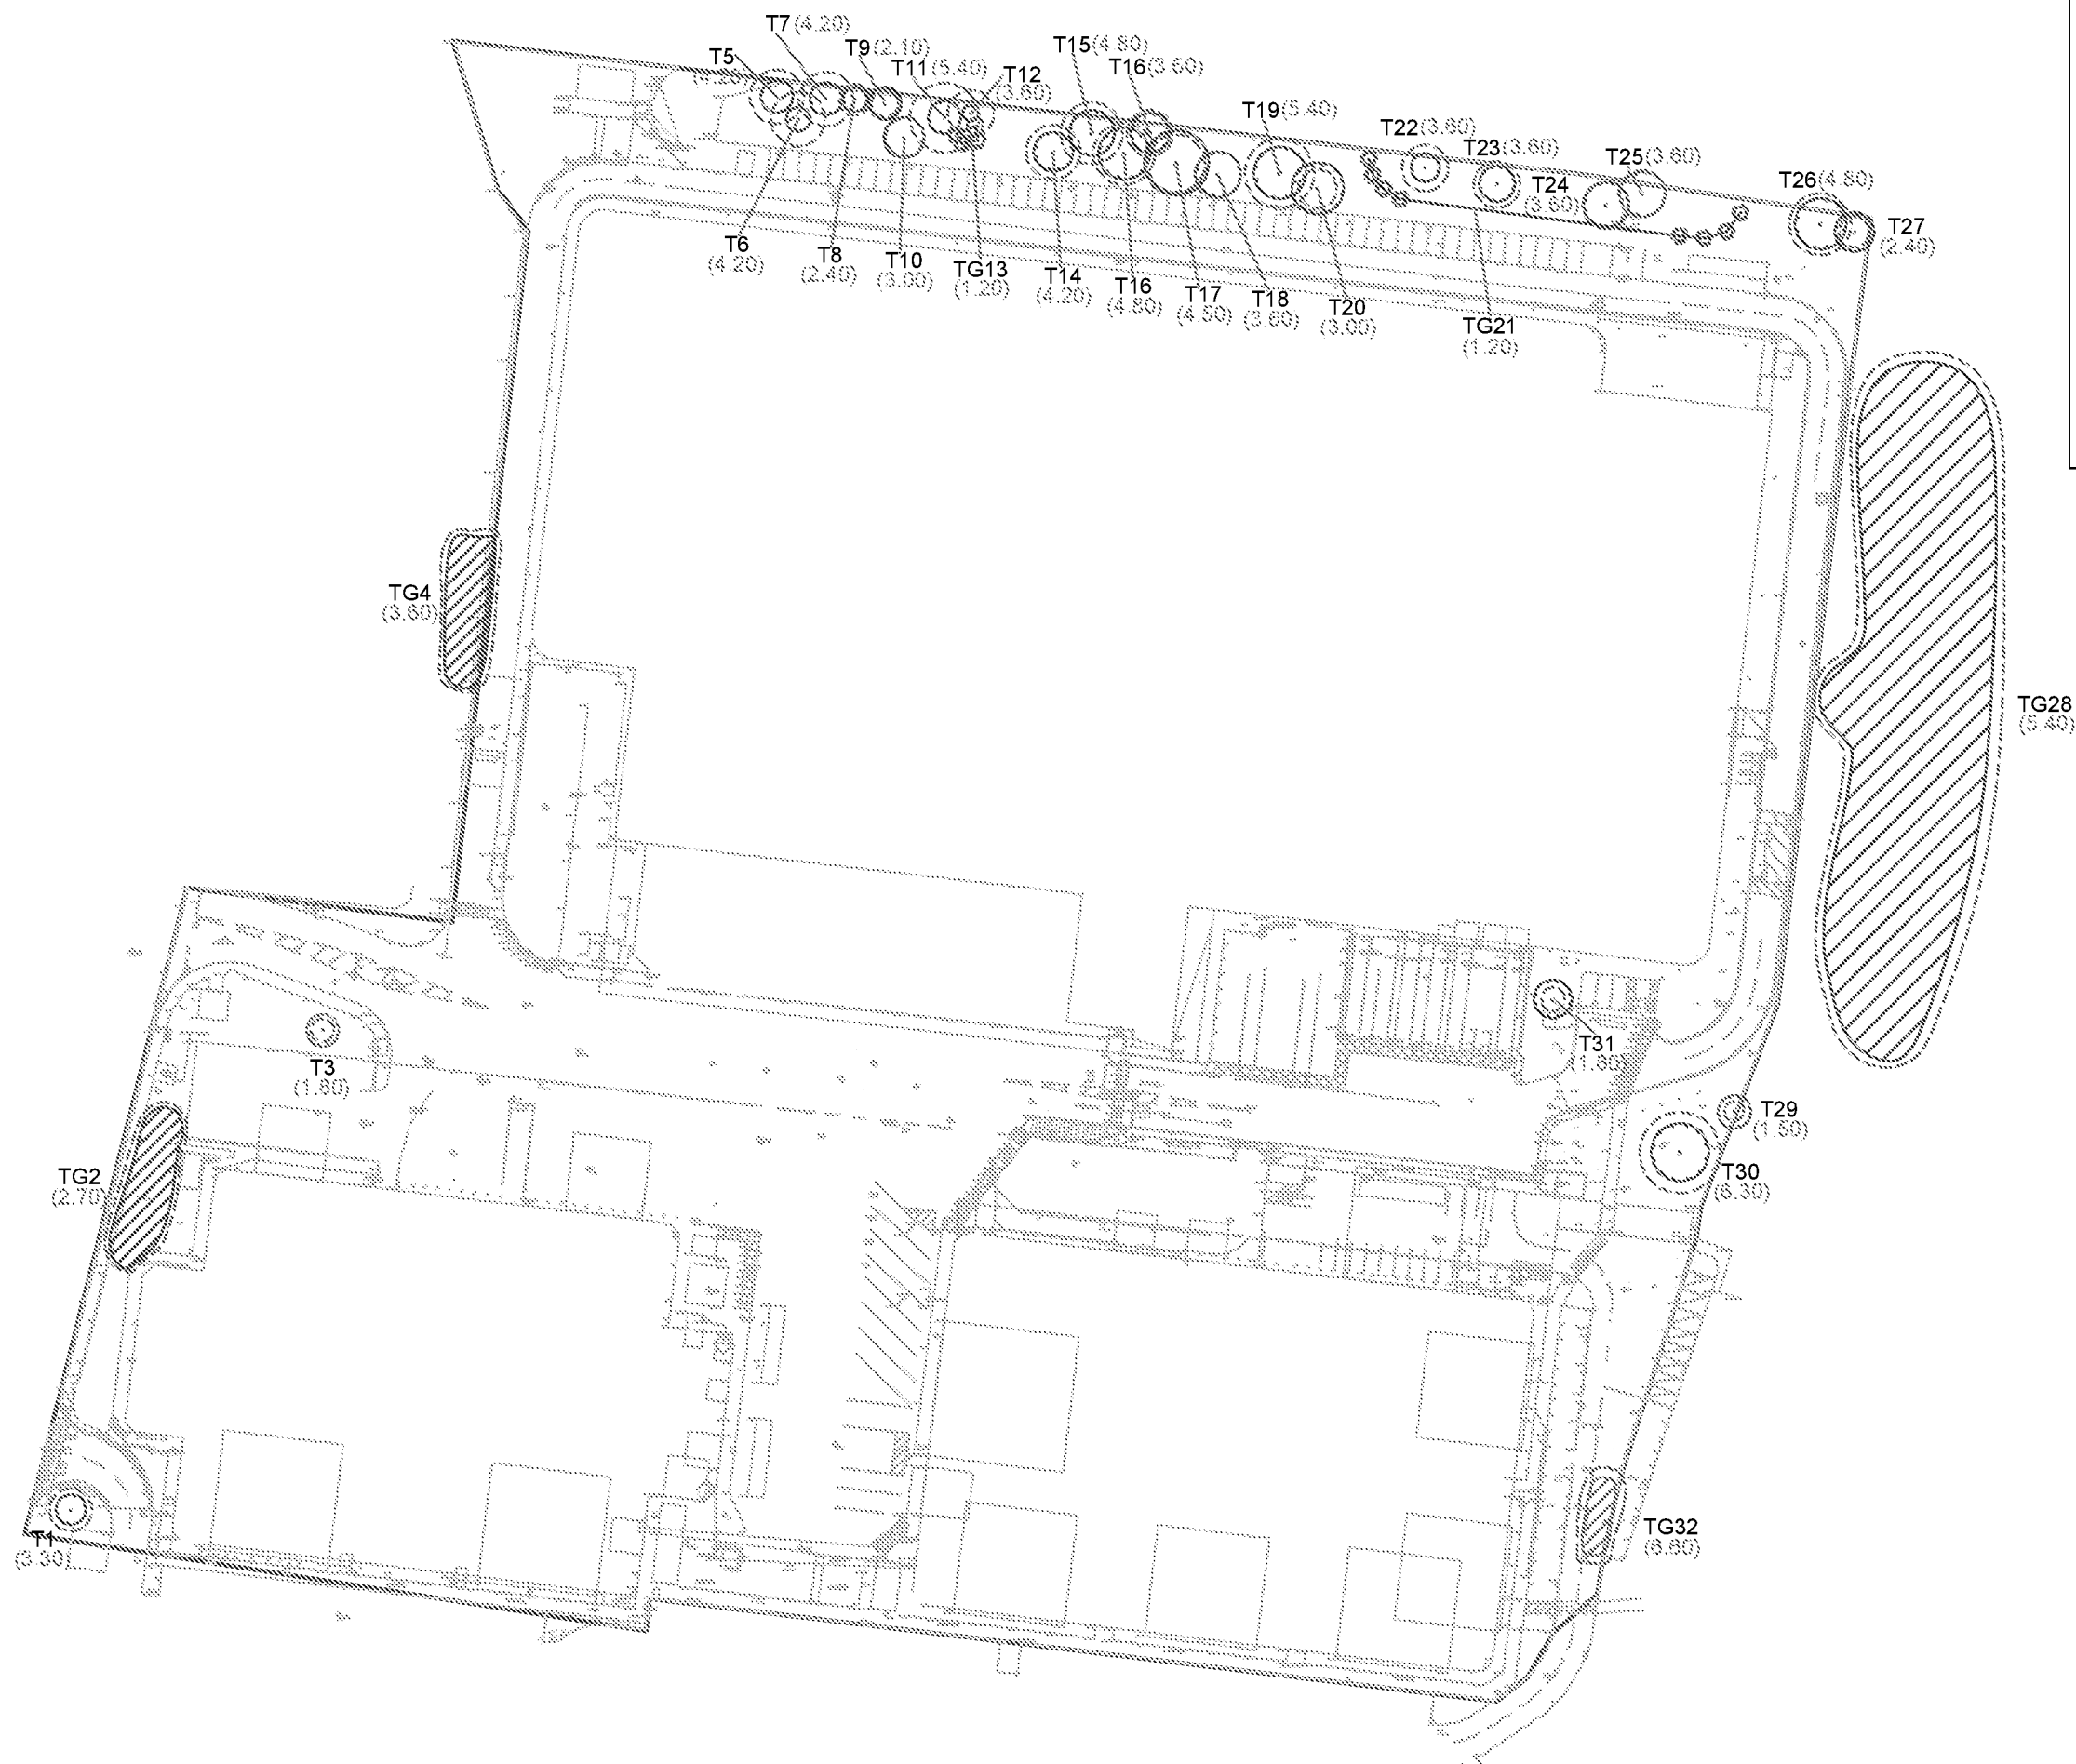
## Figure 4 – Tree Constraints Plan

The extent and positions of significant individual trees or groups of trees close to the Site are shown on the Arboricultural Survey Plan (Figure 2). The Root Protection Areas (RPA) of the key trees of value identified for, or recommended for retention have been marked within the Constraints Plan (Figure 4) using the RPAs provided in the Tree Schedule within Table 1.
