### **Project**

**Project Name:** DAISY FIELDS.LITTLEHAMPTON.BN17 6LT  
**Project Description:** TO CARRY OUT CCTV SURVEY AT THE ABOVE ADDRESS  
**Project Number:** 02  
**Project Status:** Complete  
**Project Date:** 30/06/2025  
**Inspection Standard:** MSCC5 Sewers & Drainage GB (SRM5 Scoring)

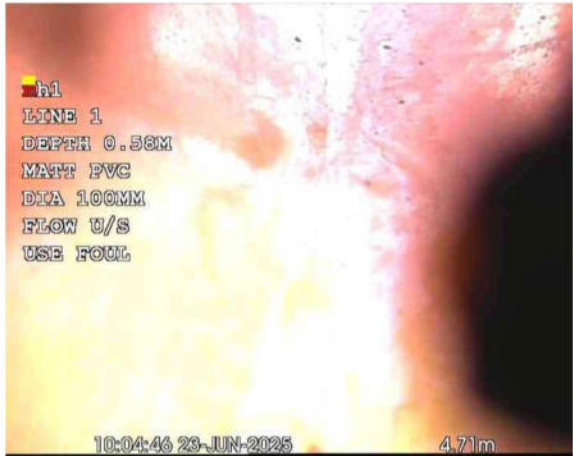
L1X\_740c3009-d51e-4fdd-b4f7-50ca08ae2276\_20250701\_165638\_085.jpg, 00:00:26, 4.71 m  
Line deviates up

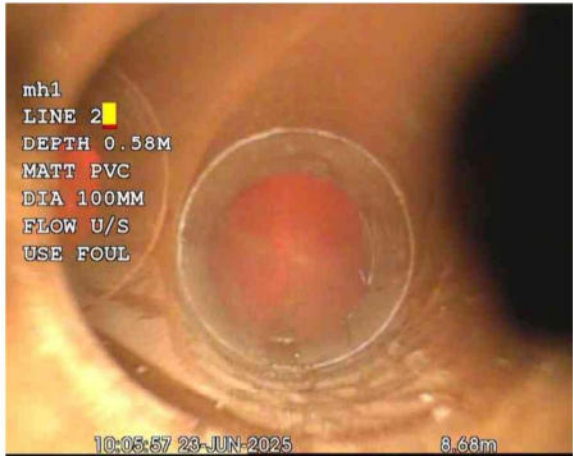
L2X\_fc0790c1-3560-447c-a154-331fc145833d\_20250701\_16  
5651\_981.jpg, 00:00:22, 8.68 m  
Junction at 9 o'clock, 100mm dia

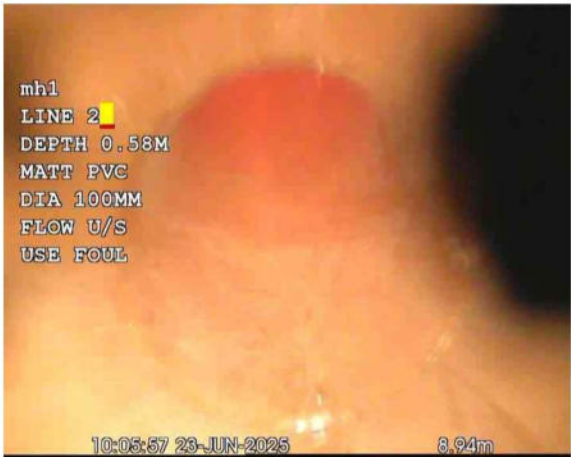
L2X\_58c295d6-6d6b-47d4-baf9-7f201caeab20\_20250701\_16  
5653\_361.jpg, 00:00:23, 8.94 m  
Line deviates up

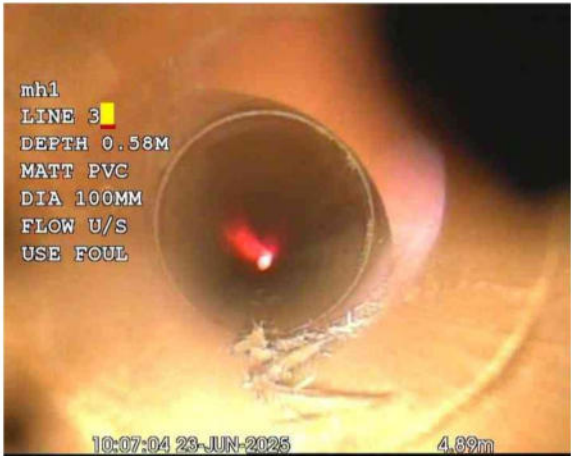
L3X\_0b9d4282-8b8e-4210-9ecb-88f7975ffd78\_20250701\_165701\_356.jpg, 00:00:13, 4.89 m  
Junction at 2 o'clock, 100mm dia

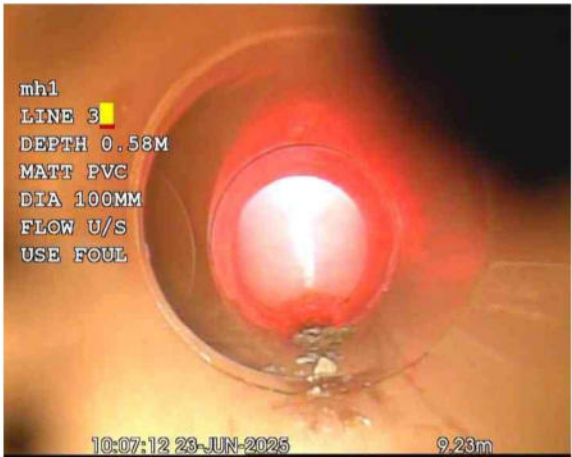
L3X\_59a283f4-b9ee-48e1-a44a-7199d18bc453\_20250701\_165702\_914.jpg, 00:00:21, 9.23 m  
Junction at 9 o'clock, 100mm dia

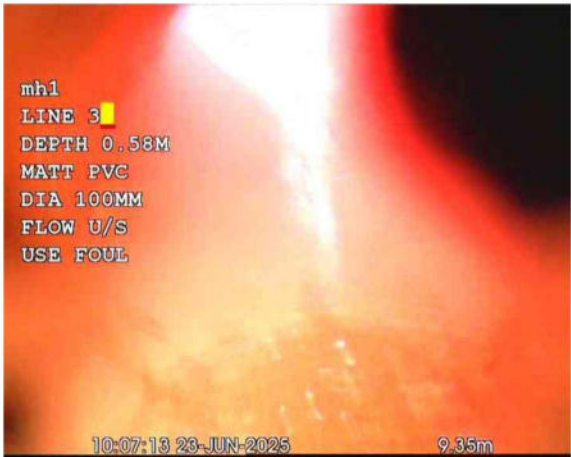
L3X\_a26419ca-6fb5-48c6-ab7a-cec7713e4c82\_20250701\_165704\_269.jpg, 00:00:22, 9.35 m  
Line deviates up

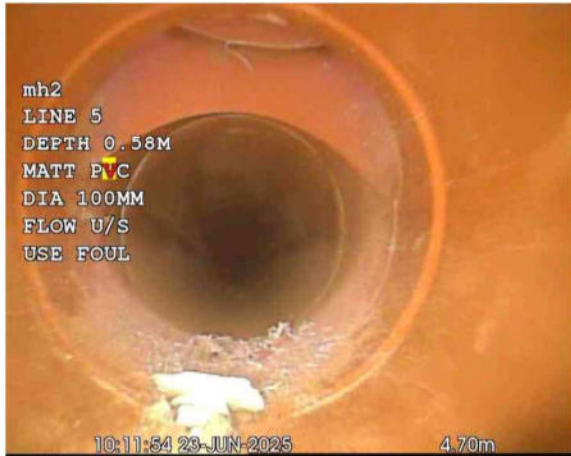
L5X\_938a87fe-7f62-4631-9572-b758cfe81fa2\_20250701\_165  
722\_310.jpg, 00:00:15, 4.70 m  
Junction at 12 o'clock, 100mm dia

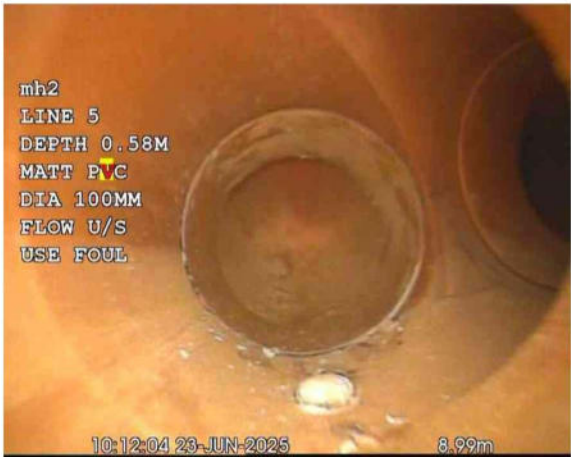
L5X\_b62dc7c2-9d0a-43de-9660-f1f9cf2db616\_20250701\_165  
723\_631.jpg, 00:00:25, 8.99 m  
Junction at 3 o'clock, 100mm dia

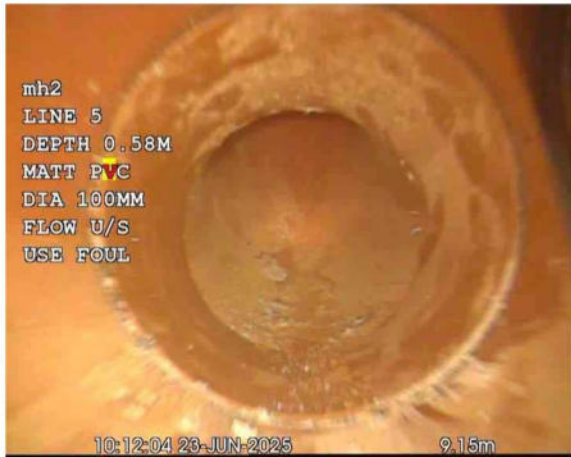
L5X\_6477f5c9-64de-4ead-b229-b5a59f14c18e\_20250701\_16  
5725\_068.jpg, 00:00:26, 9.15 m  
Line deviates up

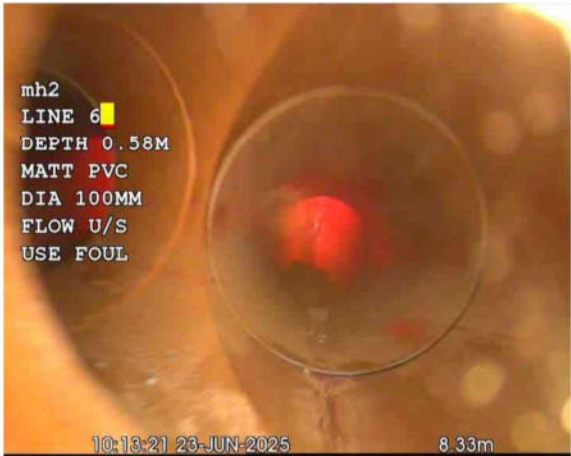
L6X\_a0c9a144-a188-4931-952a-9200940455f8\_20250701\_16  
5739\_223.jpg, 00:00:27, 8.33 m  
Junction at 9 o'clock, 100mm dia

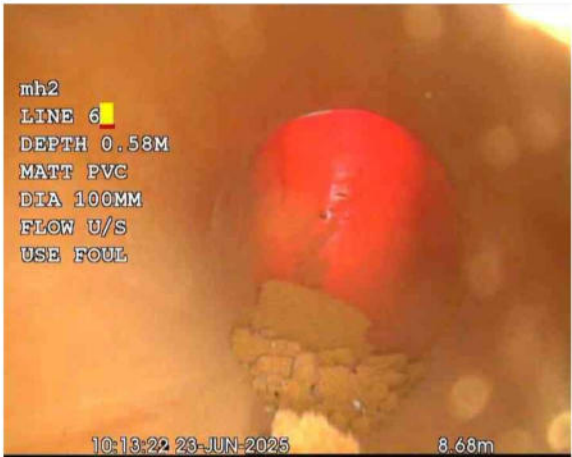
L6X\_325c04bb-f860-406e-8a77-e51080b36ace\_20250701\_16  
5740\_681.jpg, 00:00:28, 8.68 m  
Line deviates up

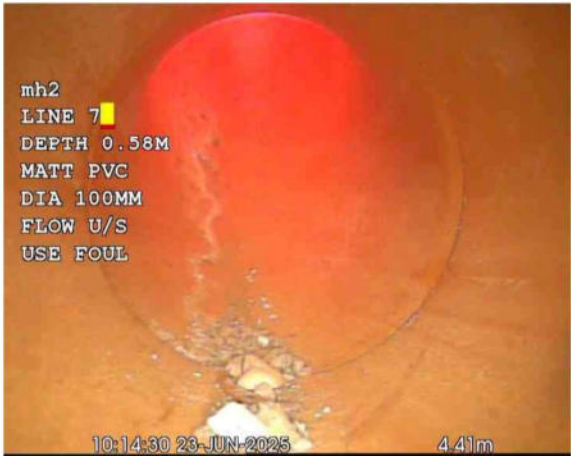
L7X\_d8a5b776-61d9-4dee-b049-ee94d4a66250\_20250701\_1  
65808\_887.jpg, 00:00:22, 4.41 m  
Line deviates up

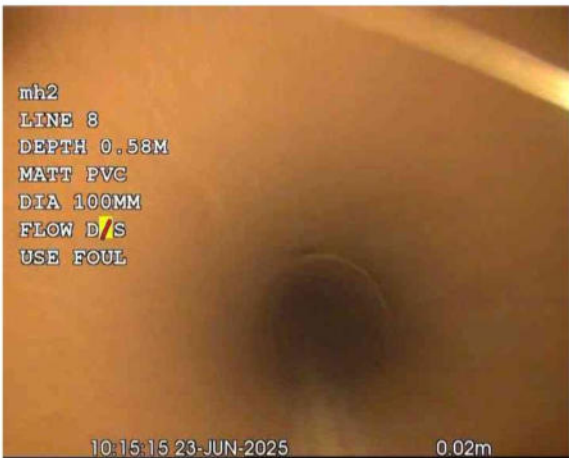
MH  
2X\_94e56988-60b4-400c-8ddf-b2c25e92e3cf\_20250701\_165820\_496.jpg, 00:00:05, 0.02 m  
Pipe material changes to vitrified clay at this point

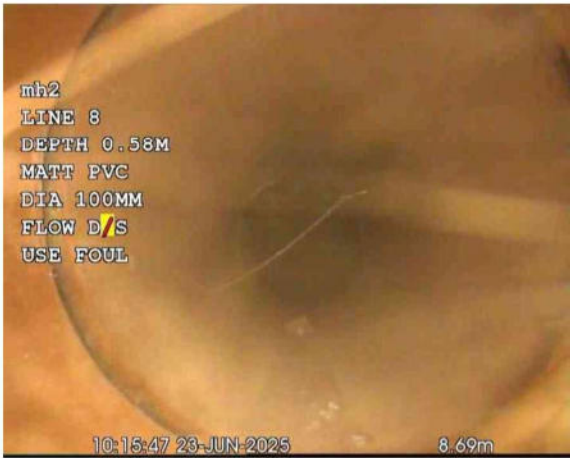
MH  
2X\_99ede1bb-544a-4a8d-a940-239d07540689\_20250701\_16  
5825\_903.jpg, 00:00:37, 8.69 m  
Pipe size changes, new size(s), 150mm high

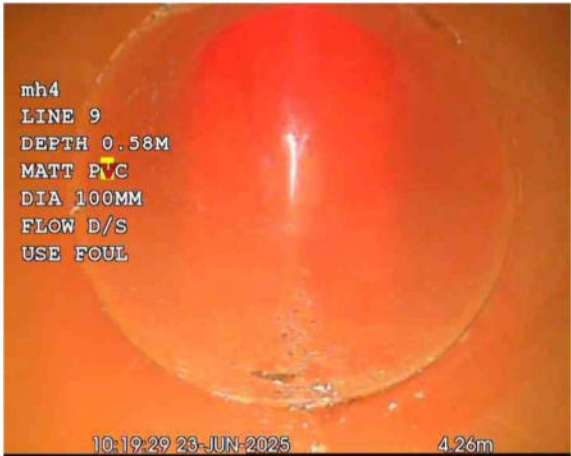
L9X\_6a8c22e5-1168-48a0-a32d-5cf0c5b7625a\_20250701\_165858\_809.jpg, 00:00:17, 4.26 m  
Line deviates up

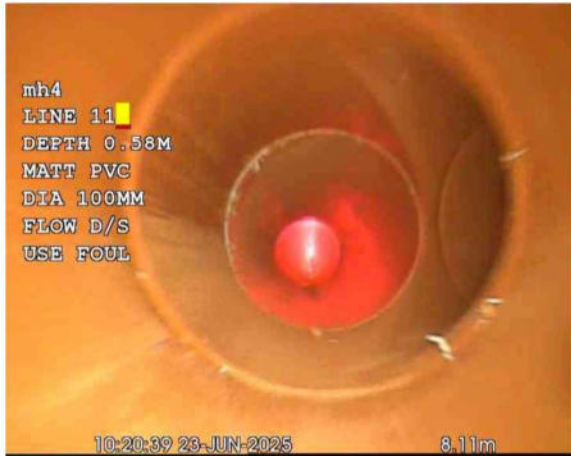
L11X\_c108a6c0-ce4f-4e71-85a6-9047abcc196d\_20250701\_165908\_983.jpg, 00:00:28, 8.00 m  
Junction at 3 o'clock, 100mm dia

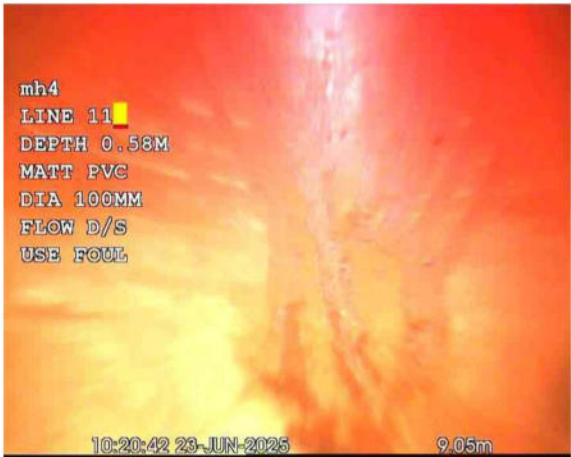
L11X\_44e2cbe1-6bee-49bd-ba8b-bcaf18e67cbf\_20250701\_165910\_196.jpg, 00:00:31, 9.05 m  
Line deviates up

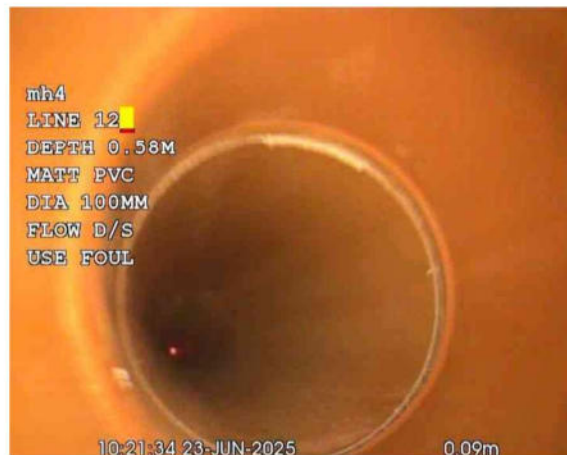
L12X\_4c26aa87-9a13-49d6-9596-9bd435029d2a\_20250701\_165919\_090.jpg, 00:00:05, 0.09 m  
Line deviates left

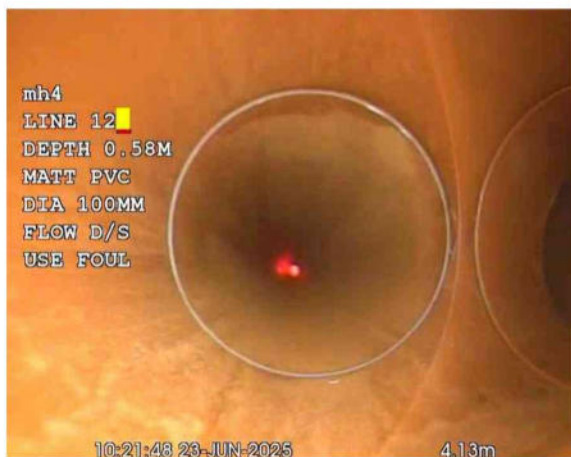
L12X\_65cd4124-d1aa-497c-a461-6fb0f24bd3ce\_20250701\_165920\_091.jpg, 00:00:19, 4.13 m  
Junction at 3 o'clock, 100mm dia

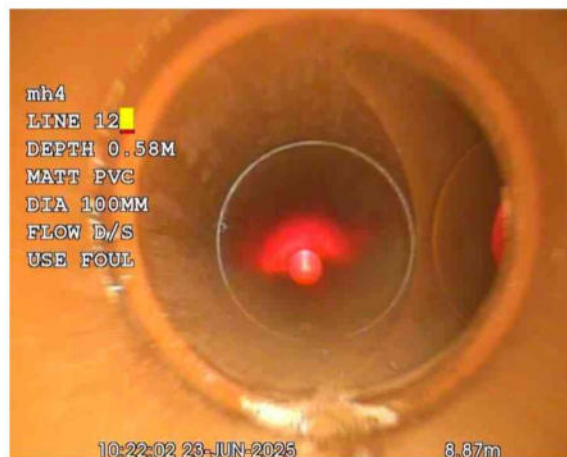
L12X\_5ce7d6ae-ff7a-4a0d-b4d9-cc27464934ca\_20250701\_165921\_952.jpg, 00:00:34, 8.87 m  
Junction at 3 o'clock, 100mm dia

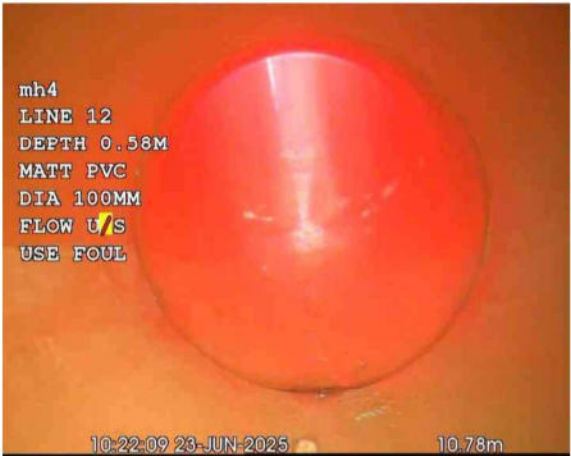
L12X\_8838090a-ad35-4fa0-95ed-027d46885759\_20250701\_165924\_960.jpg, 00:00:41, 10.78 m  
Line deviates up

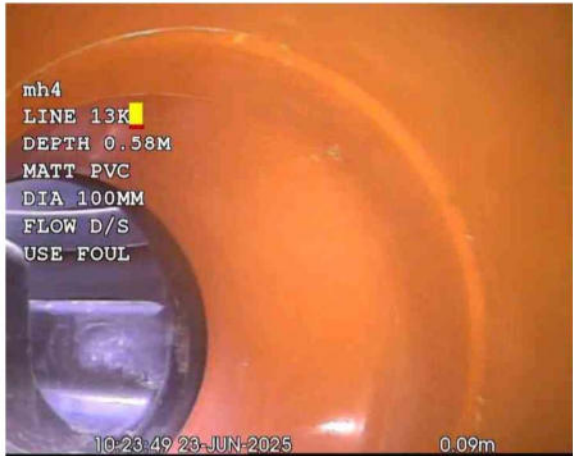
MH  
4X\_975fb1c5-2f44-413c-a3e1-faeccf9ba1cf\_20250701\_16593  
1\_628.jpg, 00:00:04, 0.09 m  
Line deviates left

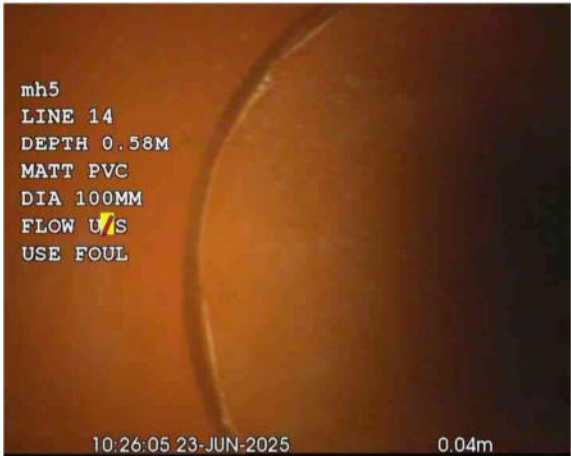
L14X\_350b519f-60d0-4551-aa9e-b8f7cb8791cb\_20250701\_1  
65941\_811.jpg, 00:00:02, 0.04 m  
Line deviates right

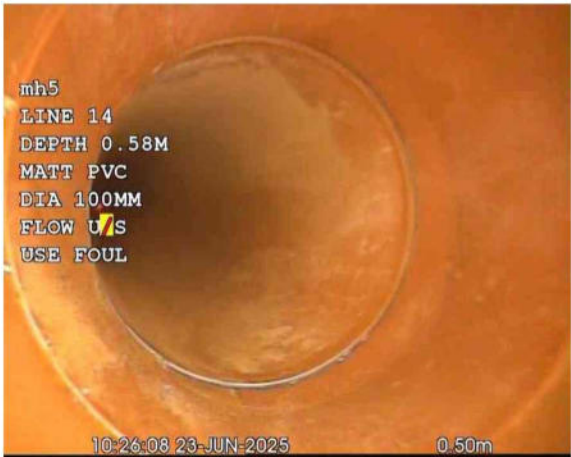
L14X\_1b6d1808-0998-4c7c-8f52-ef9d7cade173\_20250701\_1  
65943\_387.jpg, 00:00:06, 0.59 m  
Line deviates left

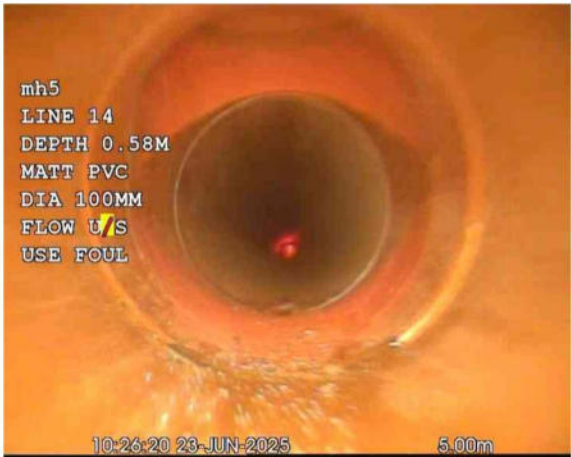
L14X\_93f9c29a-33c3-4cfe-9e9d-351cc3703759\_20250701\_1  
65944\_696.jpg, 00:00:18, 5.00 m  
Junction at 12 o'clock, 100mm dia

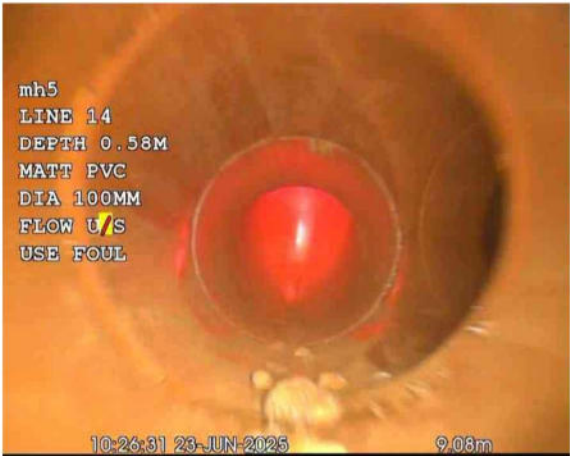
L14X\_48e92ebe-8d23-4adb-b3a8-6b40c62f347c\_20250701\_165946\_565.jpg, 00:00:28, 8.90 m  
Junction at 3 o'clock, 100mm dia

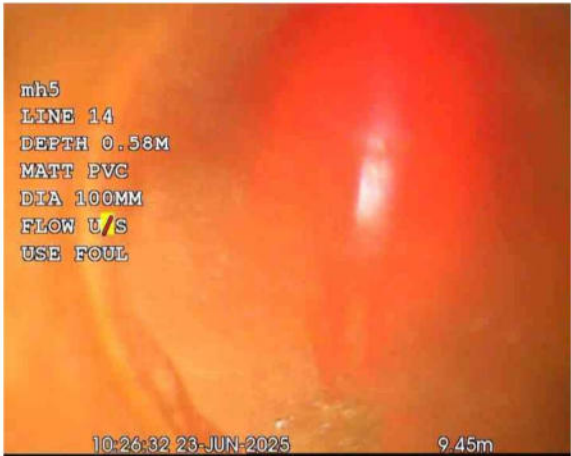
L14X\_eec33aec-2041-472c-8420-53125881882e\_20250701\_165948\_859.jpg, 00:00:29, 9.45 m  
Line deviates up

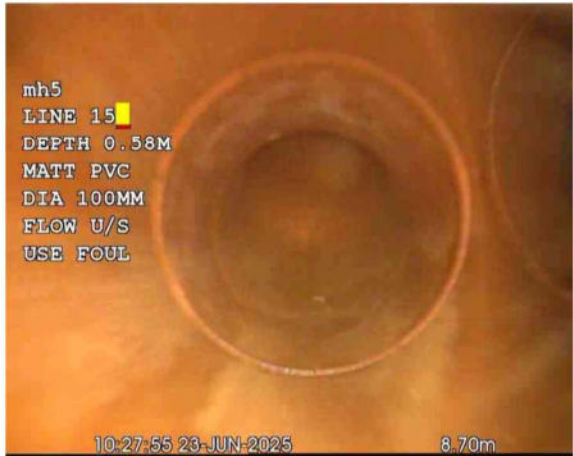
L15X\_9dd469a6-cff0-446a-8d6c-26f385a1409c\_20250701\_170006\_358.jpg, 00:00:31, 8.70 m  
Junction at 3 o'clock, 100mm dia

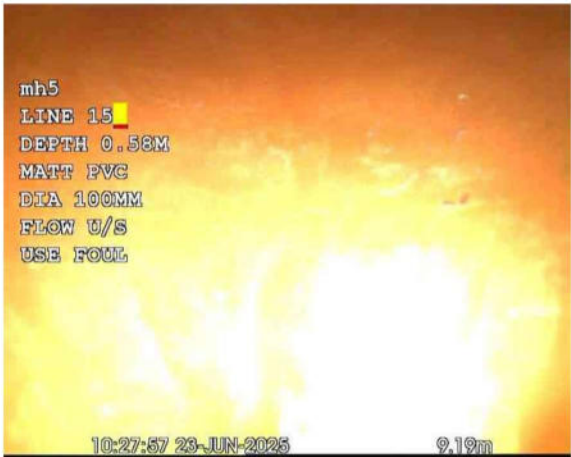
L15X\_314e08ad-9e8b-4d72-8cff-b7717ed69cd0\_20250701\_170007\_949.jpg, 00:00:33, 9.19 m  
Line deviates up

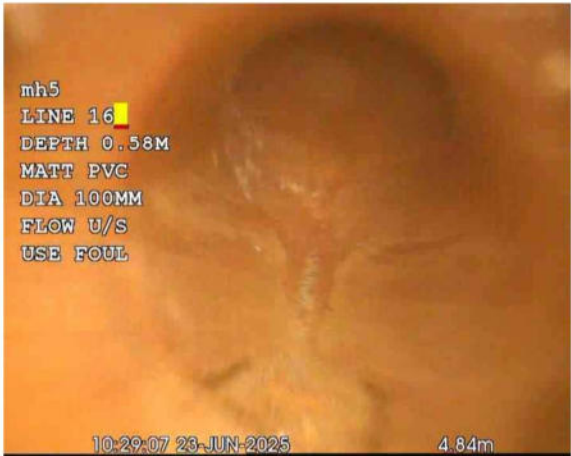
L16X\_2b70c7af-9f89-49f3-9f3e-118ce13f01d9\_20250701\_170017\_910.jpg, 00:00:19, 4.84 m  
Line deviates up

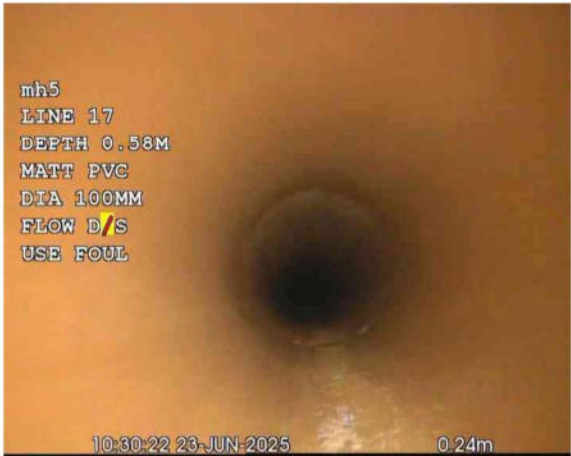
MH  
5X\_79554204-539b-43bf-9e42-5e1eb01cfb4e\_20250701\_1700  
034\_661.jpg, 00:00:05, 0.24 m  
Pipe material changes to vitrified clay at this point

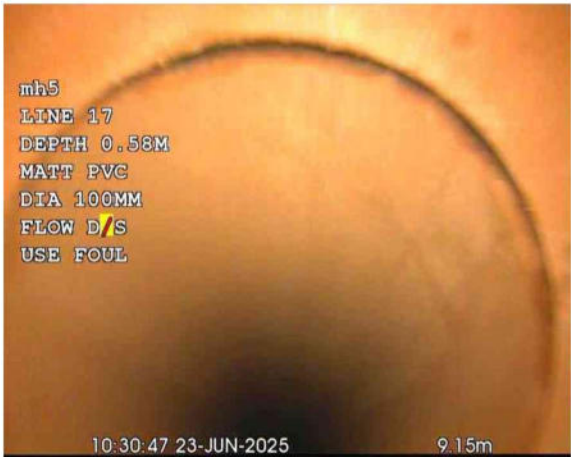
MH  
5X\_84b027ab-51f7-4928-a7e0-1d0c026f51b7\_20250701\_1700  
035\_892.jpg, 00:00:30, 9.15 m  
Line deviates down

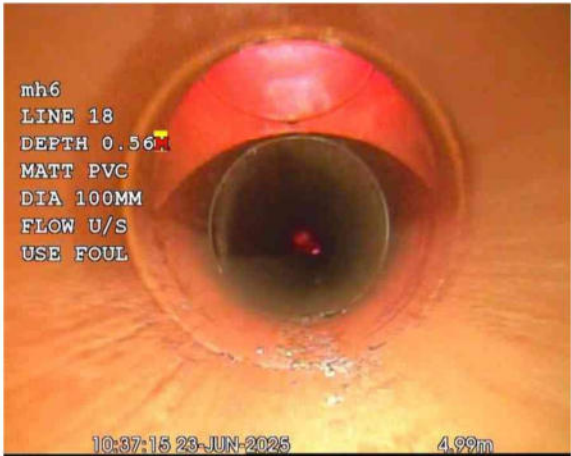
L18X\_b559e82b-323a-4201-8ed5-b0c320c86847\_20250701\_170049\_660.jpg, 00:00:20, 4.99 m  
Junction at 12 o'clock, 100mm dia

| <b>Recommendations:</b> HPWJ LINE | | | | | |

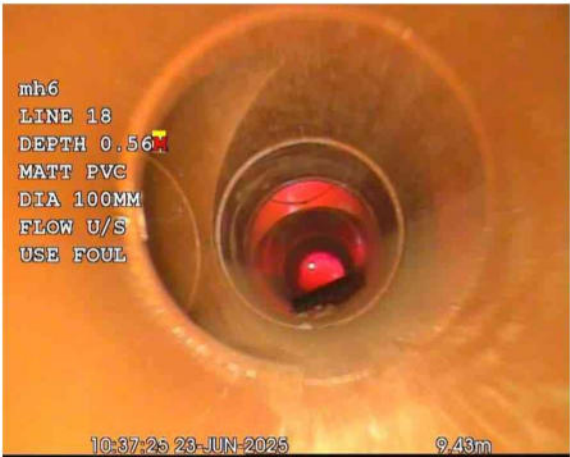
L18X\_95c00c07-51e8-4ff7-afce-76ff066155ea\_20250701\_170048\_363.jpg, 00:00:31, 9.43 m  
Junction at 9 o'clock, 100mm dia

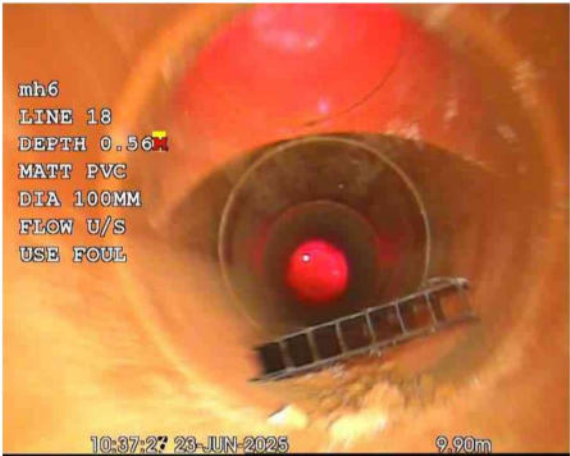
L18X\_e2a569b3-baf8-4abe-aab2-cdb83d3a3d36\_20250701\_1  
70102\_115.jpg, 00:00:32, 9.90 m  
Junction at 12 o'clock, 100mm dia

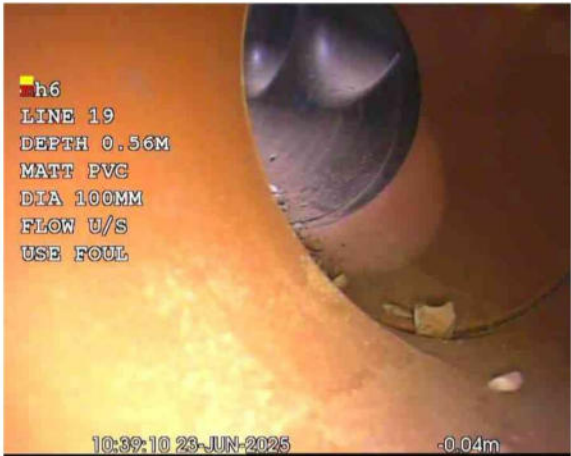
MH  
7X\_a79175aa-e2fa-4ecb-8d22-c68fd7e514fb\_20250701\_1701  
30\_436.jpg, 00:00:00, 0.04 m  
Line deviates left

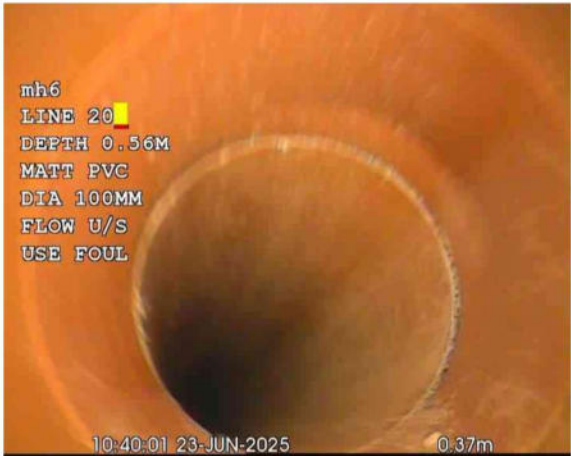
L20X\_e231ad4f-6329-4834-bbd9-60ce2bfd9fef\_20250701\_17  
0138\_447.jpg, 00:00:06, 0.37 m  
Line deviates left

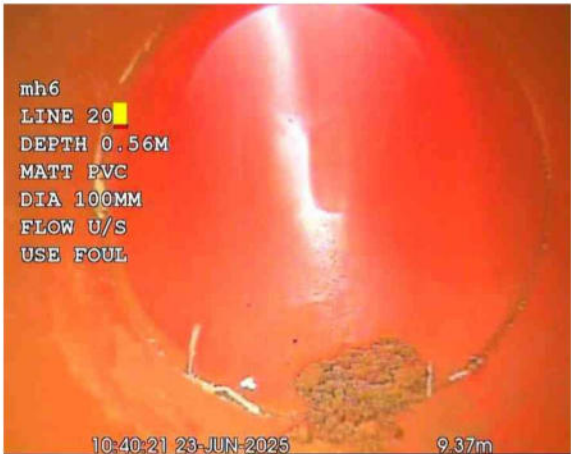
L20X\_ffd22232-8f7c-43a1-9452-a7ba47932ba9\_20250701\_17  
0139\_418.jpg, 00:00:26, 9.37 m  
Line deviates up

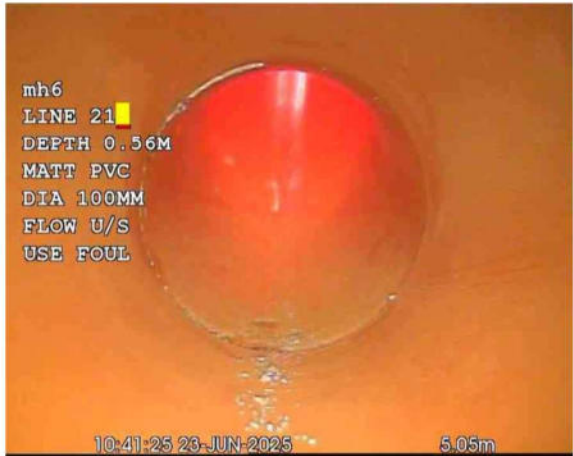
L21X\_d82494c6-9ef7-44d0-861c-520d7362bb84\_20250701\_1  
70150\_265.jpg, 00:00:16, 5.05 m  
Line deviates up

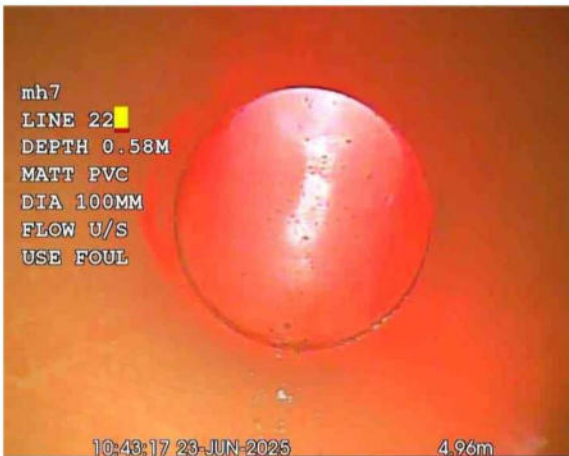
L22X\_45675bc0-01f7-4c64-a830-67f27a4f2d40\_20250701\_170204\_018.jpg, 00:00:16, 4.96 m  
Line deviates up

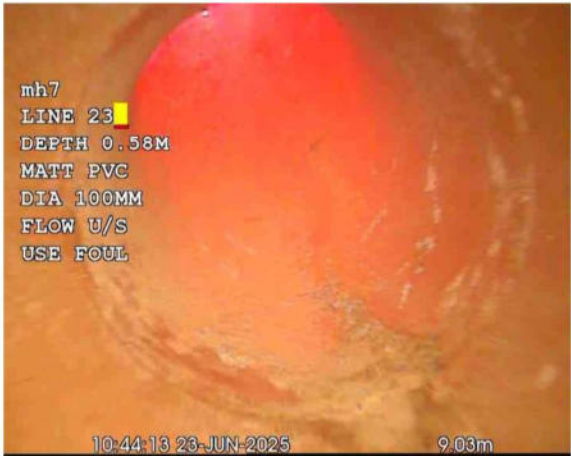
L23X\_c1caa1c2-c20d-4253-8b0c-4cec330014f6\_20250701\_1  
70223\_349.jpg, 00:00:29, 9.03 m  
Line deviates up

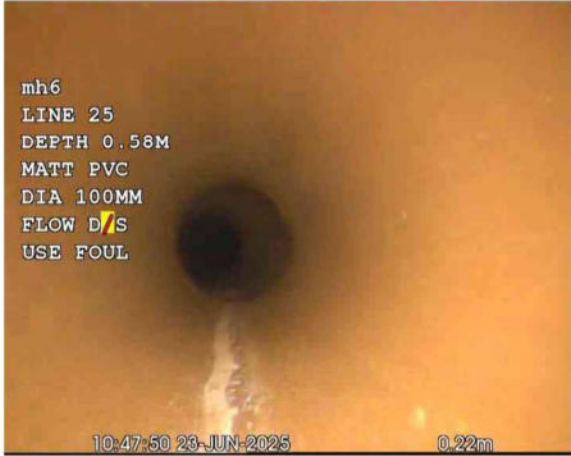
MH  
6X\_28a93d44-dc4d-4996-aa35-585673cb0242\_20250701\_17  
0253\_926.jpg, 00:00:08, 0.22 m  
Pipe material changes to vitrified clay at this point

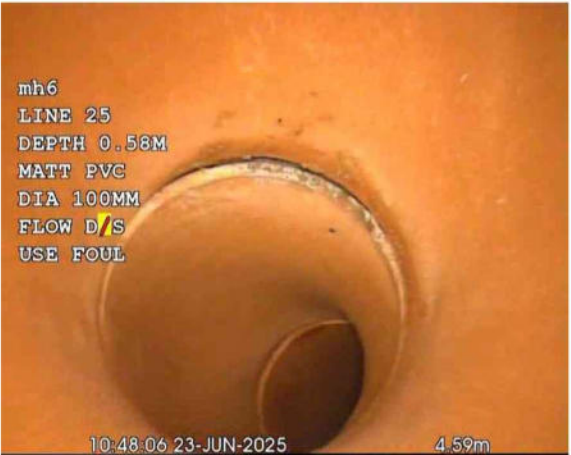
MH  
6X\_dd7489f3-b8fd-4936-8070-ffeff079b4e4\_20250701\_17025  
6\_010.jpg, 00:00:24, 4.59 m  
Line deviates down

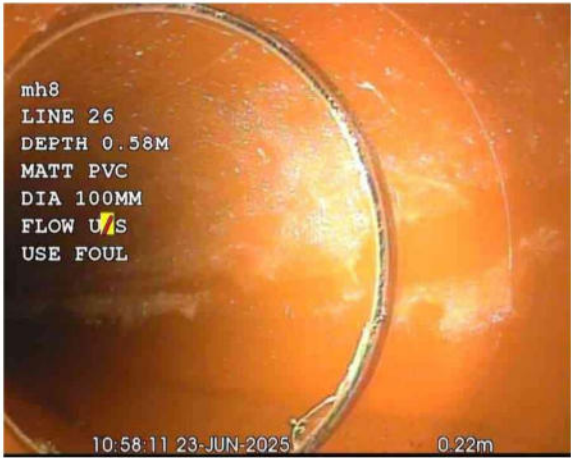
10:58:11 23-JUN-2025 0.22m  
L26X\_fbcd8b09-5c2b-45e3-9260-c38fb52b49f9\_20250701\_170325\_927.jpg, 00:00:04, 0.22 m  
Line deviates left

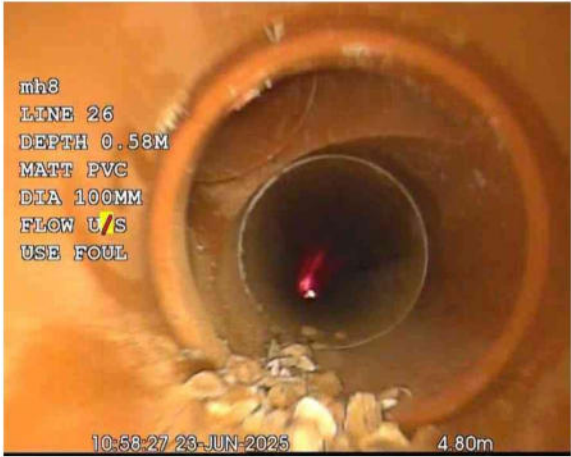
10:58:27 23-JUN-2025 4.80m  
L26X\_8c748d7e-6e80-41d5-8e9e-3ca6b8908f4d\_20250701\_170329\_128.jpg, 00:00:20, 4.80 m  
Settled deposits, coarse, 5% cross-sectional area loss

| Recommendations: HPWJ LINE | | | | | |

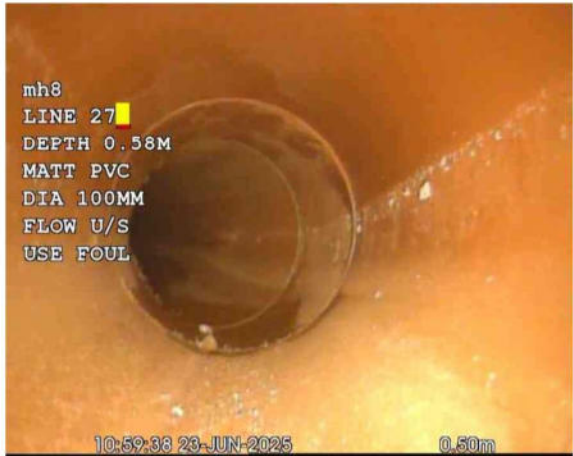
L27X\_ddb0d084-8b81-450a-921b-cdab44ff2023\_20250701\_170657\_353.jpg, 00:00:05, 0.50 m  
Line deviates left

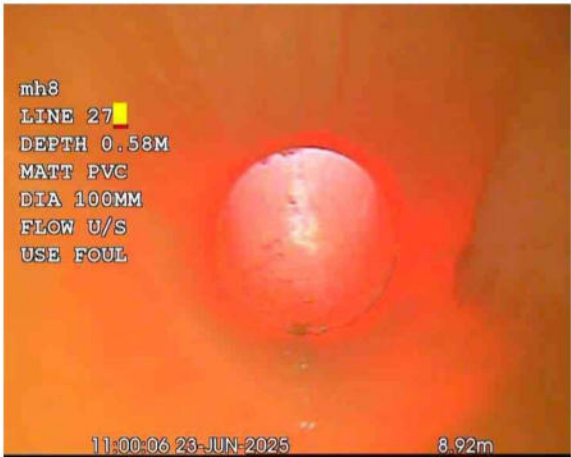
L27X\_1367f3f5-dd01-4eb3-9be0-1bb0528067d6\_20250701\_170658\_752.jpg, 00:00:34, 8.92 m  
Line deviates up

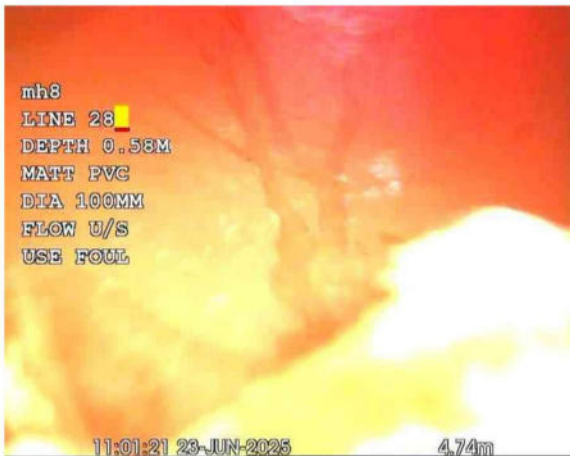
L28X\_6ece63e4-544b-49c5-bb9f-0567f6524307\_20250701\_170706\_596.jpg, 00:00:15, 4.74 m  
Line deviates up

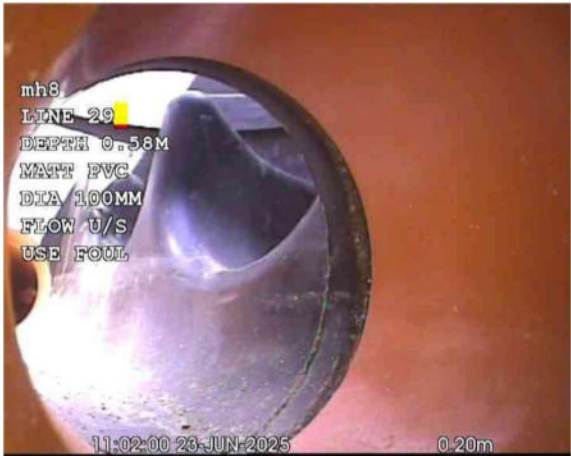
MH  
9X\_ff6d5cc7-60f5-4b17-87d1-b45710adc309\_20250701\_1707  
22\_563.jpg, 00:00:04, 0.20 m  
Line deviates left

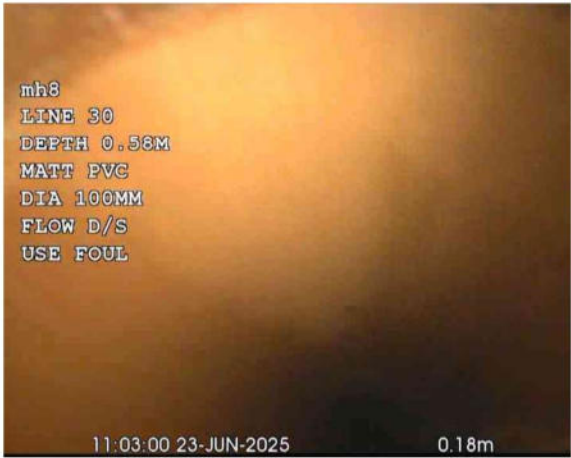
MH  
8X\_6e208c22-d6a4-4988-92a0-0fb0cd3422ce\_20250701\_170  
728\_259.jpg, 00:00:04, 0.18 m  
Pipe material changes to vitrified clay at this point

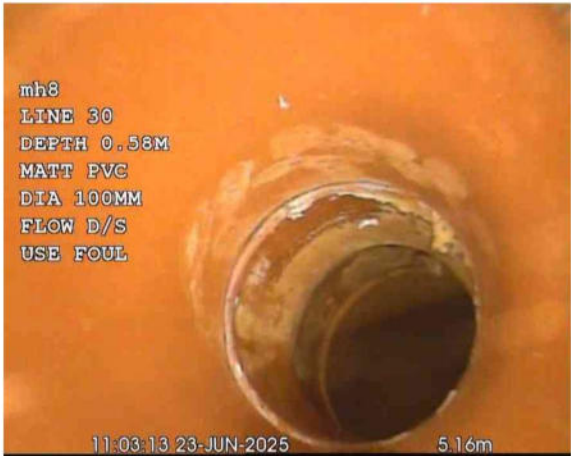
MH  
8X\_ea9f699c-a617-46f3-b323-6ab1b76fb2e4\_20250701\_170732\_567.jpg, 00:00:18, 5.16 m  
Line deviates down

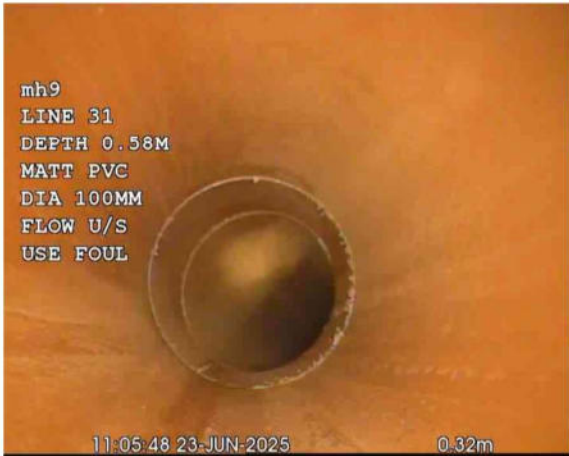
L31X\_7b19a8f0-dca6-4bb9-b6b3-050d38c26002\_20250701\_170752\_079.jpg, 00:00:00, 0.00 m

Start node, manhole, reference: FIC8

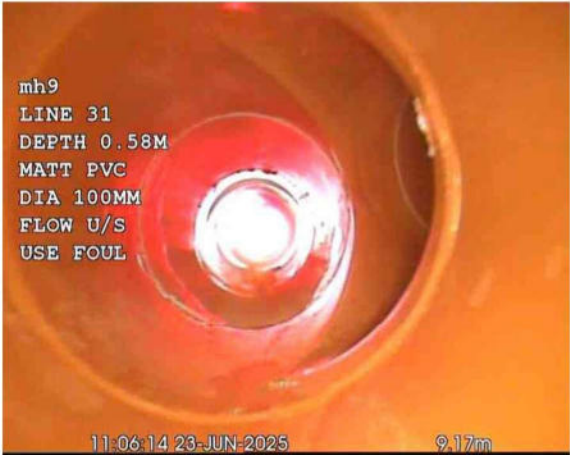
L31X\_3b2e0d3d-8fa8-4fc7-a71a-8be422023423\_20250701\_170752\_924.jpg, 00:00:06, 0.32 m

Line deviates right

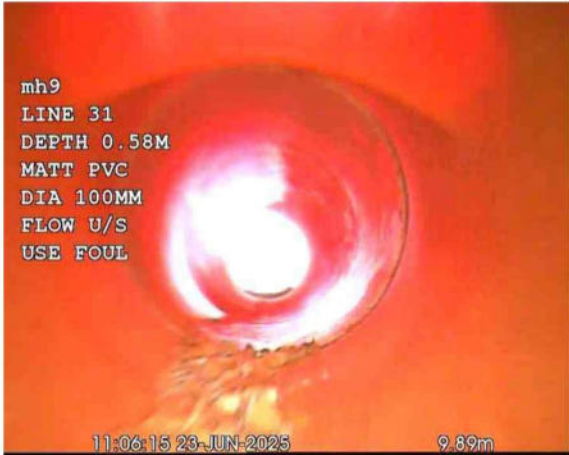
L31X\_17a81b75-1a42-4daa-9a7e-307be2c49266\_20250701\_170753\_850.jpg, 00:00:32, 9.17 m

Junction at 3 o'clock, 100mm dia

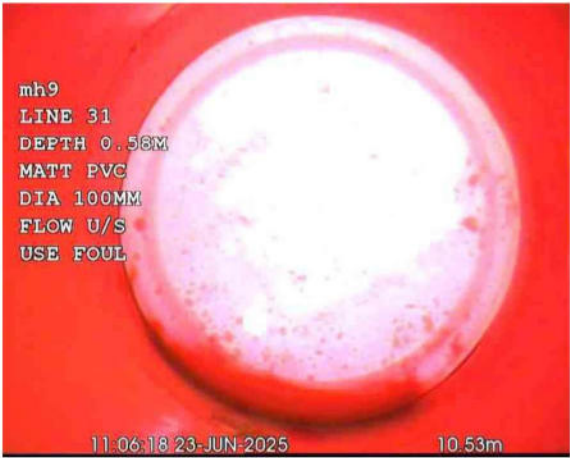
L31X\_18350002-44d5-4eaf-80ba-452eaa3bf113\_20250701\_1  
70756\_338.jpg, 00:00:36, 10.53 m  
Finish node, other special chamber, reference: L31

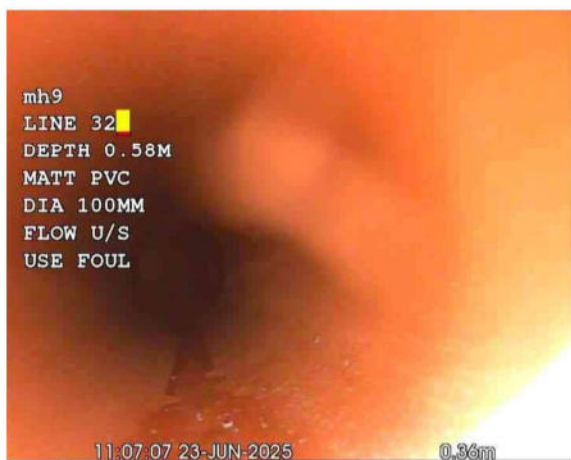
L32X\_ef774b42-8bb7-4e83-96a9-bd27bfc016f7\_20250701\_17  
0802\_674.jpg, 00:00:00, 0.00 m  
Start node, manhole, reference: FIC8

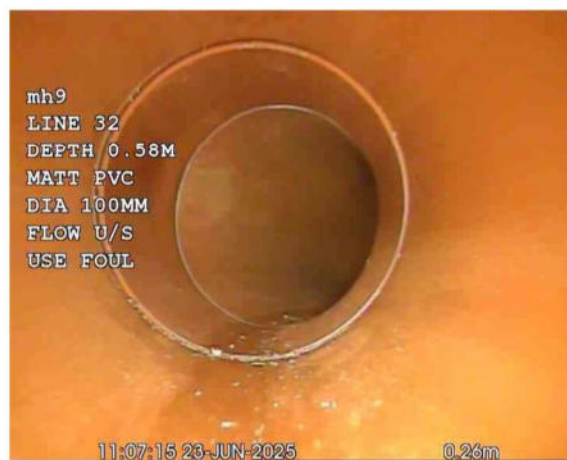
L32X\_a653e029-9f5b-4e61-be3b-7592023faccd\_20250701\_1  
70803\_809.jpg, 00:00:08, 0.26 m  
Line deviates right

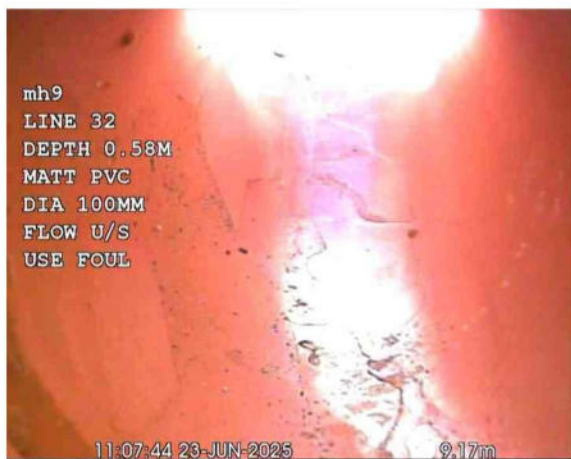
L32X\_15bb80fe-d993-43e1-b97b-02fa2b90178f\_20250701\_1  
70804\_974.jpg, 00:00:36, 9.17 m  
Line deviates up

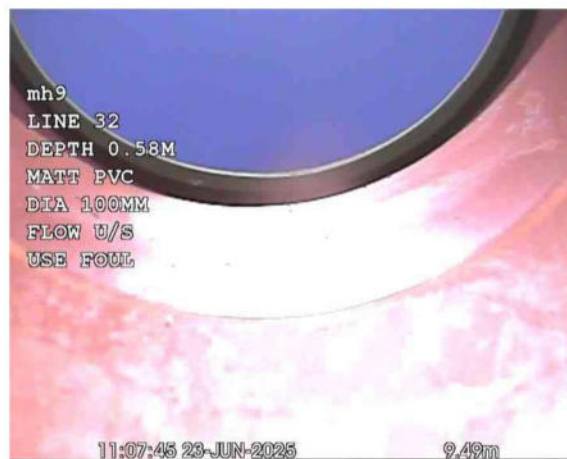
L32X\_5425e612-715c-43b0-a841-f79979034c5f\_20250701\_1  
70806\_866.jpg, 00:00:38, 9.49 m  
Finish node, other special chamber, reference: L32

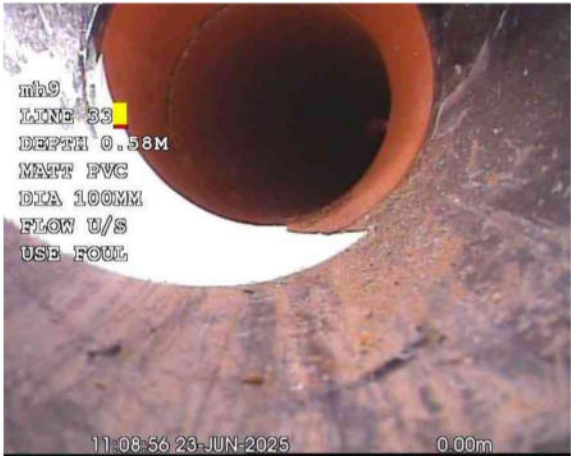
L33X\_a02971be-6f89-4ced-9161-63f0ef750068\_20250701\_15  
2404\_141.jpg, 00:00:00, 0.00 m  
Start node, manhole, reference: FIC8

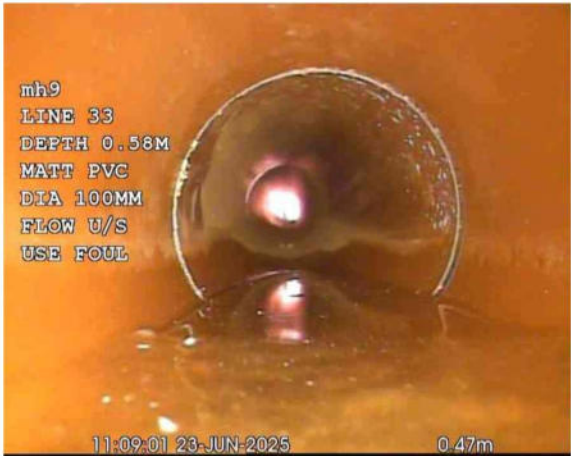
L33X\_21a7342b-2438-4a3f-a4d1-a4bb3c42f243\_20250701\_1  
70813\_347.jpg, 00:00:06, 0.47 m  
Water level, 5% of the vertical dimension

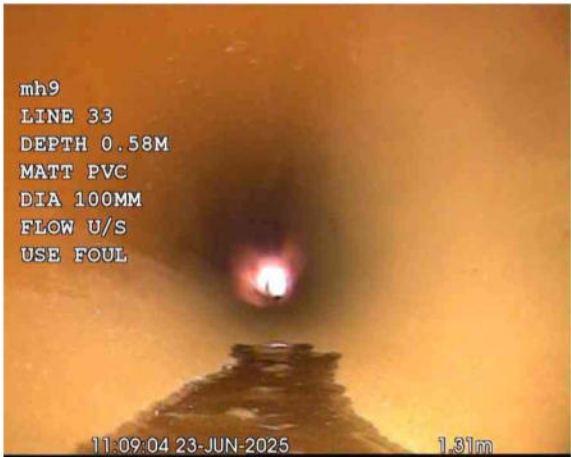
L33X\_1e2cc001-e770-4413-b151-5020a8396adb\_20250701\_  
170814\_568.jpg, 00:00:09, 1.31 m  
Water level, 5% of the vertical dimension

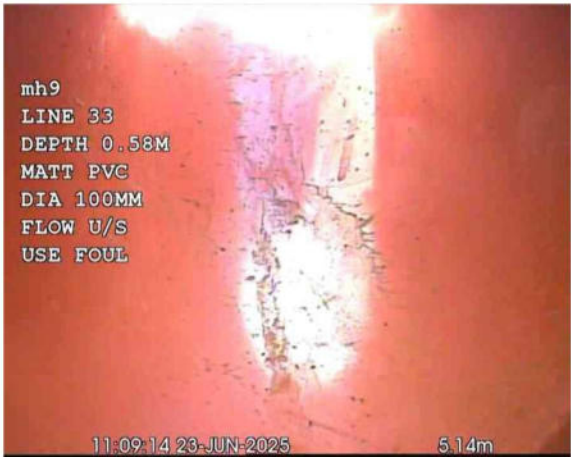
L33X\_45c437ca-615a-4fc3-b1de-97e3714f5d1f\_20250701\_17  
0815\_782.jpg, 00:00:19, 5.14 m  
Line deviates up

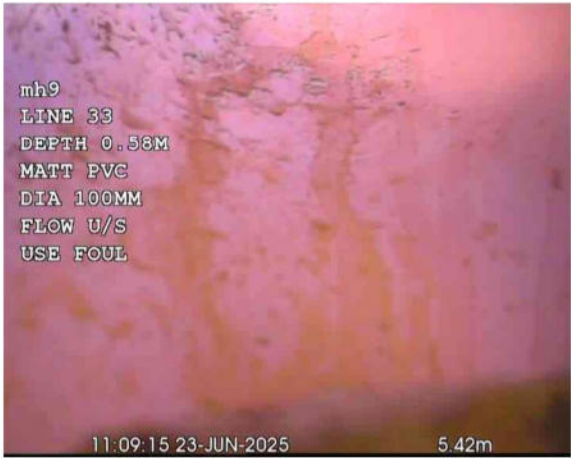
L33X\_133461c5-9c80-4335-90c3-45fd7edccf2f\_20250701\_17  
0816\_900.jpg, 00:00:20, 5.42 m  
Finish node, other special chamber, reference: L33

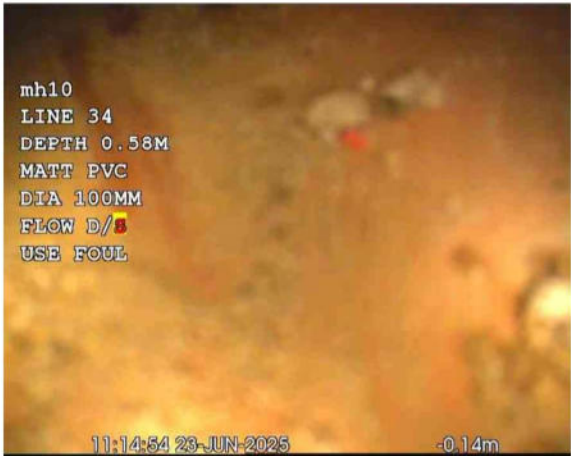
MH  
10X\_2cbfc18d-a6a1-41fa-a0d2-7c275e7a450a\_20250701\_17  
0821\_815.jpg, 00:00:00, 0.00 m  
Start node, manhole, reference: FIC9

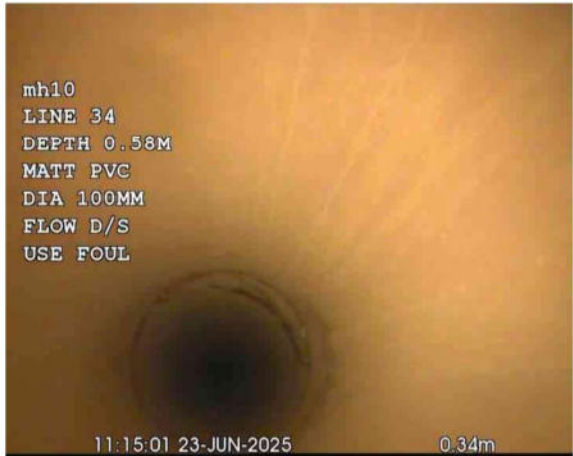
MH  
10X\_d9c31105-c8fa-4a63-8956-95dd5c9a69ad\_20250701\_17  
0822\_692.jpg, 00:00:07, 0.34 m  
Pipe material changes to vitrified clay at this point

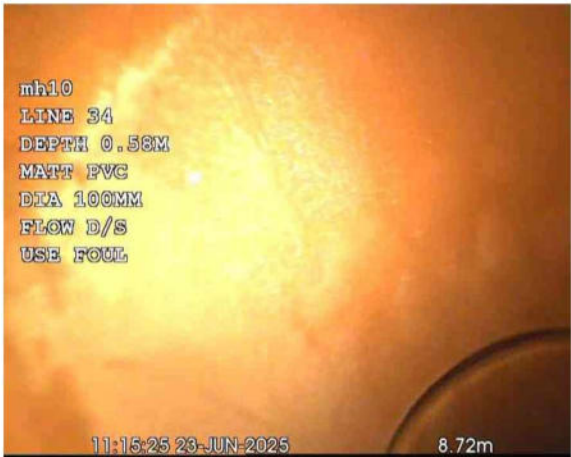
MH  
10X\_1a97efa3-373a-4a10-9a0b-812b99802d83\_20250701\_1  
70824\_007.jpg, 00:00:30, 8.72 m  
Line deviates down

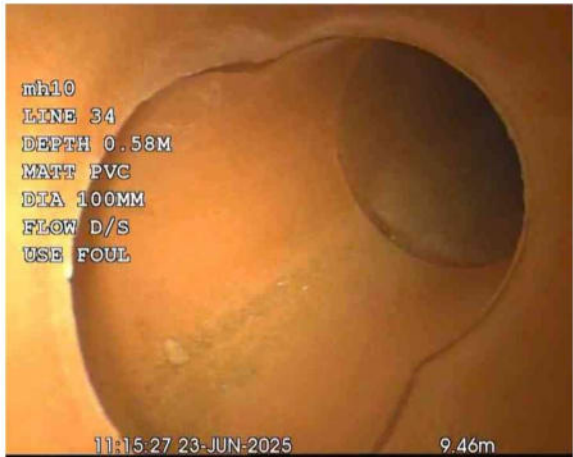
MH  
10X\_adbcc411-c696-410b-b1b7-faa9e9a4c3ce\_20250701\_17  
0825\_407.jpg, 00:00:33, 9.46 m  
Finish node, major connection without manhole, reference: L34

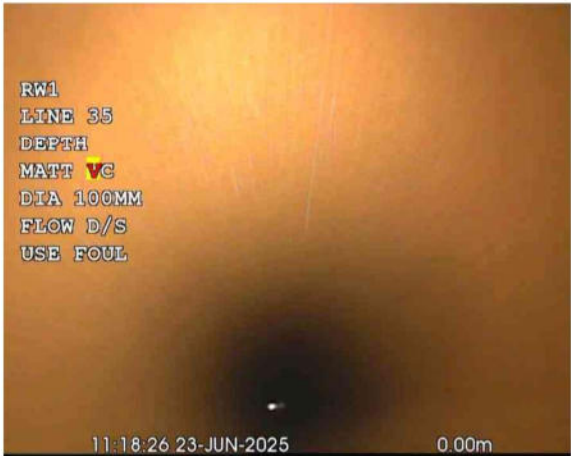
RW1X\_17f319a1-05c0-444b-a076-ac21c78080f6\_20250701\_152835\_305.jpg, 00:00:00, 0.00 m  
Start node, manhole, reference: PCPP1

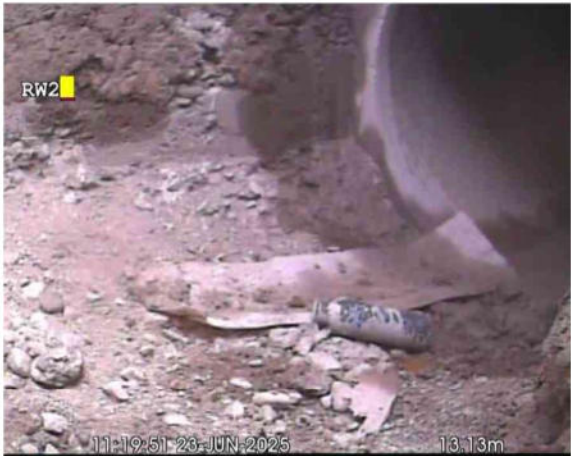
RW1X\_25a4fa14-6ce2-47e6-be28-dda2abd915fd\_20250701\_170838\_272.jpg, 00:01:01, 13.13 m  
Finish node, manhole, reference: SMH32

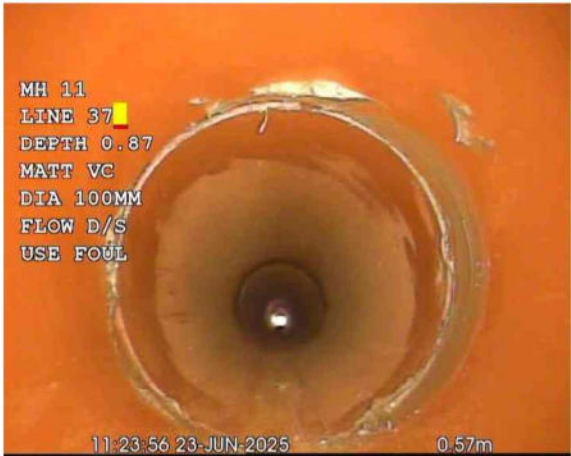
MH  
11X\_1965b6ba-210c-480b-9f64-abe928a145e6\_20250701\_17  
0905\_822.jpg, 00:00:00, 0.00 m  
Start node, manhole, reference: FIC10

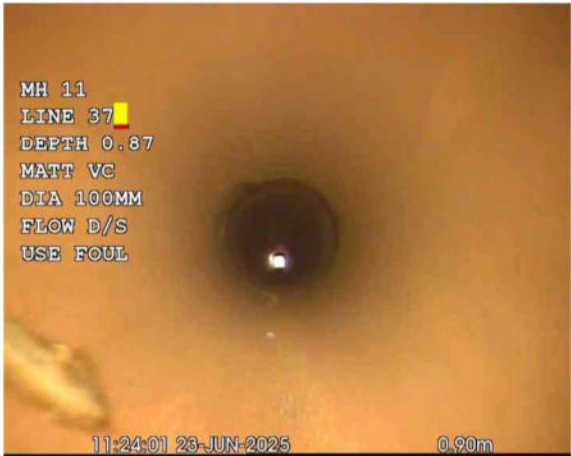
MH  
11X\_f9c60126-d79b-426f-ad26-8be088aa6ce7\_20250701\_17  
0907\_112.jpg, 00:00:06, 0.90 m  
Pipe material changes to vitrified clay at this point

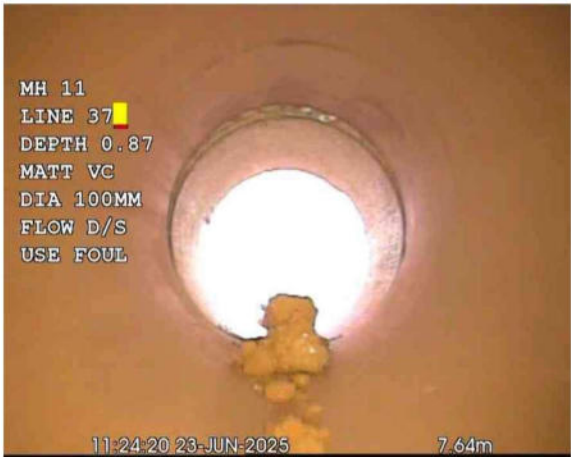
MH  
11X\_91691825-464d-4d15-ba6c-5119b173f1fa\_20250701\_17  
0908\_566.jpg, 00:00:25, 7.64 m  
Settled deposits, coarse, 15% cross-sectional area loss

| <b>Recommendations:</b> | HPWJ LINE | | | | |

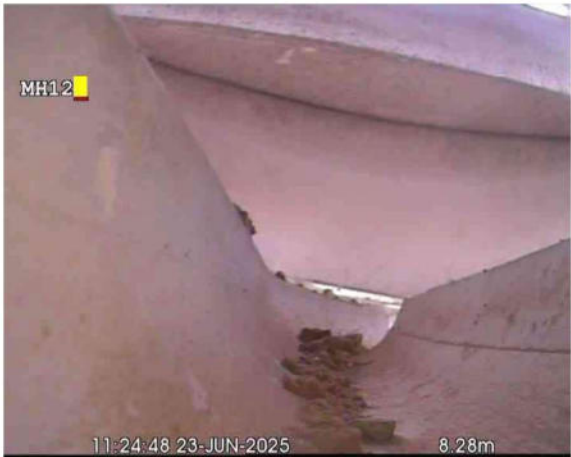
MH  
11X\_52ea81d8-a3e5-4f90-a435-5e0d3a37668b\_20250701\_1  
70909\_809.jpg, 00:00:29, 8.28 m  
Finish node, manhole, reference: FMH77

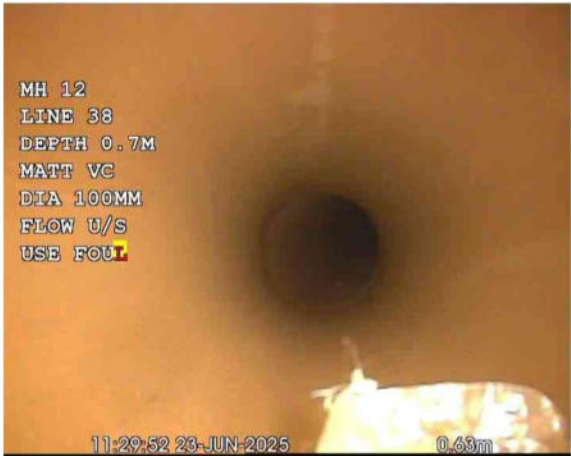
MH  
13X\_542487ce-bc2b-41e8-a440-7d6d188d7837\_20250701\_170926\_996.jpg, 00:00:00, 0.00 m  
Start node, manhole, reference: FMH77

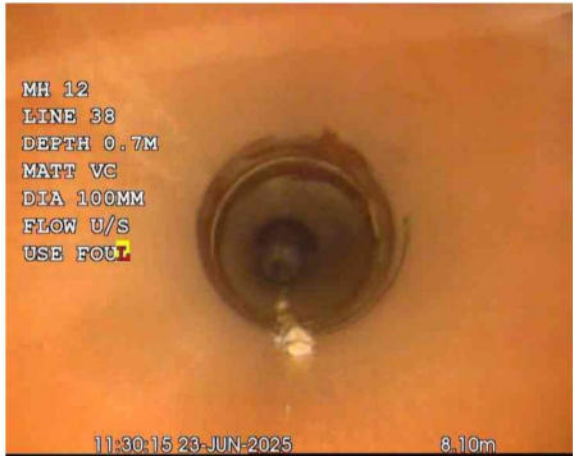
MH  
13X\_df2f6b5c-d883-4533-8373-055732486320\_20250701\_170928\_132.jpg, 00:00:23, 8.10 m  
Pipe material changes to polyvinyl chloride at this point

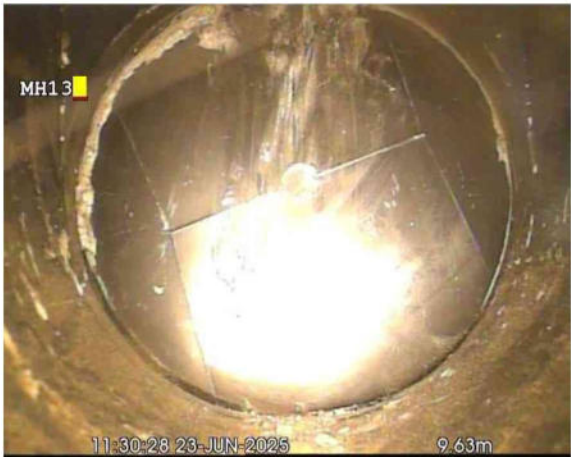
MH  
13X\_73656d1d-e237-4282-a5ae-75aa3a4f0259\_20250701\_170929\_326.jpg, 00:00:28, 9.63 m  
Finish node, manhole, reference: FIC11
