### **Project**

**Project Name:** DAISY FIELDS.LITTLEHAMPTON.BN17 6LT  
**Project Description:** TO CARRY OUT CCTV SURVEY AT THE ABOVE ADDRESS  
**Project Number:** 02  
**Project Status:** Complete  
**Project Date:** 30/06/2025  
**Inspection Standard:** MSCC5 Sewers & Drainage GB (SRM5 Scoring)

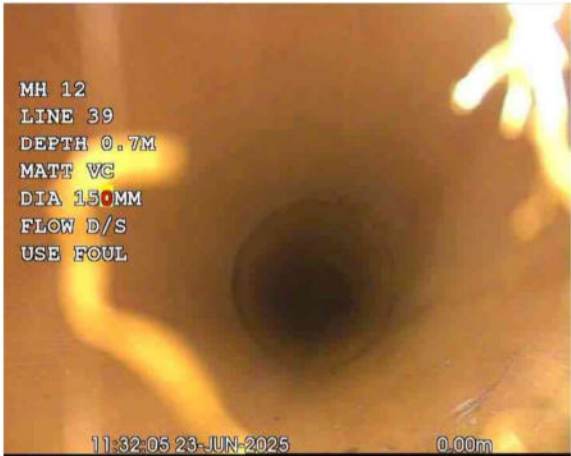
MH  
12X\_0df86777-8bc3-4ab2-b3e1-925b22642569\_20250701\_153725\_379.jpg, 00:00:00, 0.00 m  
Start node, manhole, reference: FMH77

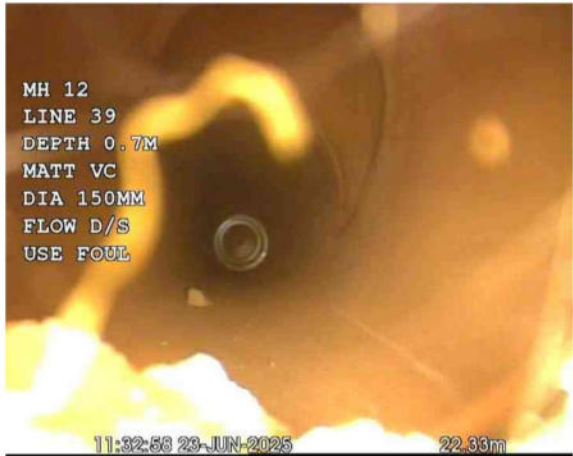
MH  
12X\_ae8ecd57-5ba5-4875-9bd5-2c010693ccb7\_20250701\_170942\_601.jpg, 00:00:53, 22.23 m  
Junction at 2 o'clock, 150mm dia

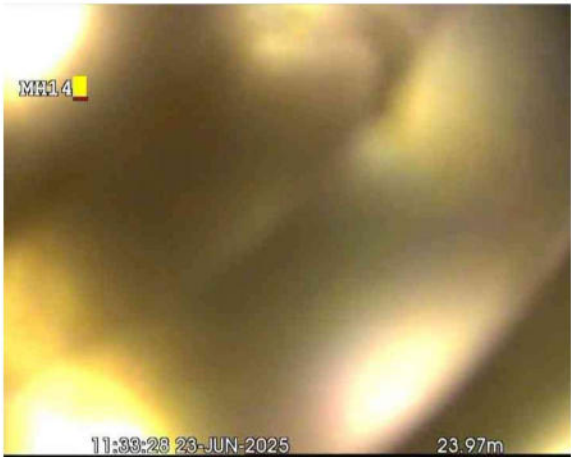
MH  
12X\_9cc4ca99-7b63-4d42-b7a6-9b2d1fb69134\_20250701\_170944\_553.jpg, 00:00:59, 23.97 m  
Finish node, manhole, reference: FMH56

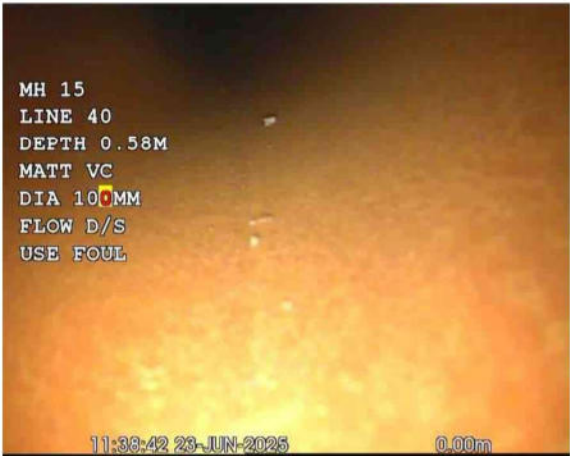
MH  
15X\_9b5831c1-41ab-46be-a468-ebcd7b7b22cc\_20250701\_160736\_294.jpg, 00:00:00, 0.00 m  
Start node, manhole, reference: FIC12

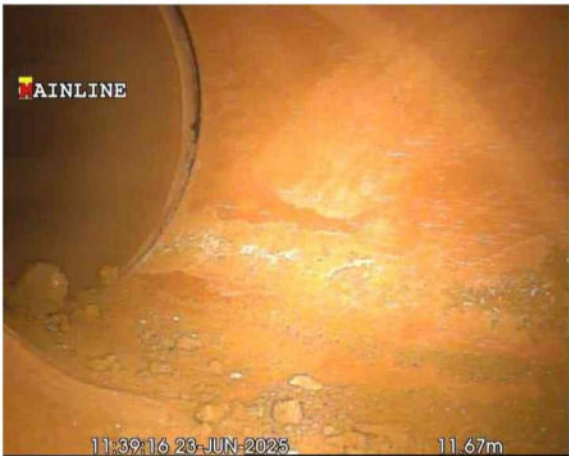
MH  
15X\_70693e50-5f42-4988-8b93-f4438a912902\_20250701\_171001\_299.jpg, 00:00:31, 11.67 m  
Finish node, major connection without manhole, reference: L40

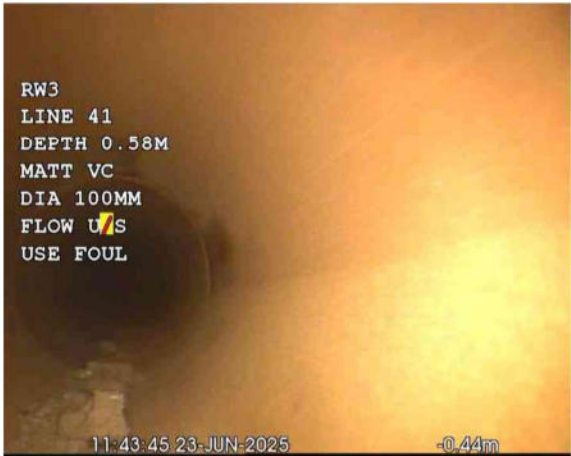
RW  
4X\_a93b3982-9e1b-4ea8-9f32-d73468393559\_20250701\_17  
1036\_564.jpg, 00:00:00, 0.00 m  
Start node, manhole, reference: SMH49

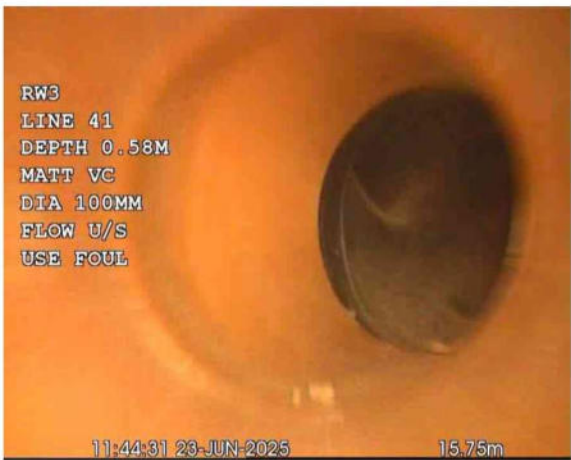
RW  
4X\_4a3d0c84-57e7-43e7-932e-ecde1b48e52d\_20250701\_17  
1038\_965.jpg, 00:00:46, 15.75 m  
Line deviates right

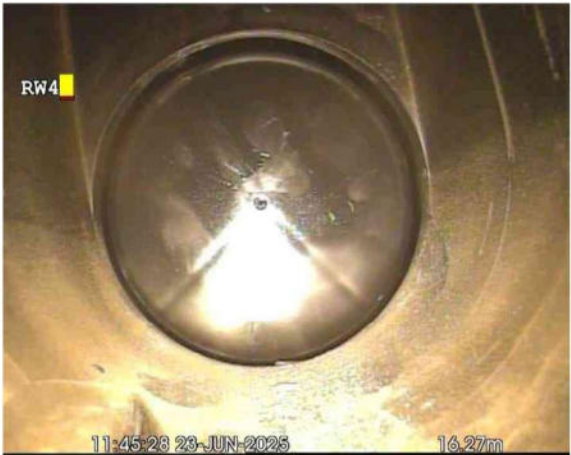
RW  
4X\_4293e051-128e-43bd-af61-42012154903d\_20250701\_17  
1040\_244.jpg, 00:00:52, 16.27 m  
Finish node, manhole, reference: PPCP2

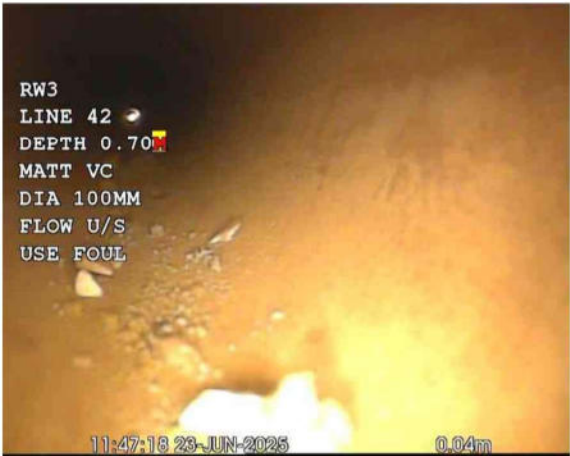
L42X\_b19ed3d1-e8ac-49b8-bcbc-5ecef1a1e853\_20250701\_171102\_905.jpg, 00:00:00, 0.00 m  
Start node, manhole, reference: SMH49

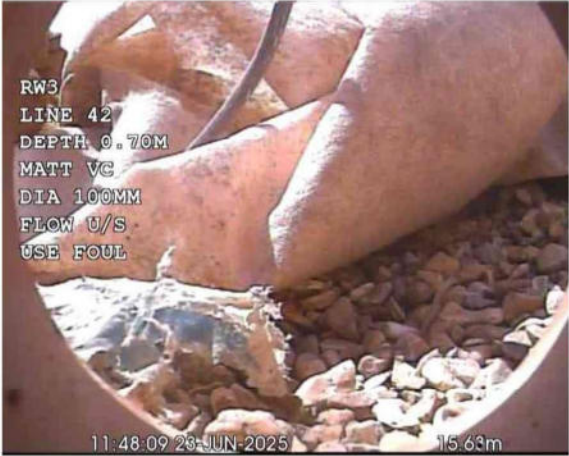
L42X\_671d8aa7-91ea-4559-851a-df5ee5461d31\_20250701\_171105\_580.jpg, 00:00:51, 15.63 m  
Finish node, other special chamber, reference: PPCP4

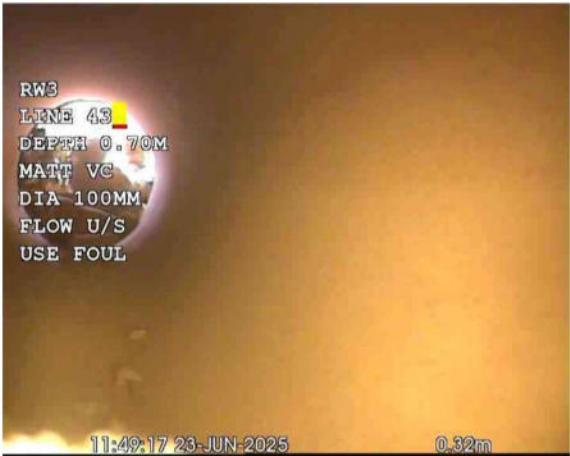
L43X\_e186bf16-5689-4693-b09f-43388f8e7d29\_20250701\_171125\_590.jpg, 00:00:00, 0.00 m  
Start node, manhole, reference: SMH49

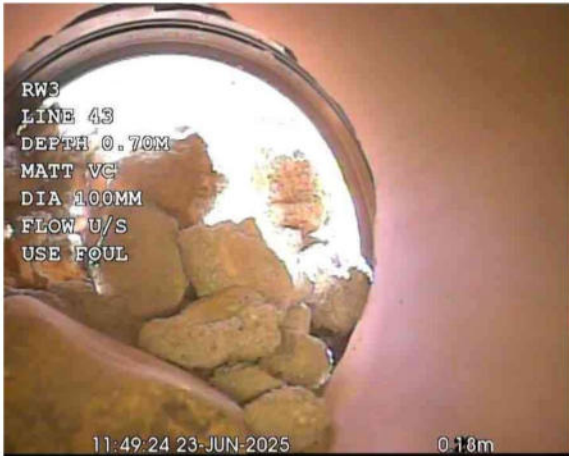
L43X\_89ba41a3-68c9-46a7-b7f3-e1fc5b98fa28\_20250701\_171126\_579.jpg, 00:00:07, 0.18 m  
Finish node, other special chamber, reference: L43

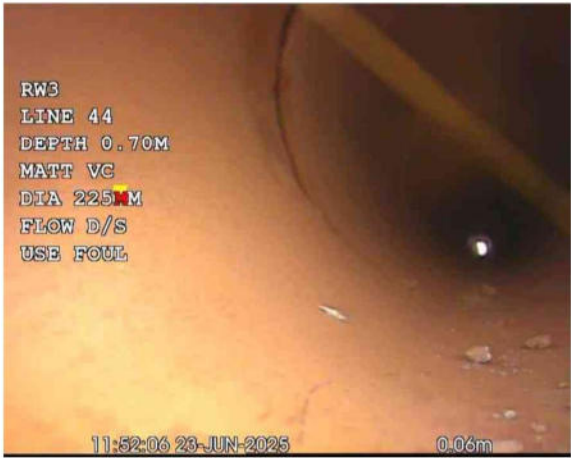
RW  
3X\_7a290796-02cb-4df0-9696-5199da4b61f3\_20250701\_171  
131\_646.jpg, 00:00:00, 0.00 m  
Start node, manhole, reference: SMH49

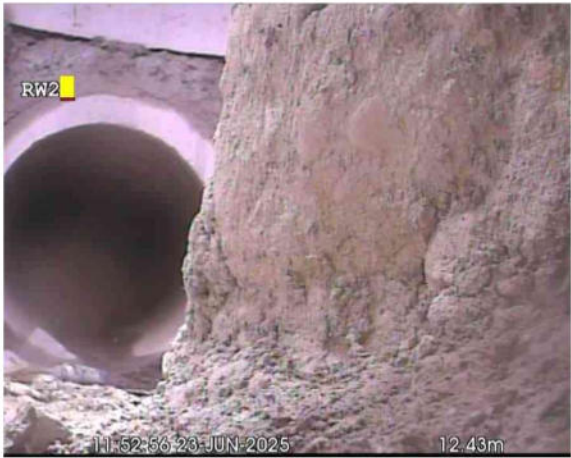
RW  
3X\_1f598720-5046-4406-8d08-ccb434507be9\_20250701\_171  
133\_556.jpg, 00:00:35, 12.43 m  
Finish node, manhole, reference: SMH32

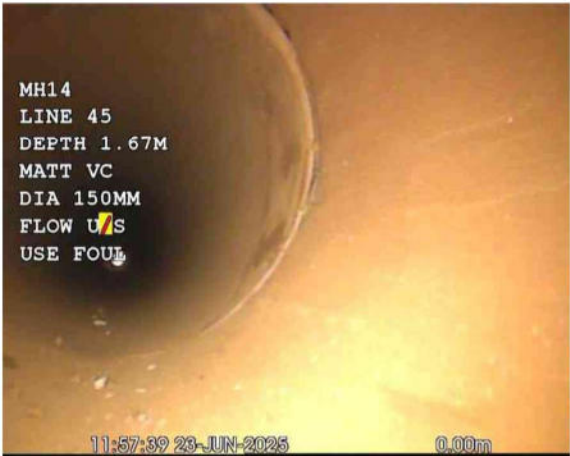
L45X\_54fa6a9d-8fa3-4c87-8269-b961a2f7090e\_20250701\_17  
1145\_211.jpg, 00:00:00, 0.00 m  
Start node, manhole, reference: FMH56

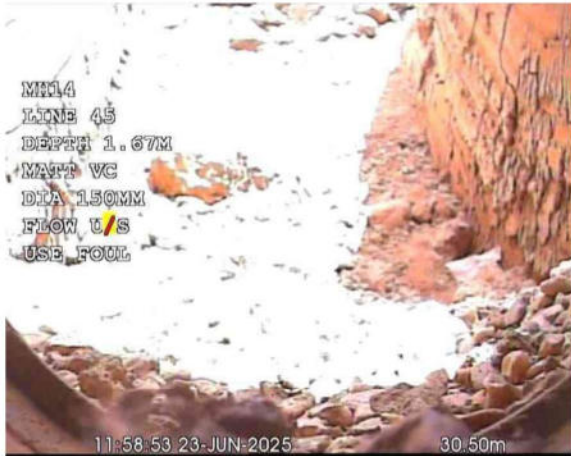
FMH51X\_c519aef4-3824-4b76-9d7c-9d17c2d02585\_2025072  
2\_124522\_253.jpg, 00:01:14, 30.50 m  
Survey abandoned

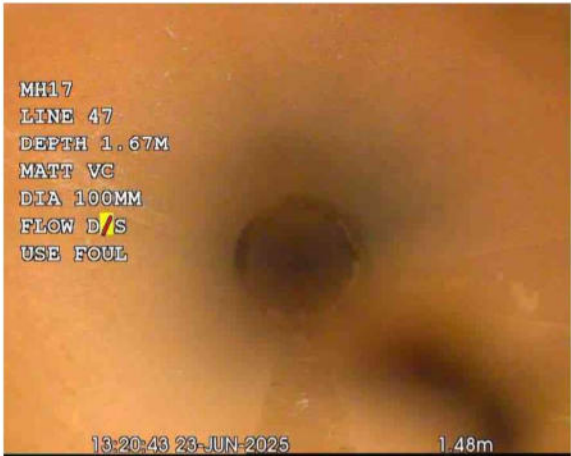
MH  
17X\_a10aedf6-cdeb-4ae4-b22b-f10f512d74c5\_20250701\_171  
159\_431.jpg, 00:00:00, 0.00 m  
Start node, manhole, reference: FIC13

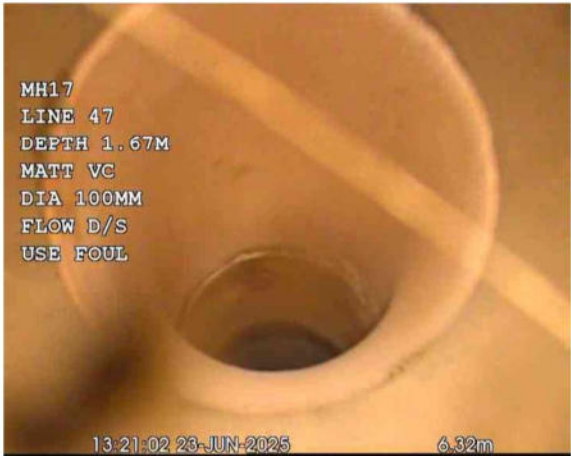
MH  
17X\_637123b5-5d38-49b0-9d51-6bcc010a04c3\_20250701\_1  
71201\_084.jpg, 00:00:18, 6.32 m  
Line deviates down

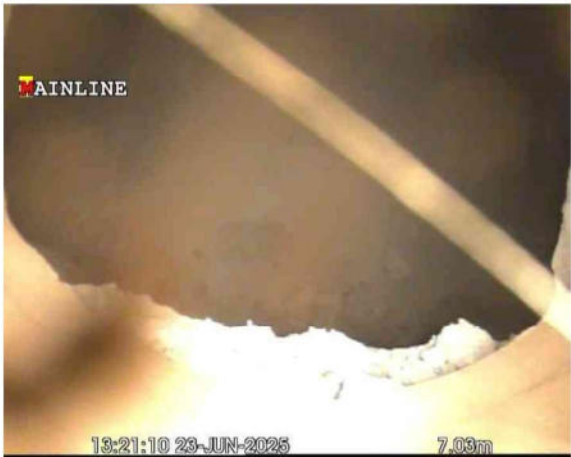
MH  
17X\_c161e9a8-ab15-4730-91e9-96ed611f1553\_20250701\_17  
1202\_241.jpg, 00:00:21, 7.03 m  
Finish node, major connection without manhole, reference: L47

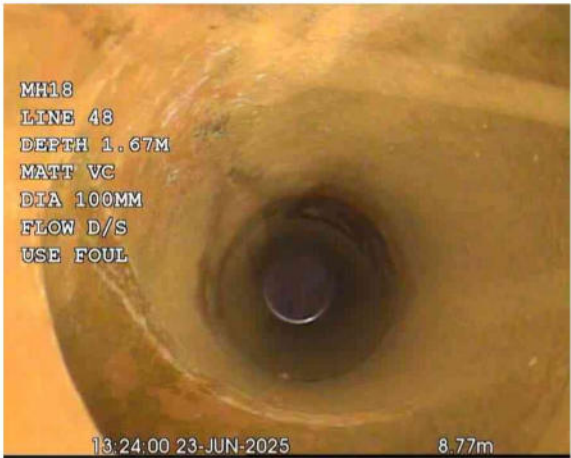
MH  
18X\_90cf7bcf-f849-4bdd-b5a4-65d855e184d4\_20250701\_171  
212\_939.jpg, 00:00:26, 8.77 m  
Junction at 6 o'clock, 100mm dia

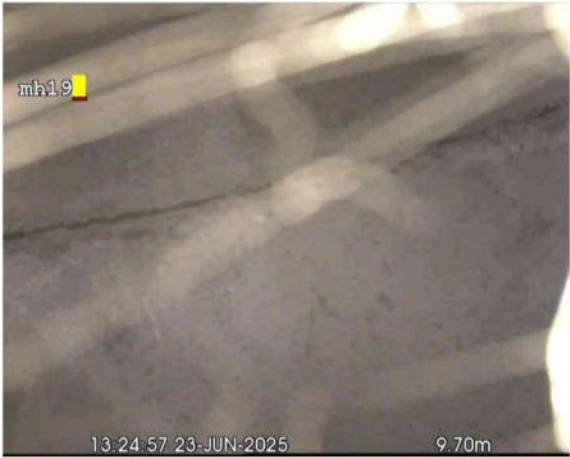
MH  
18X\_202dd446-6da3-4391-ad8d-15a0a9b2aed1\_20250701\_1  
71213\_817.jpg, 00:00:39, 9.70 m  
Finish node, manhole, reference: FMH78

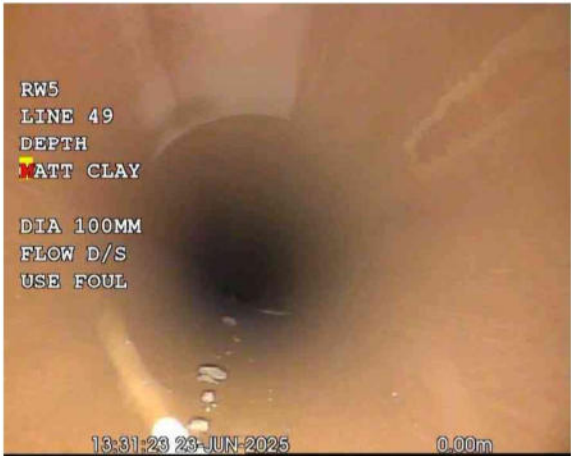
RW  
5X\_67376e35-7df7-4393-8606-b9a703663b0b\_20250701\_163005\_166.jpg, 00:00:00, 0.00 m  
Start node, manhole, reference: PPCP3

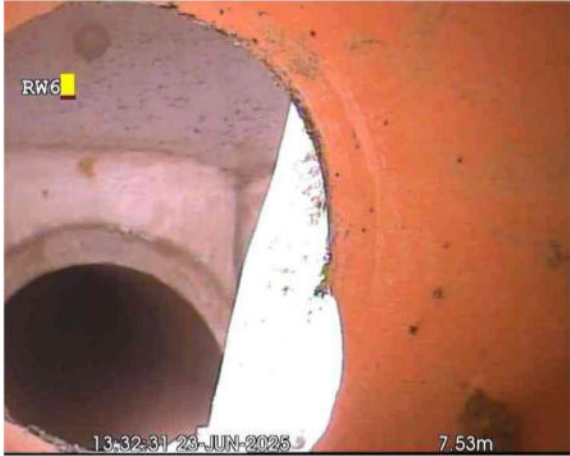
RW  
5X\_d1ce2970-2dca-4650-b1c8-1f0f291bfa46\_20250701\_171236\_366.jpg, 00:00:30, 7.53 m  
Finish node, manhole, reference: SMH19

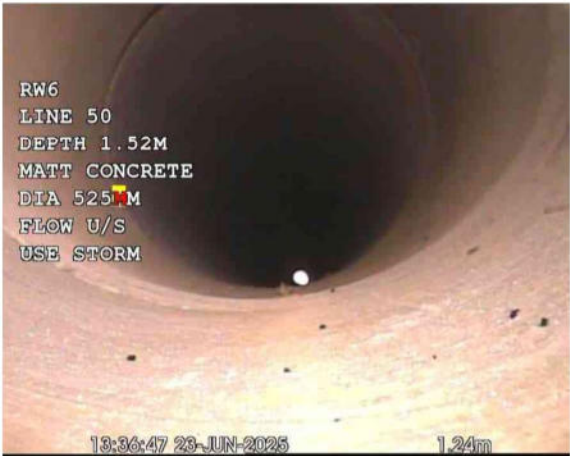
RW  
6X\_ee1bd8ae-80e0-481e-a8f9-742d6a44516c\_20250701\_171  
254\_847.jpg, 00:00:00, 0.00 m  
Start node, manhole, reference: SMH19

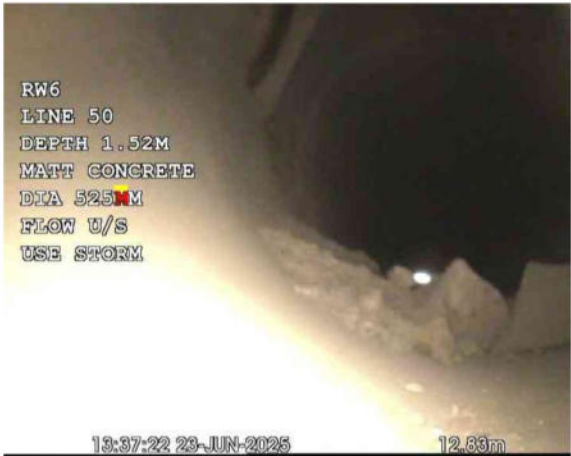
RW  
6X\_a3597531-0668-4c4c-8051-6e759ca75387\_20250701\_17  
1256\_231.jpg, 00:00:35, 12.83 m  
Connection other than junction at 9 o'clock, 150mm dia

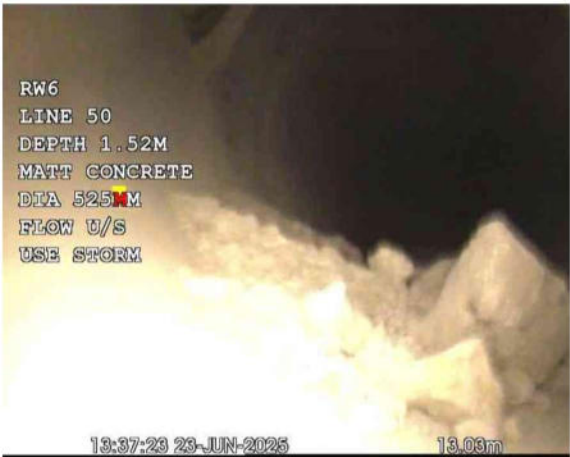
RW  
6X\_41c2864b-3924-4bc4-96b7-07289dc46039\_20250701\_17  
1257\_433.jpg, 00:00:35, 13.03 m  
Settled deposits, coarse, 10% cross-sectional area loss

| <b>Recommendations:</b> HPWJ LINE | | | | | |

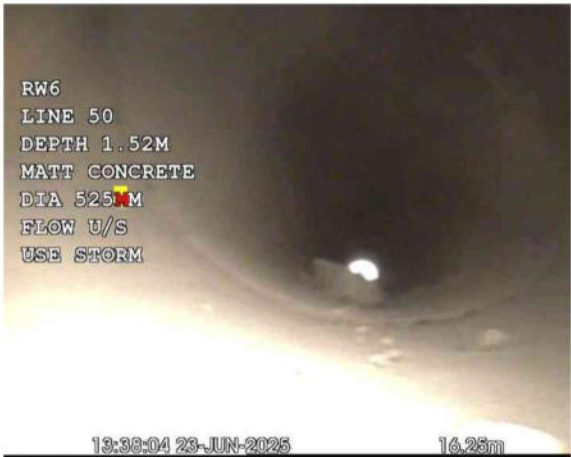
RW  
6X\_3b52f4c5-18b4-459b-8301-7d3856c56ca3\_20250701\_171  
259\_239.jpg, 00:01:17, 16.25 m  
Connection other than junction at 2 o'clock, 150mm dia

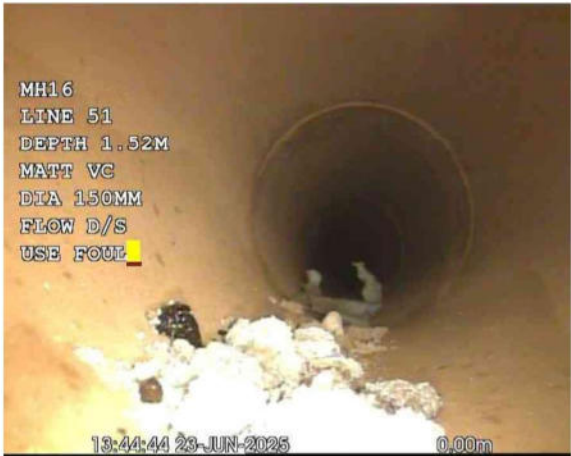
MH  
16X\_ffa5caad-b699-48b2-b22e-d61fc1640811\_20250701\_163  
439\_190.jpg, 00:00:00, 0.00 m  
Start node, manhole, reference: MH 16

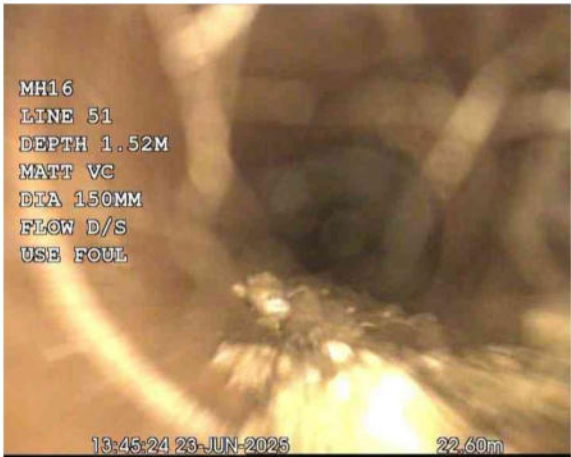
MH  
16X\_49207387-fce9-4f86-a358-b32d11aac392\_20250701\_17  
1322\_631.jpg, 00:00:44, 22.60 m  
Junction at 2 o'clock, 150mm dia

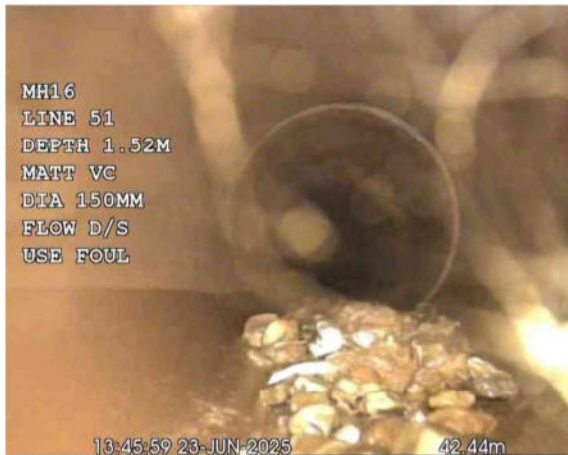
16X\_f04515b5-4de7-4fef-a6a0-a0ded038ff0f\_20250701\_1713  
26\_485.jpg, 00:01:18, 42.44 m  
Settled deposits, coarse, 10% cross-sectional area loss

| Recommendations: | HPWJ LINE | | | | |

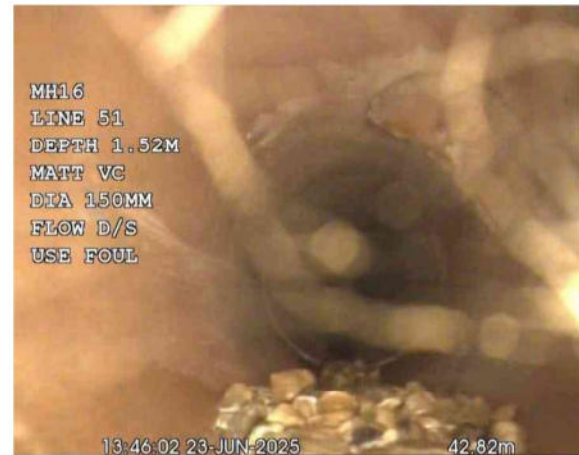
16X\_06d9a35f-f385-4247-8ba2-0711951d2b2b\_20250701\_17  
1328\_973.jpg, 00:01:22, 42.82 m  
Junction at 2 o'clock, 100mm dia

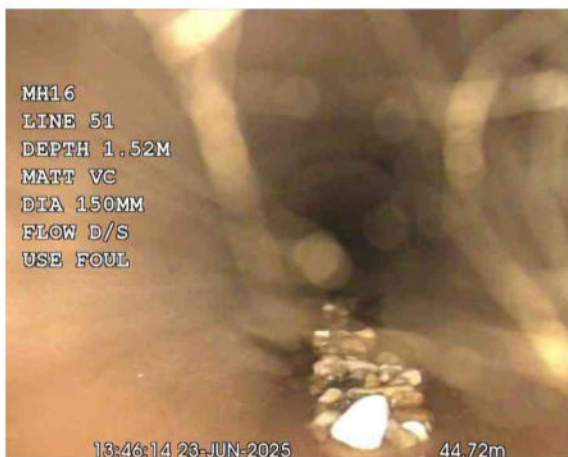
16X\_21b82981-a94f-4b09-a015-4cd51ef86c41\_20250701\_17  
1331\_125.jpg, 00:01:34, 44.72 m  
Settled deposits, coarse, 10% cross-sectional area loss

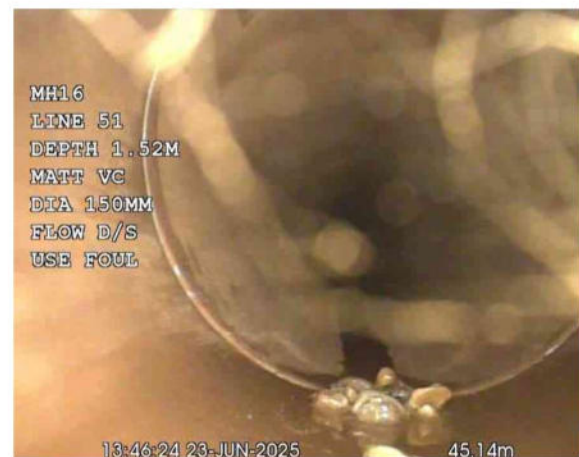
16X\_1ecabeb2-2ba5-4ac7-ae40-e368e776e9f1\_20250701\_17  
1333\_167.jpg, 00:01:43, 45.14 m  
Survey abandoned

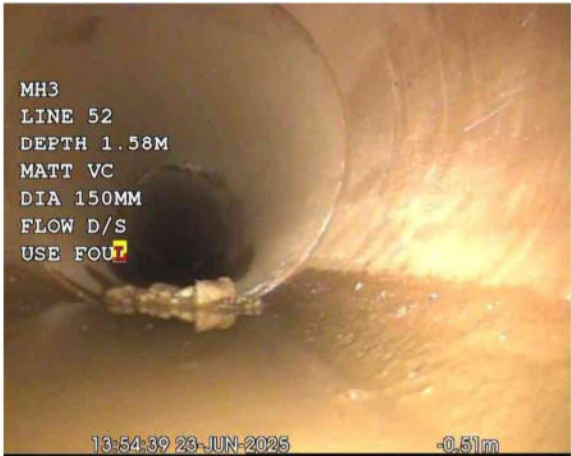
MH  
3X\_cd882e98-e9b0-49f6-88cb-8ad3bf3c588e\_20250701\_171  
346\_507.jpg, 00:00:00, 0.00 m  
Start node, manhole, reference: FMH52

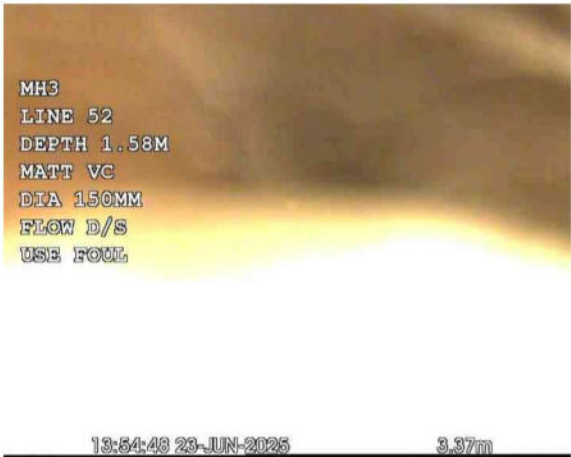
MH  
3X\_89e96bbc-6644-4496-b404-0162371237fa\_20250701\_171  
350\_903.jpg, 00:00:10, 3.37 m  
Water level, 20% of the vertical dimension

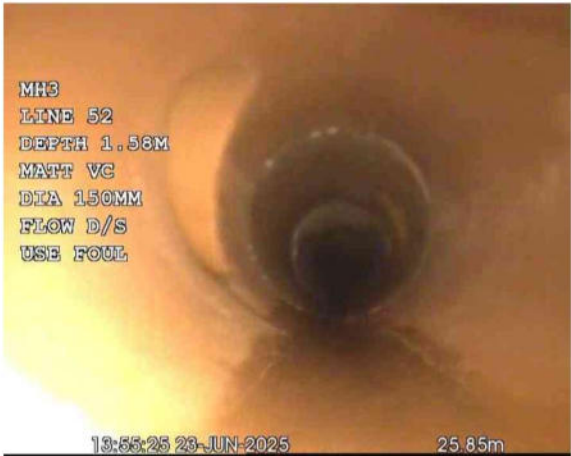
MH  
3X\_48989a1c-9e95-4c8e-8925-695b3b9f80b9\_20250701\_171354\_153.jpg, 00:00:47, 25.85 m  
Junction at 9 o'clock, 100mm dia

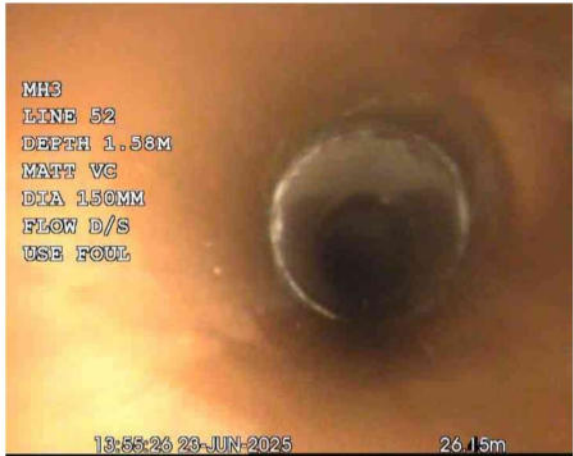
MH  
3X\_f1f45171-fd3f-45b6-89f7-ecc838128f44\_20250701\_171355\_430.jpg, 00:00:48, 26.15 m  
Junction at 3 o'clock, 100mm dia

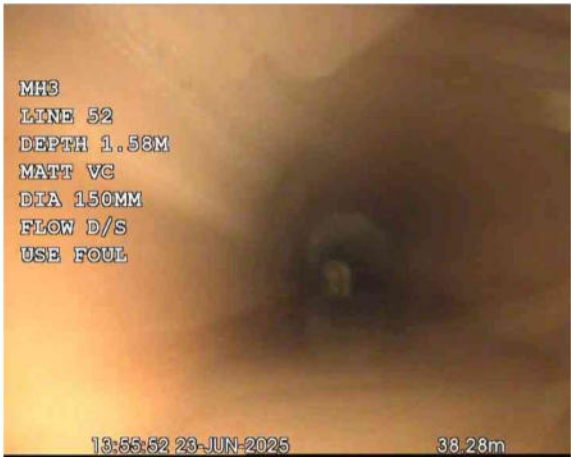
MH  
3X\_b00ace25-f294-404c-9763-72f83220d81c\_20250701\_171357\_040.jpg, 00:01:14, 38.28 m  
Water level, 20% of the vertical dimension

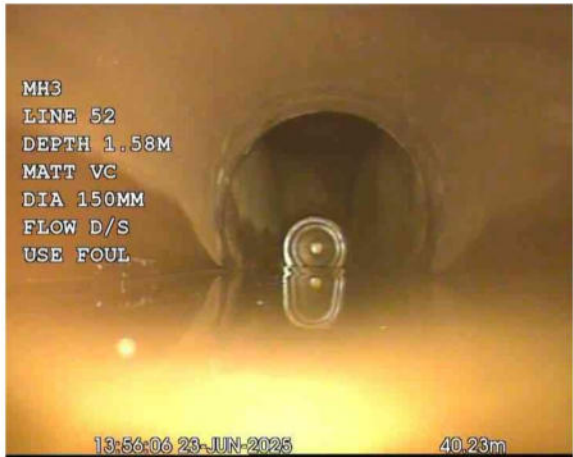
MH  
3X\_c2314810-71d2-42b8-a1a5-269413f999c8\_20250701\_171359\_152.jpg, 00:01:28, 40.23 m  
Finish node, manhole, reference: FMH59

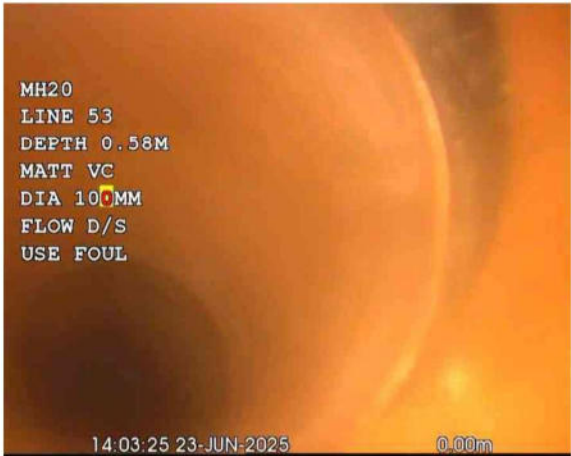
MH  
20X\_46c1ffb-e7ae8-44dc-b555-49cfe8c7dc1c\_20250701\_164  
240\_563.jpg, 00:00:00, 0.00 m  
Start node, manhole, reference: FIC16

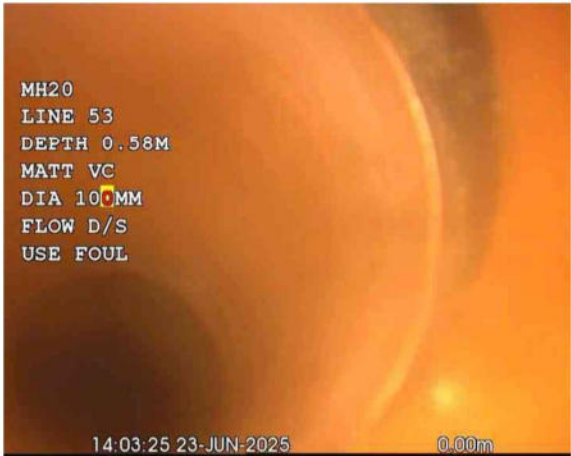
MH  
20X\_19a75c38-5faa-45f8-801b-16fc79676ae1\_20250701\_171  
404\_367.jpg, 00:00:01, 0.00 m  
Line deviates down

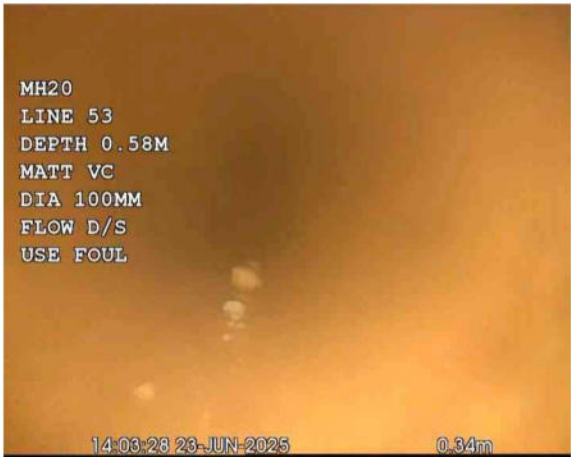
MH  
20X\_1a579186-68b0-4579-979a-5bfcdb216fde\_20250701\_17  
1405\_246.jpg, 00:00:04, 0.34 m  
Pipe material changes to vitrified clay at this point

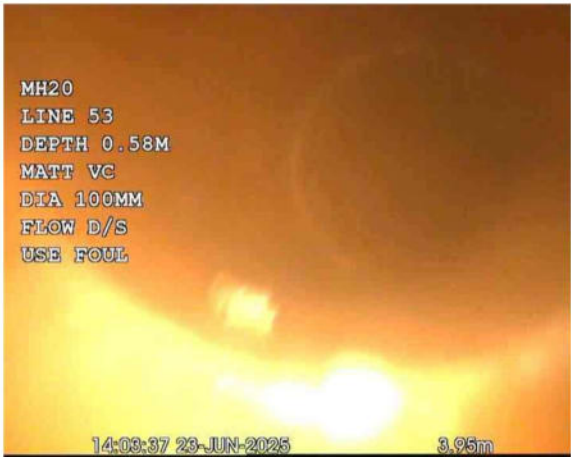
MH  
20X\_64f35a48-bdcb-4e49-97a6-66b6e013821a\_20250701\_17  
1406\_201.jpg, 00:00:13, 3.95 m  
Line deviates right

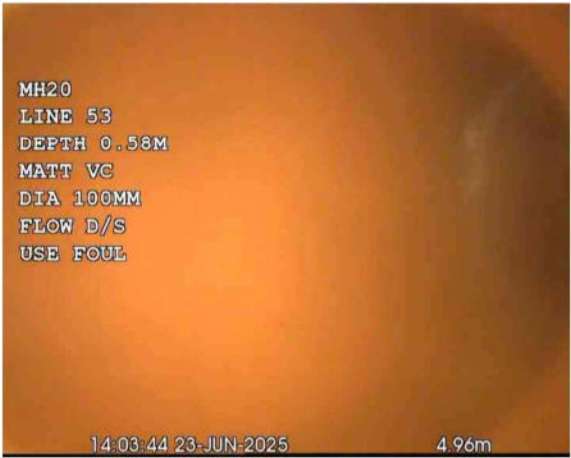
MH  
20X\_b0299369-bae6-4a13-863e-0d6773b594ee\_20250701\_1  
71407\_949.jpg, 00:00:20, 4.96 m  
Finish node, major connection without manhole, reference: L53
