# **Tree Works Report, June 2026**

## **Old Granary, Lyminster**

**Report Reference Number: 01083**  
Version: One

Site address:  
Old Granary  
Church Lane  
Lyminster  
BN17 7QL

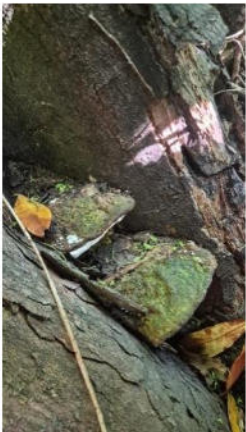
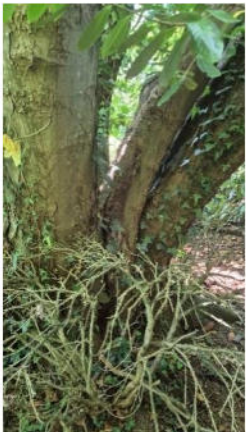
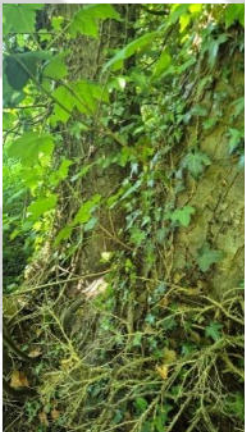
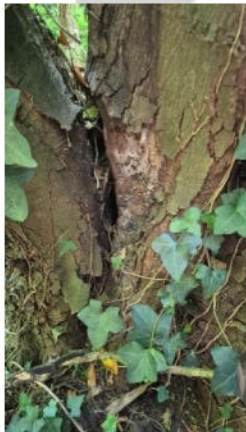
| <b>Tree Number:</b> | T17 | | |

| <b>Condition Comments:</b> | Major decay at base of trunk | | |
| <b>Overall Tree Condition:</b> | Poor | | |
