Our ref: PJW/31713

Report on Structural Inspection for West Sussex County Council and Strutt and Parker  
Guernsey Farm, Yapton Road

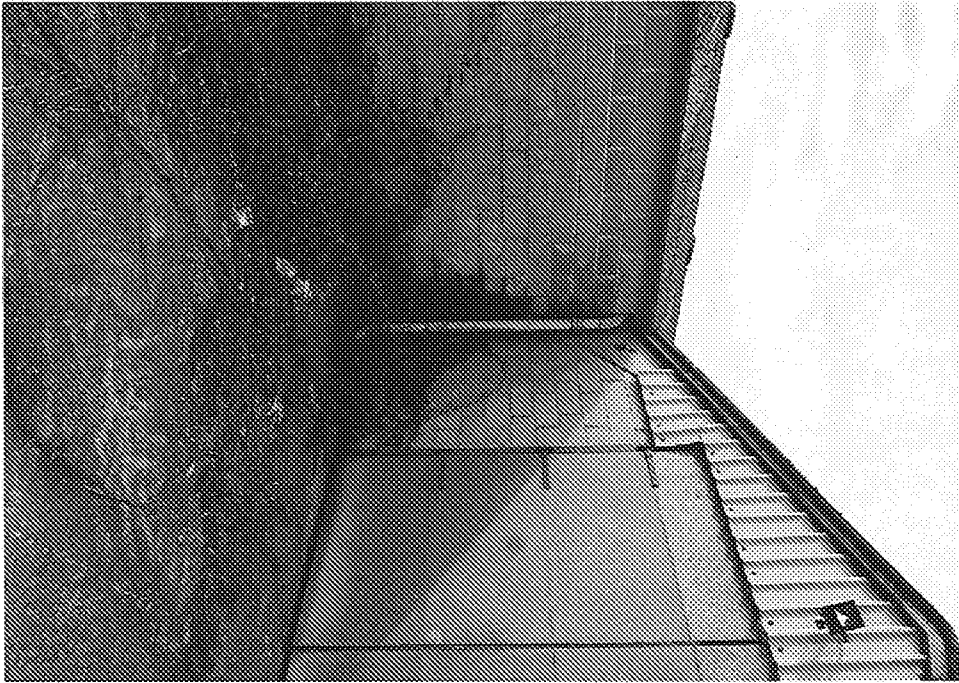
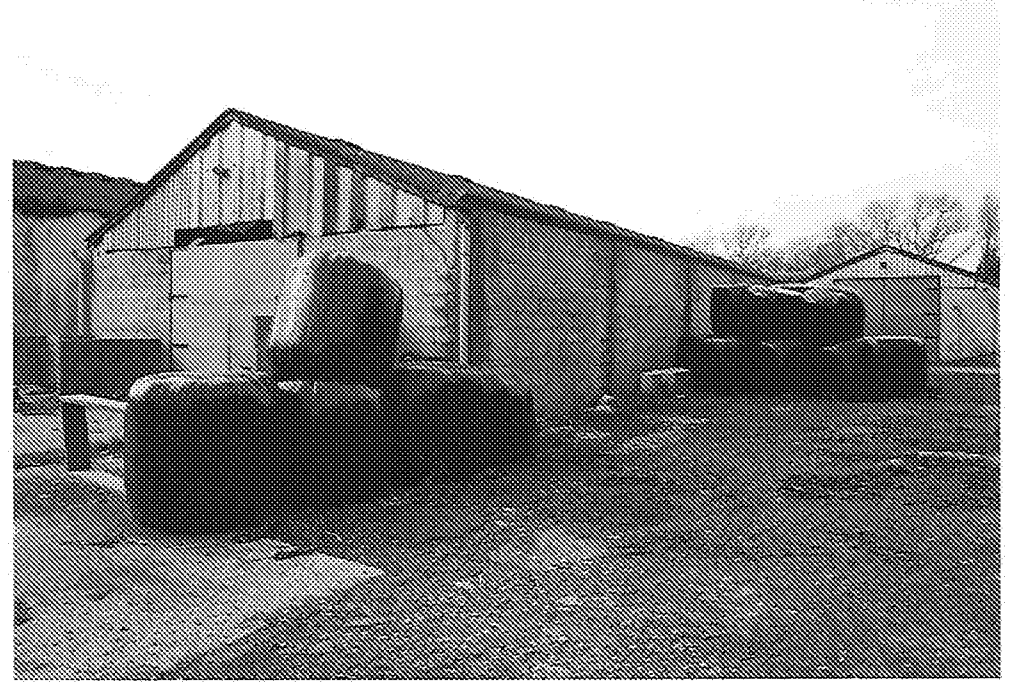
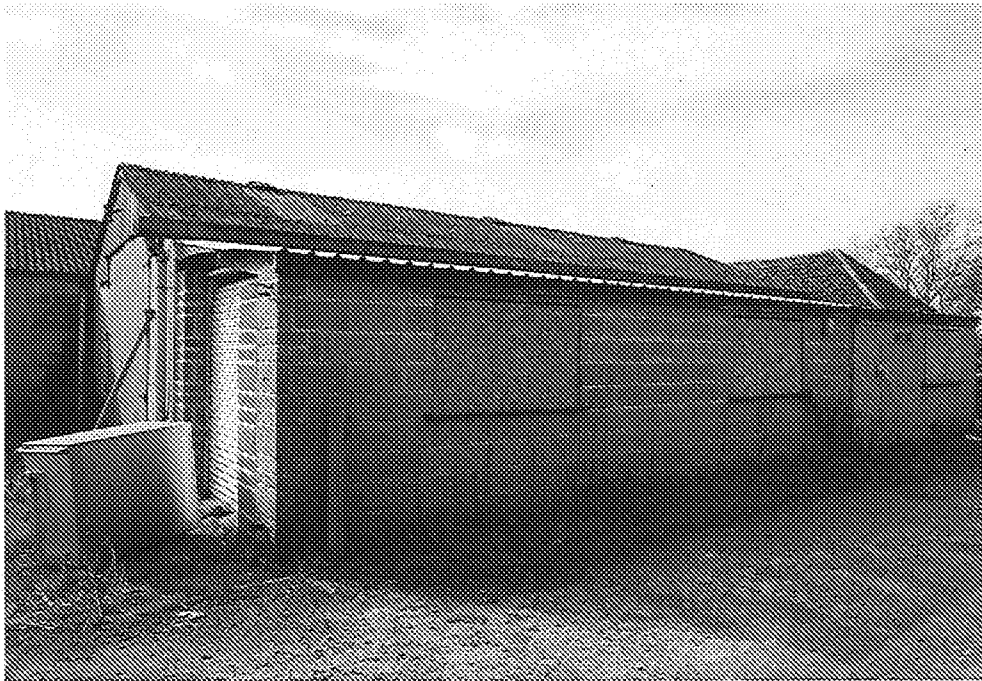
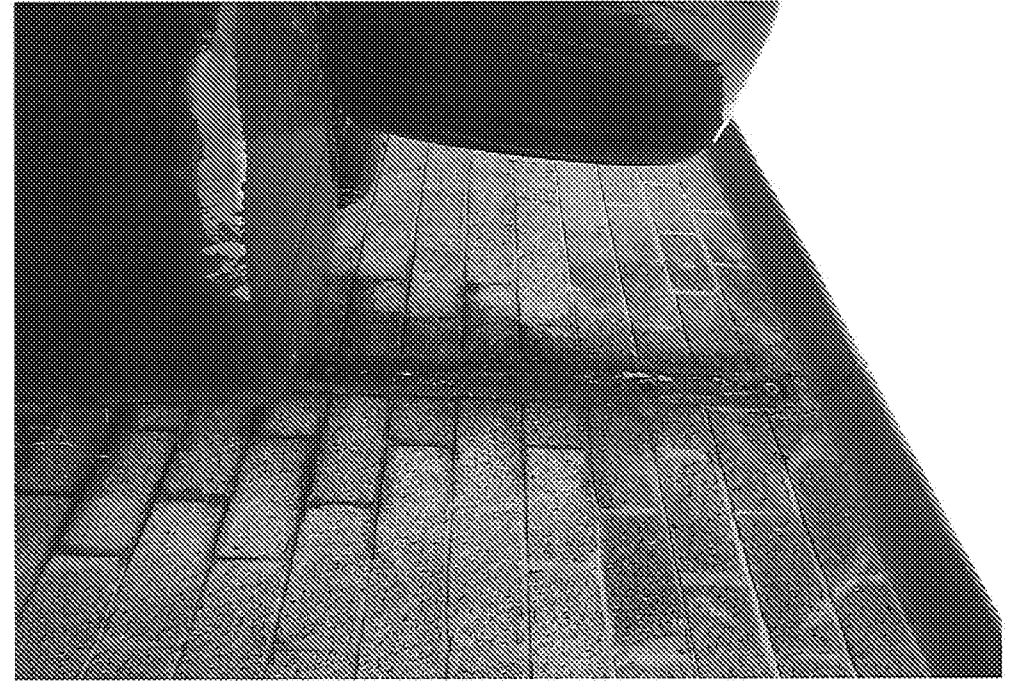
Sheets 1-3 Farm Shop showing general appearance instances of minor cracking and wear to brick quoins: also typical interior roof beams and buckling of timber floor overlay to former sales area south end.
