# ST JOHN'S COTTAGE

POLING STREET, POLING, ARUNDEL, WEST  
SUSSEX, BN18 9PS

## TIMBER CONDITION ASSESSMENT

AUGUST 2021

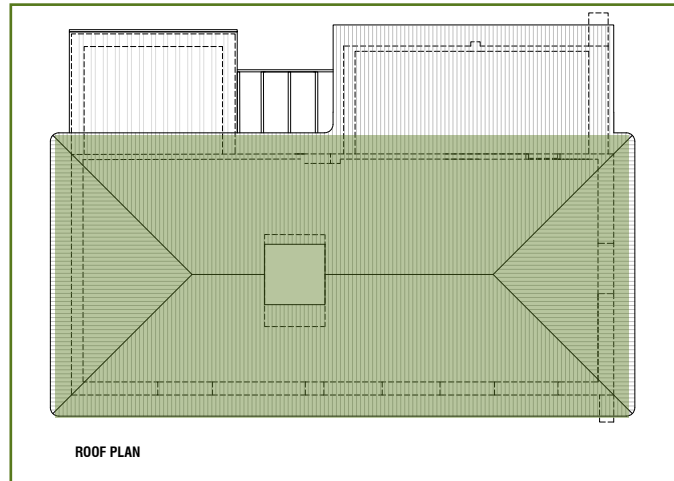
1. All elm rafters and roof timbers are severely decayed due to insect attack.
