# ST JOHN'S COTTAGE

POLING STREET, POLING, ARUNDEL, WEST  
SUSSEX, BN18 9PS

## TIMBER CONDITION ASSESSMENT

AUGUST 2021

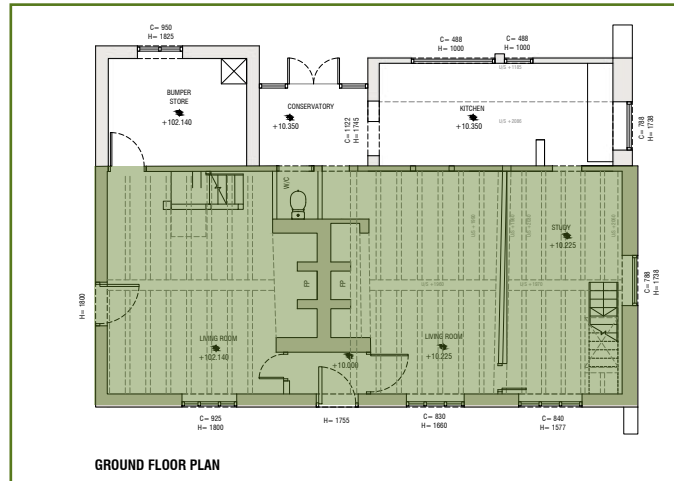
1. Ends of original joists failed. Splint repairs could be improved or joist ends repaired with oak/resin splice with grp reinforcing.
2. Further investigation around splint to spine beam required after the removal of board.

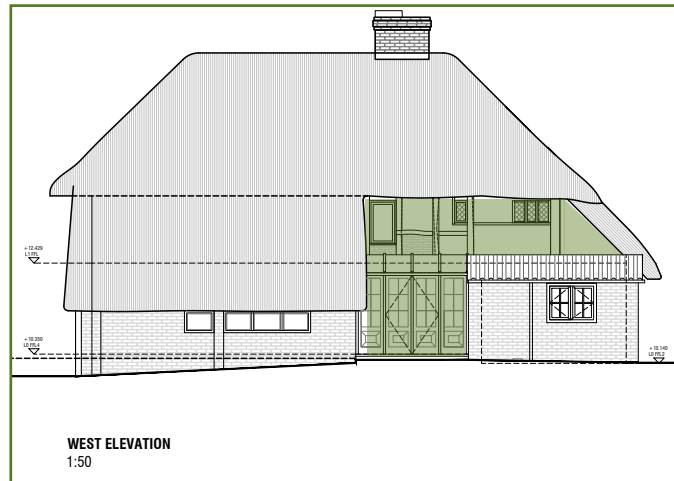
1. Face patch and iron strap required to area of decay around failed tenon.
2. Remove cement mortar around timbers and repoint using lime mortar.
