# ST JOHN'S COTTAGE

POLING STREET, POLING, ARUNDEL, WEST  
SUSSEX, BN18 9PS

## TIMBER CONDITION ASSESSMENT

AUGUST 2021

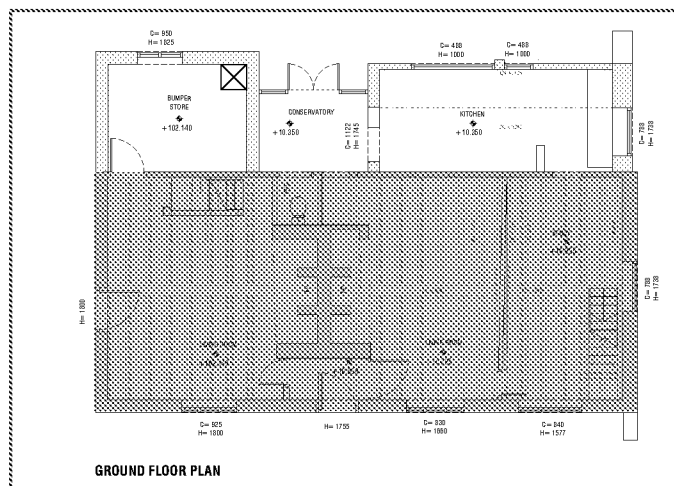
1. Ends of original joists failed. Splint repairs could be improved or joist ends repaired with oak/resin splice with grp reinforcing.
2. Further investigation around splint to spine beam required after the removal of board.
