**SITE NAME:** Summer Lane, Pagham  
**REPORT NAME:** Inspection of watercourse along northern boundary  
**DATE:** 02/12/2019  
**REF:** DSM/E4761/17564

## **Introduction**

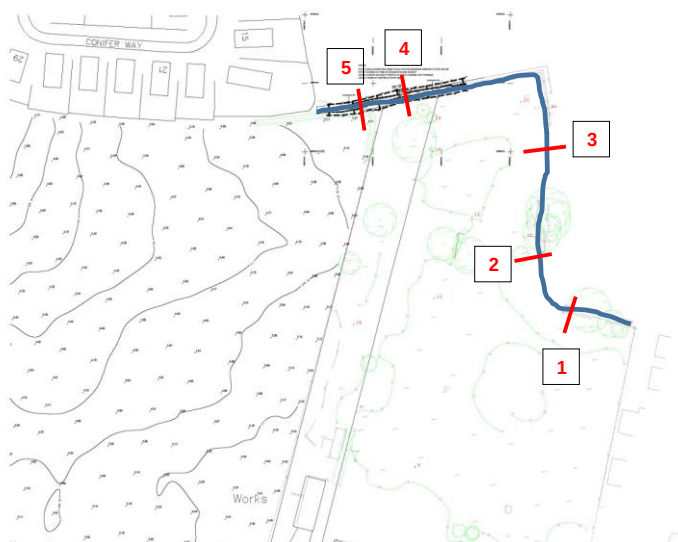
The inspection commenced from the north eastern part of the site and continued westwards terminating at the existing outfall of the ditch at the north western corner of the site. **Figure 1** below provides an indication referencing key sections of the inspection.
