**Project Name:** NEWLANDS BARN.PAGHAM ROAD.CHICHESTER.PO20 1LL  
**Project Description:** TO CARRY OUT CCTV SURVEY AT THE ABOVE ADDRESS  
**Project Number:** 02  
**Project Status:** Complete  
**Project Date:** 10/09/2025  
**Inspection Standard:** MSCC5 Sewers & Drainage GB (SRM5 Scoring)

| Section Item 1: RESEVOIR > MH 1 (RESEVOIRX) ..... | 1 |
| Section Item 2: MH 1 > DITCH (MH 1X) ..... | 3 |
| Section Item 3: MH 1 > DITCH (MH 1X) ..... | 6 |

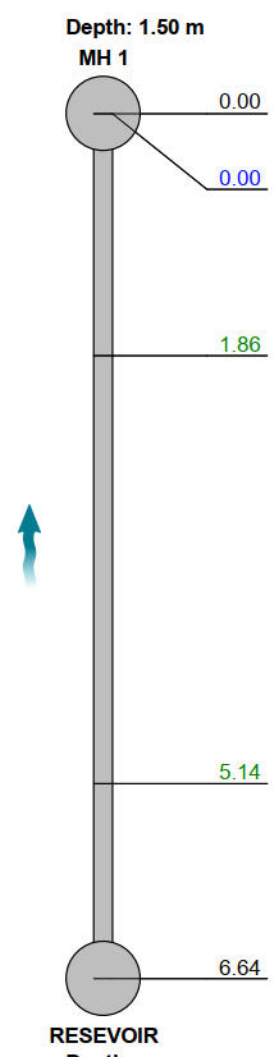
<table><tr><td>0.00</td><td>MH</td><td>Start node, manhole, reference: MH 1</td><td>00:00:00</td><td>RESEVOI<br/>RX_9fe33<br/>7a5-89c3-</td><td></td></tr><tr><td>0.00</td><td>WL</td><td>Water level, 5% of the vertical dimension</td><td>00:00:00</td><td></td><td></td></tr><tr><td>1.86</td><td>DER</td><td>Settled deposits, coarse, 5% cross-sectional area loss</td><td>00:00:28</td><td>RESEVOI<br/>RX_7b2bf<br/>5ca-8bb9-</td><td>3</td></tr><tr><td>5.14</td><td>LU</td><td>Line deviates up</td><td>00:00:40</td><td>RESEVOI<br/>RX_10982<br/>a43-b268-</td><td></td></tr><tr><td>6.64</td><td>OFF</td><td>Finish node, outfall, reference: RESEVOIR</td><td>00:00:54</td><td>RESEVOI<br/>RX_bdc79<br/>af6-eead-4</td><td></td></tr></table>

**Recommendations:** HPWJ LINE

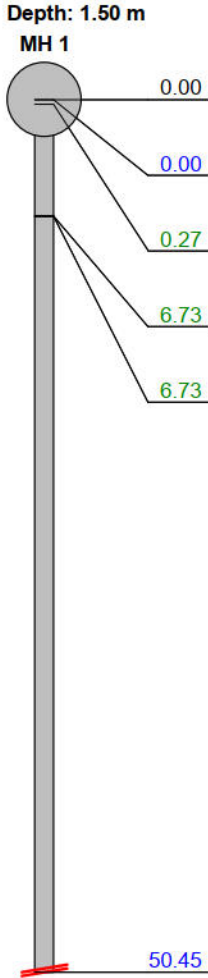
| Scale: | 1:437 | Position [m] | Code | Observation | MPEG | Photo | Grade |
|---|---|---|---|---|---|---|---|
| | | 0.00 | MH | Start node, manhole, reference: MH 1 | 00:00:00 | MH 1X_f757e2f3-1870-40 | |
| | | 0.00 | WL | Water level, 5% of the vertical dimension | 00:00:02 | | |

| <b>Recommendations:</b> HPWJ LINE | | | | | |
