| Rustington Convalescent Home<br>Sea Road, BN16 2LZ | | | |
| Carpenter's House<br>Masonry / Lintel repairs & replacements<br>elevations, sections and details. | | | |
| 5279 / 53 | | | P1 |

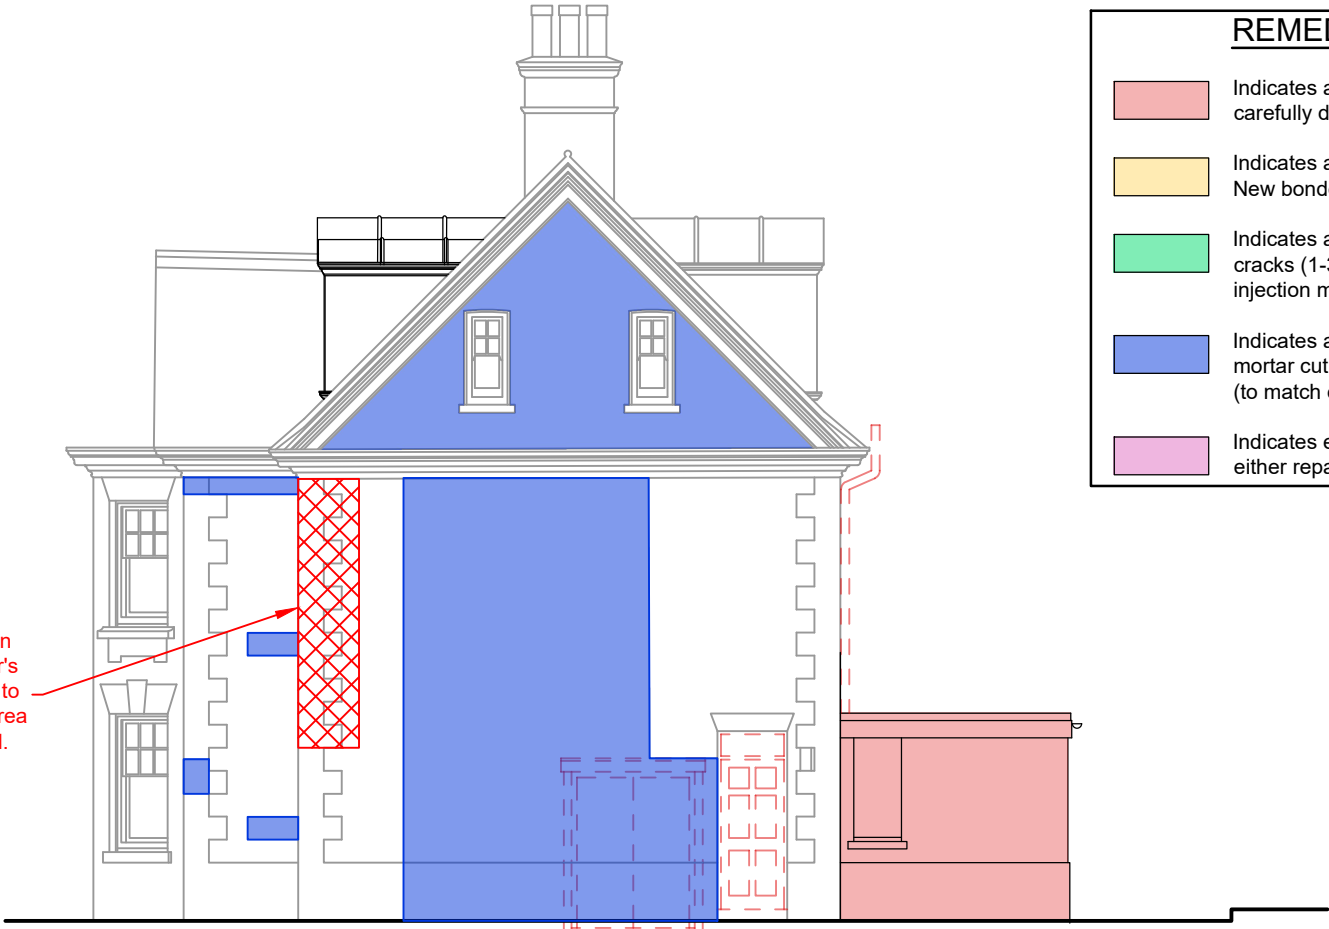
Condition of existing masonry to be assessed following provision of safe access.  
Assume mortar repairs throughout, unless proven otherwise.

Brick arch lintels at first floor to be uncovered to allow for further inspection

Crack stitching bars installed in accordance with manufacturer's recommendations and details to strengthen masonry around area of significant cracking in panel.

RAINWATER MANAGEMENT SYSTEM TO BE REPAIRED / REPLACED, IN ACCORDANCE WITH ARCHITECT'S DETAILS, TO ENSURE DISCHARGE OF WATER IS REMOVED FROM BRICKWORK.
