| Rustington Convalescent Home<br>Sea Road, BN16 2LZ | | | | |
| Cook House<br>Wall tie replacement / remedial works<br>elevations, sections and details. | | | | |
| DRAWING No. | | 5279 / 56 | | REVISION |

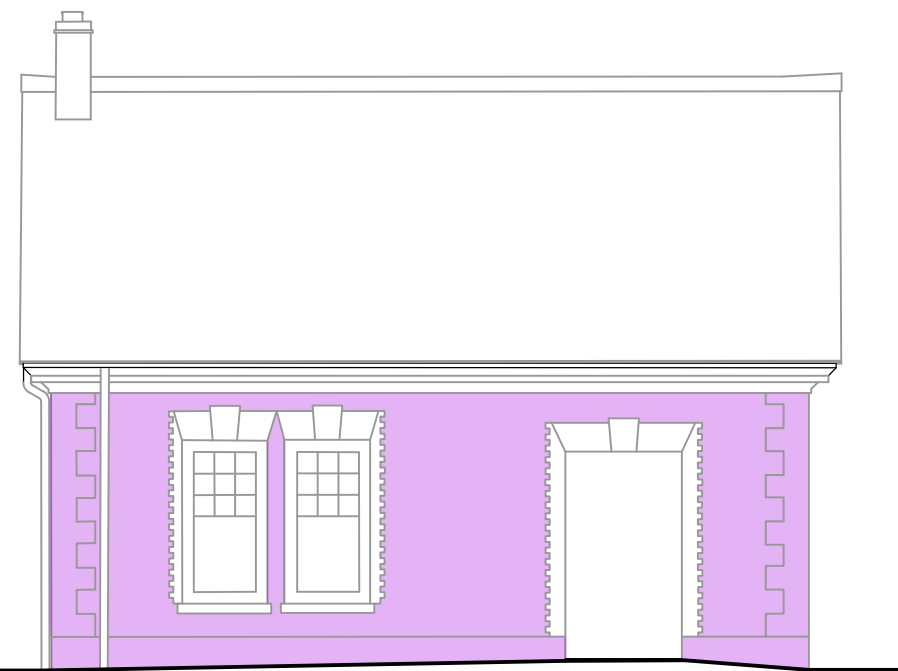
West Elevation

- Indicates area of wall requiring wall tie removal and replacement with new Helifix 'RetroFit' cavity wall ties (installed through external leaf). Refer to details.

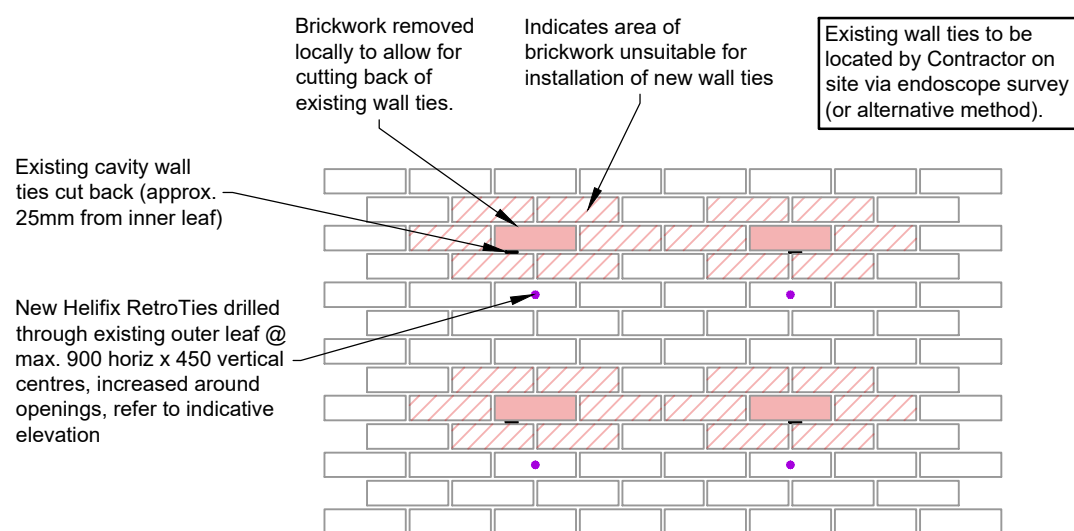
Typical indicative elevation showing local area of brick removal to allow for tie replacement works.

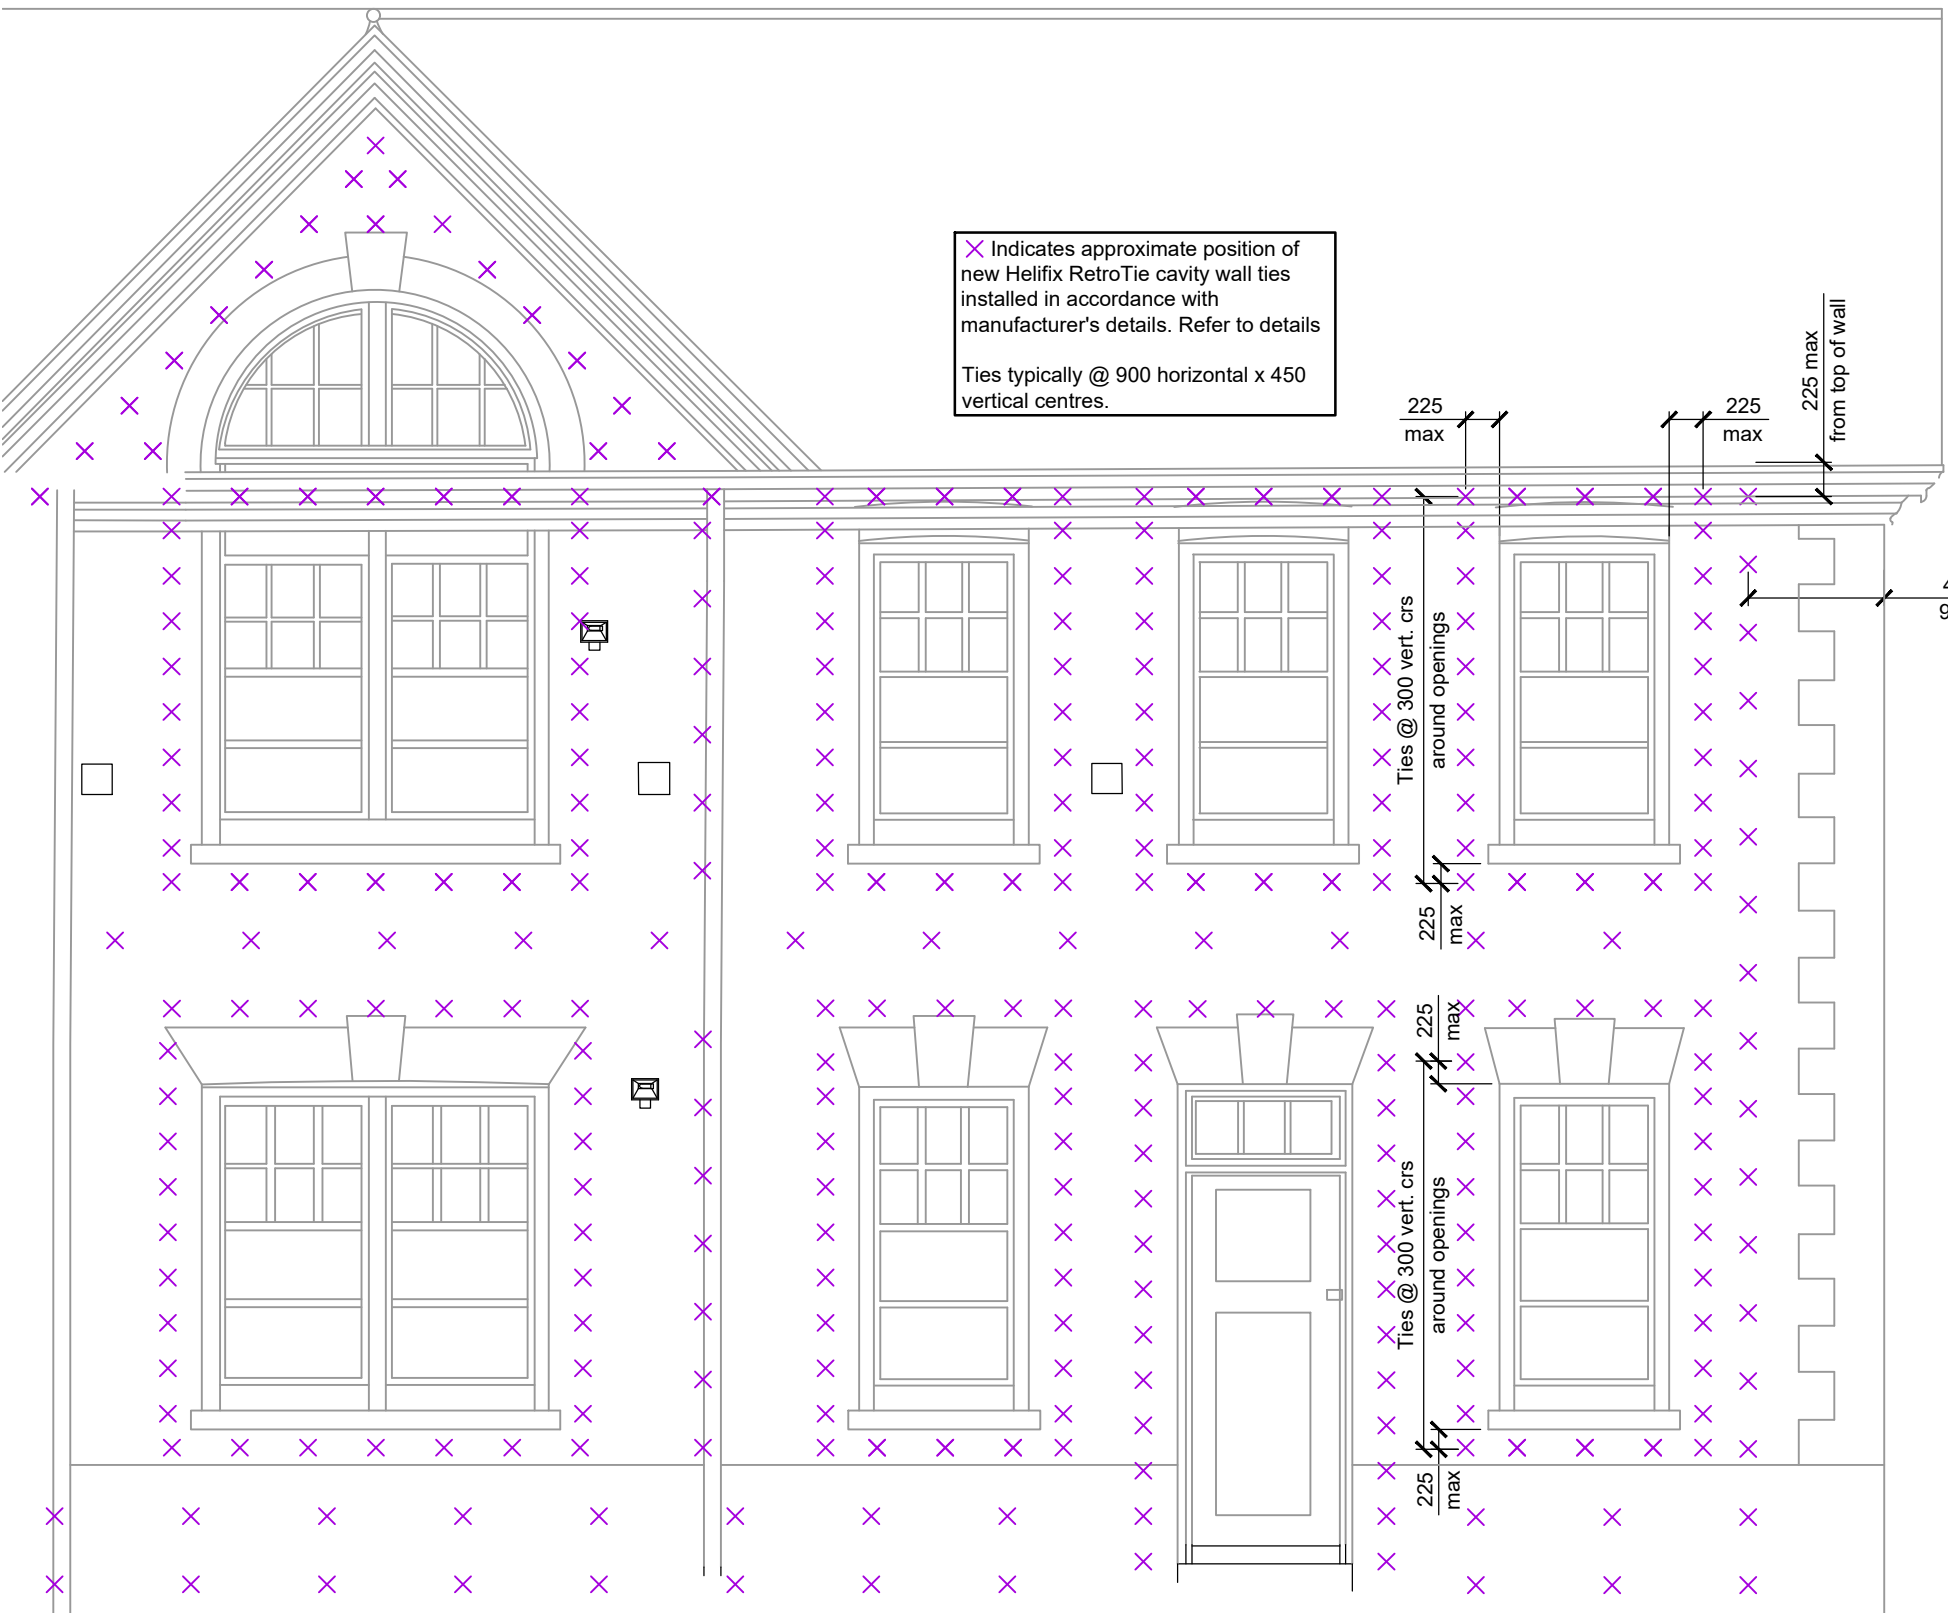
Indicative elevation showing a typical corner, window openings, and typical wall panel.

REFER TO INDICATIVE  
ELEVATION FOR MINIMUM /  
MAXIMUM REQUIREMENTS OF  
NEW WALL TIE PLACEMENT.
