**Report of Bat Survey  
(including Barn Owls)**

**conducted  
on stables and a barn  
at  
Wandleys Farm  
Walberton  
on  
16<sup>th</sup> January 2008**

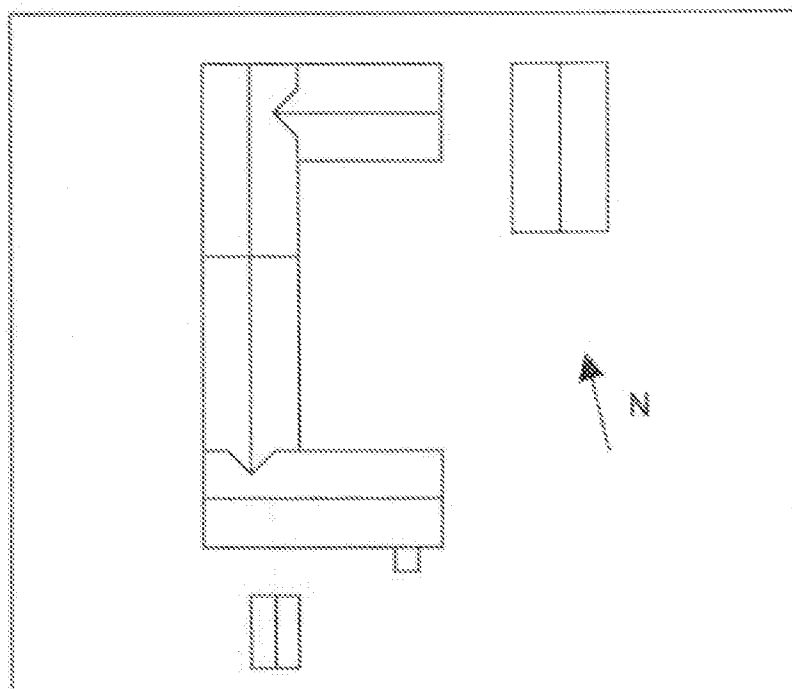
Diagram of stable block with barn on the north east corner and a small separate block of three stables to the south west of the main block. Diagram shows roof lines and is not to scale
