Green Lane Forestry LLP

## Application for tree works: work to tree(s) in a conservation area

**Location:** The Old Apple Store, The Street, Walberton, West Sussex, BN18 0PJ

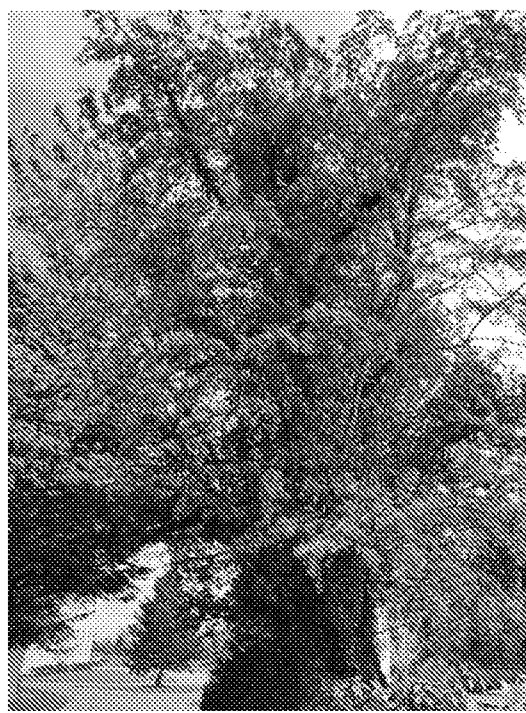
*Figure. 4 Hawthorn (T5)*

1.2.1 T5 is situated next to a building and driveway, falling limbs and deadwood are causing damage to the driveway.

1.2.2 Damage to the stem; several small wounds on the trunk are allowing water ingress and rot.

1.1 Removal of the entire tree.

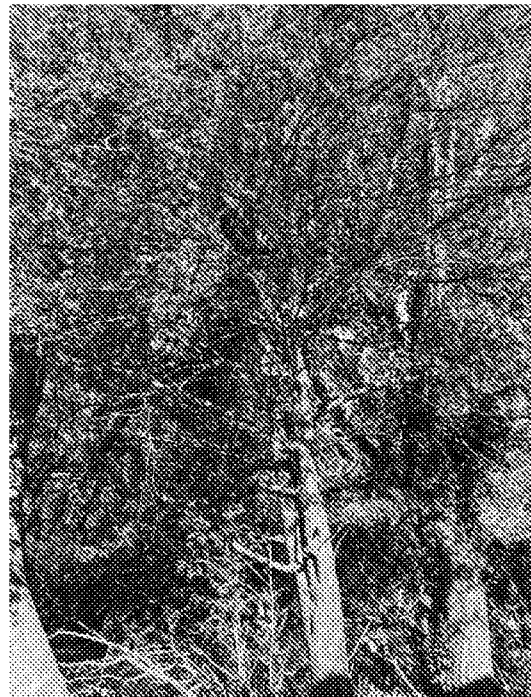
*Figure. 12 Yew (T2)*

**2.2.1** Light starved and unhealthy; this tree is situated underneath two other trees and has started to decay and die off due to lack of light.
