# Drainage Verification Report

Barnfield House, Arundel Road, Fontwell BN18 0SD

Planning Ref: WA/80/22/PL

Ref: **C2911**

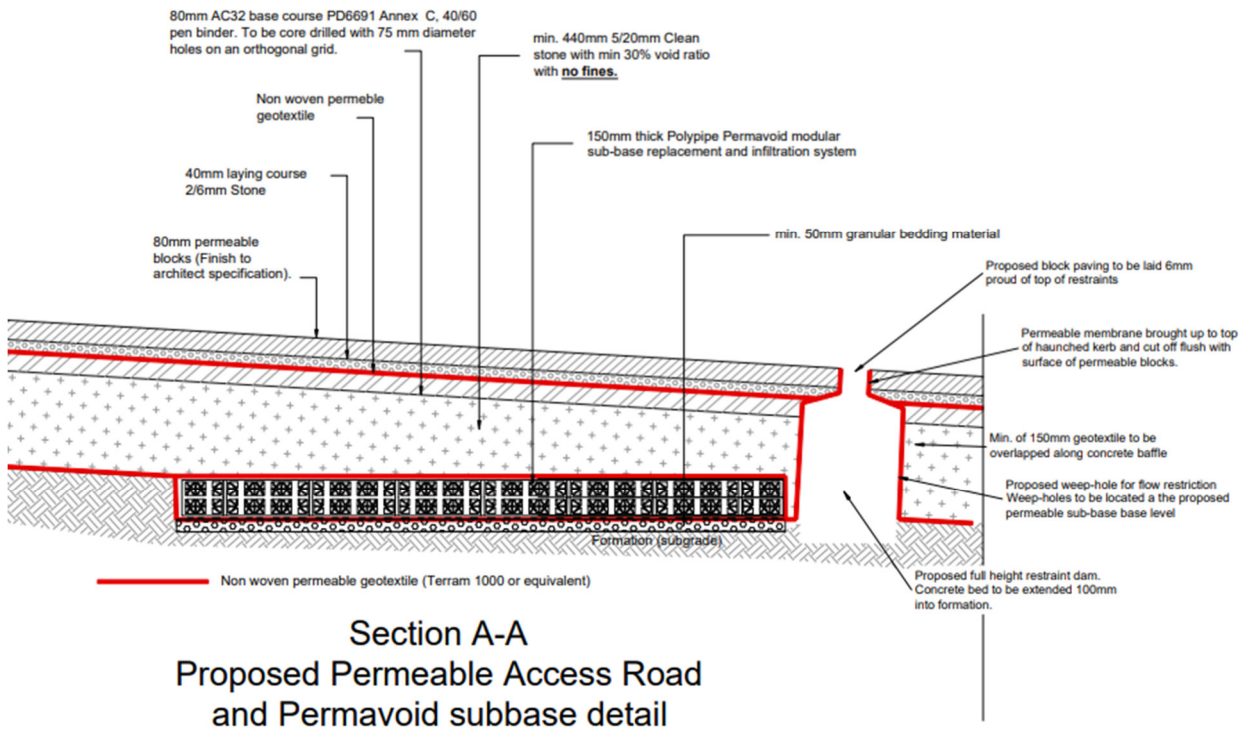
**Fig 5. Road Formation.**

All roads have been constructed in accordance with the Proposed Permeable Access Road and Permavoid subbase detail shown below and installed as shown in the photographs provided:

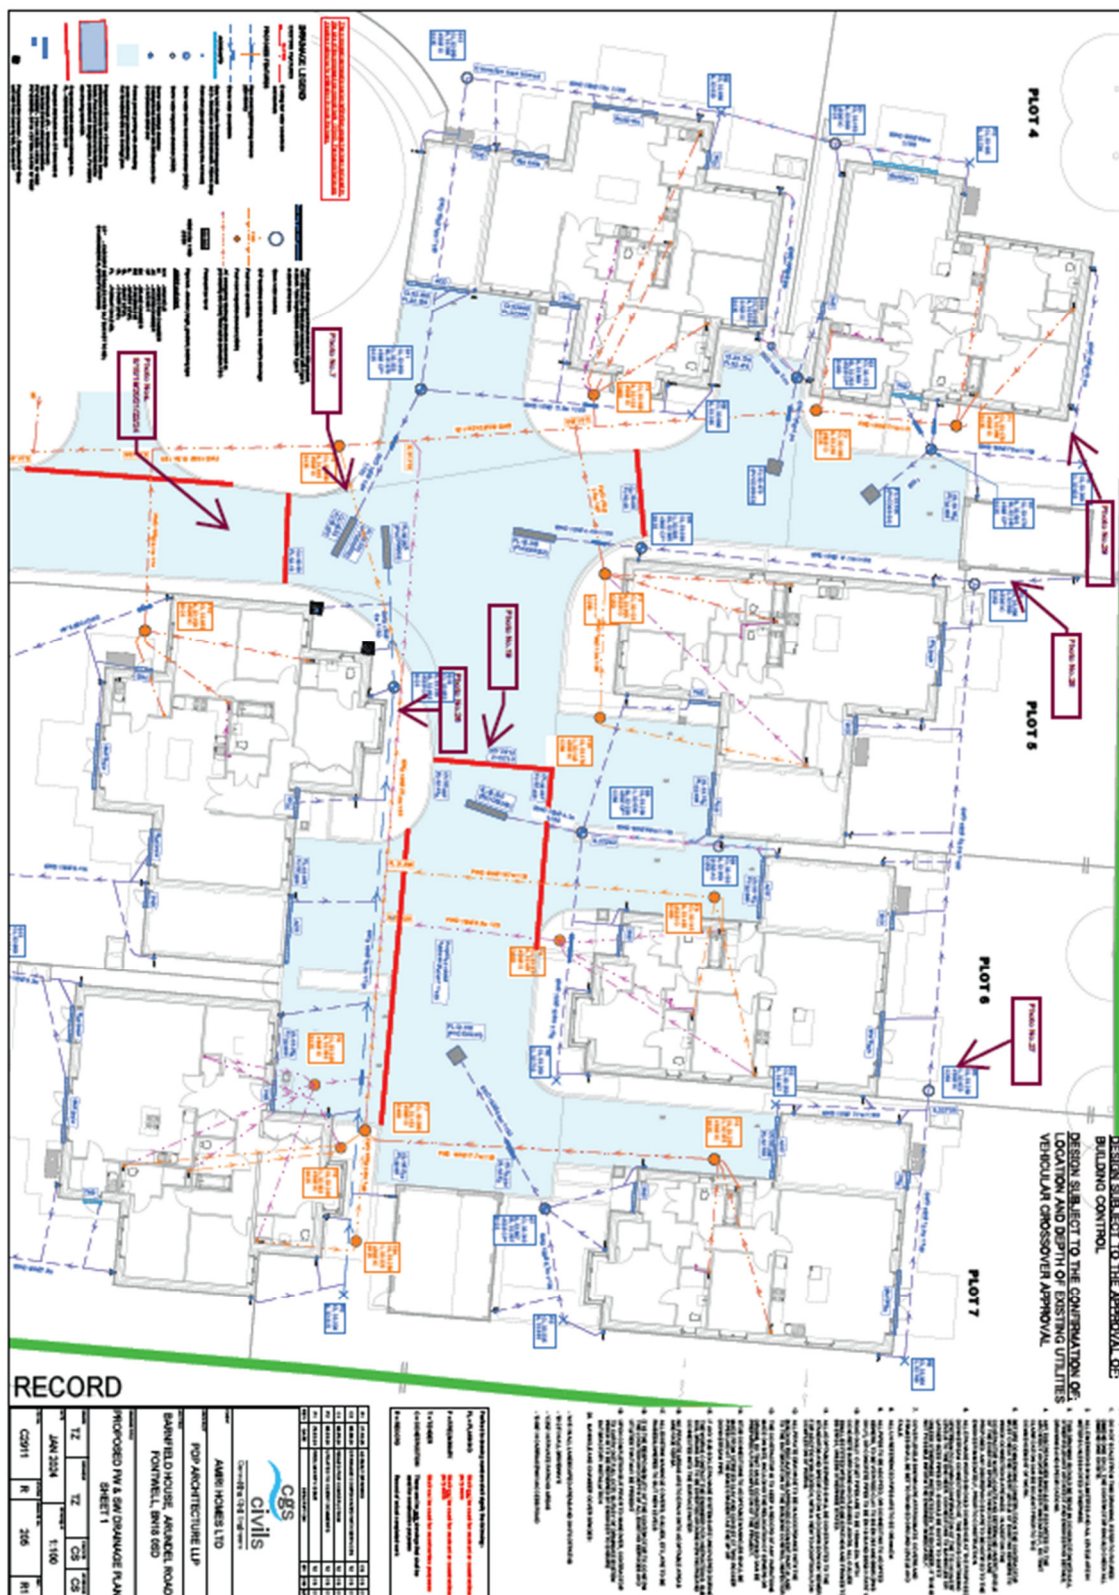
## Drainage Layout Sheet 1

- 5.1 There are a few discrepancies between the approved drainage design and the drainage network that was installed on site. A copy of the marked up plan from the CCTV Surveyors will be supplied within **Appendix B**.
1. Chambers S1, S2a and S9 have not been installed on site with the associated drainage making the same connection downstream apart from S1 which has been diverted into the rodding eye which then discharges into S12. It should be noted that this has no impact on the effectiveness of the drainage network as the changes are minor.
