Project Name: Stakers Farm Barns, Yapton, BN10 0PU

QED Ref: 19-211

Date of Issue: 26 July 2019

Date of Site Visit: 27 June 2019

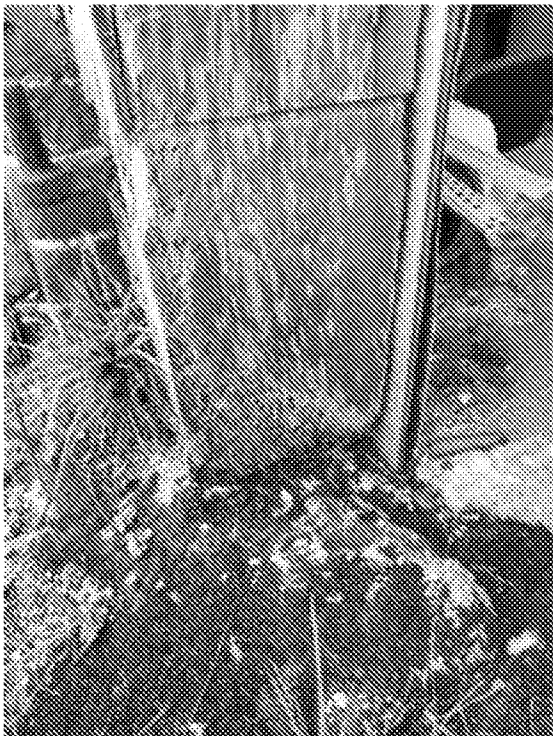
Building 4 – Rotten base of post to door opening

Front Wall – The front brickwork/flint walls can be retained and underpinned to provide a good firm foundation, the existing timber cladding would need to be demolished and rebuilt, as they are not in very good condition and it is assumed there are no or minimal foundations supporting these walls. The posts supporting the main timber trusses are to be underpinned to be able to provide a good firm foundation. The new wall would need to be built off a new foundation that would be constructed between the underpin sections for the posts. The new walls would then provide a good solid support for the roof with new Catnic or

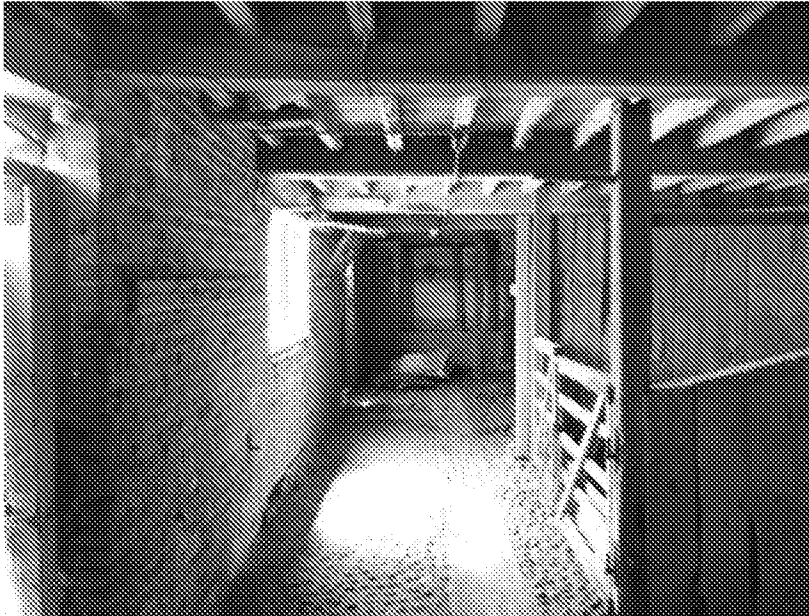
Building 2 – Timber beams and floor joists for first floor and timber divisions at ground floor level

First Floor – A design check would need to be undertaken on the existing timber beams and joists to ensure they are sufficient for proposed dead and live load requirements. If they are deemed to be insufficient, they can either be strengthened or replaced to suit. It is recommended that the timber bearers under the ends of each timber beam are replaced with concrete padstones.

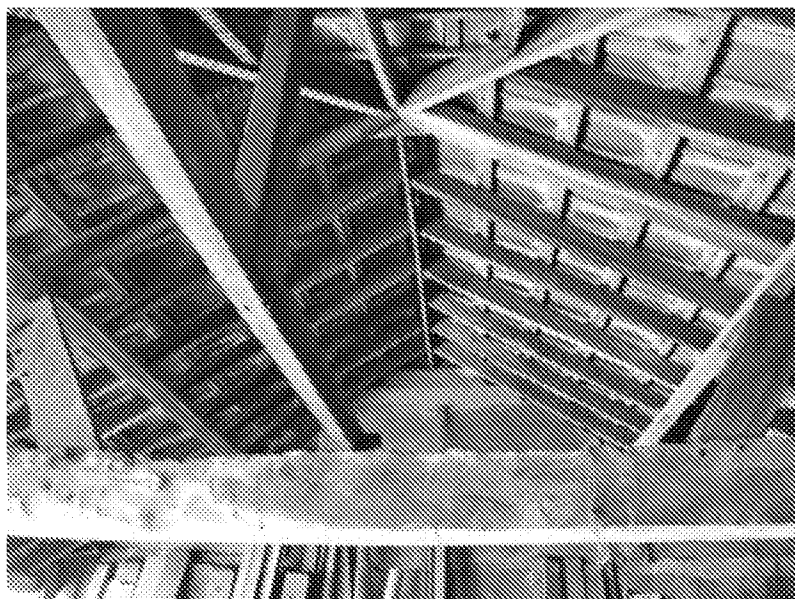
Building 5 – Roof trusses visible in room 16

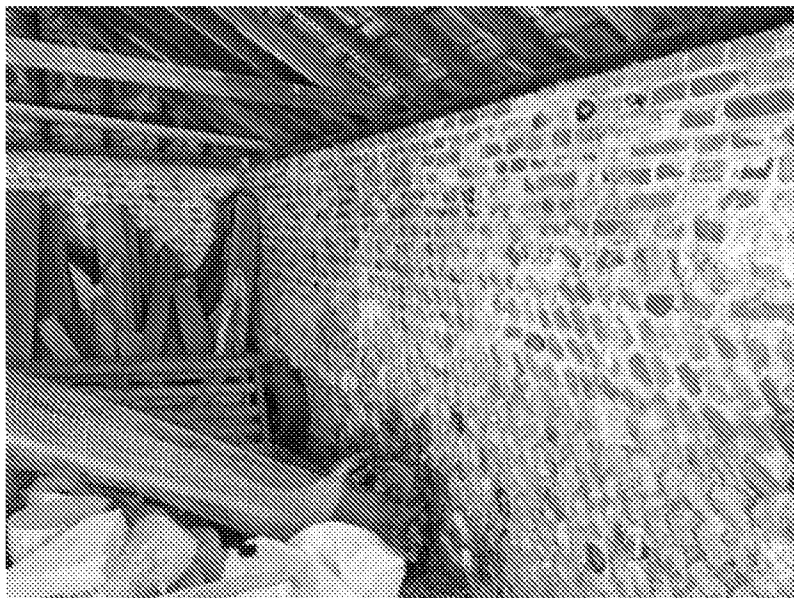
Building 5 – Room 16 exposed walls

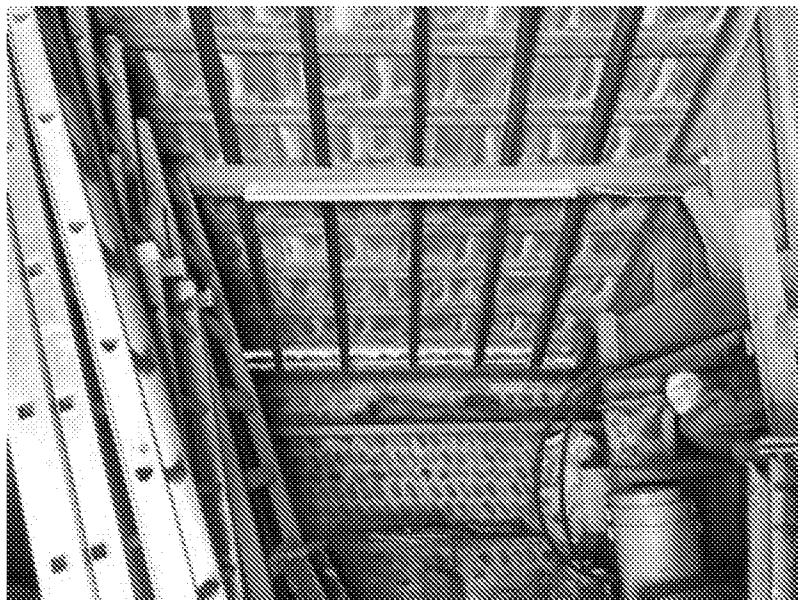
Building 5 – Room 17 showing roof and walls

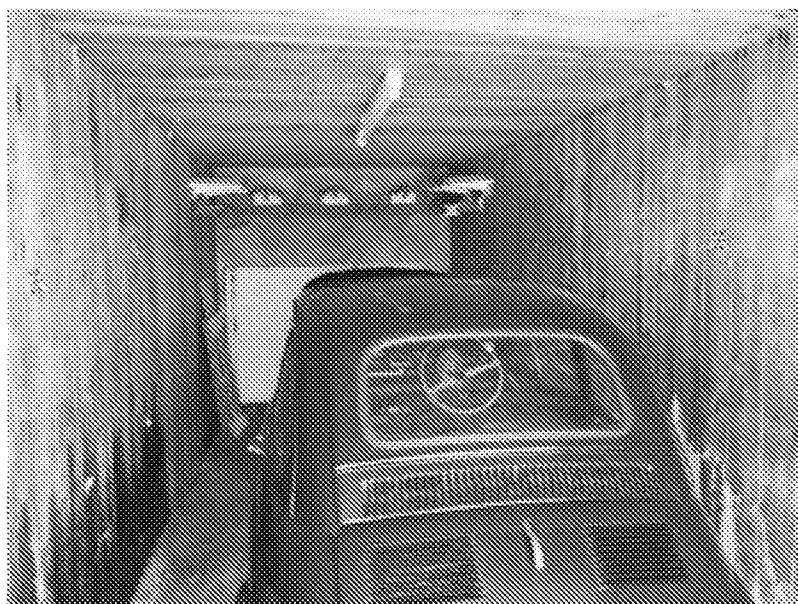
Building 5 – Timber clad room, structure not visible

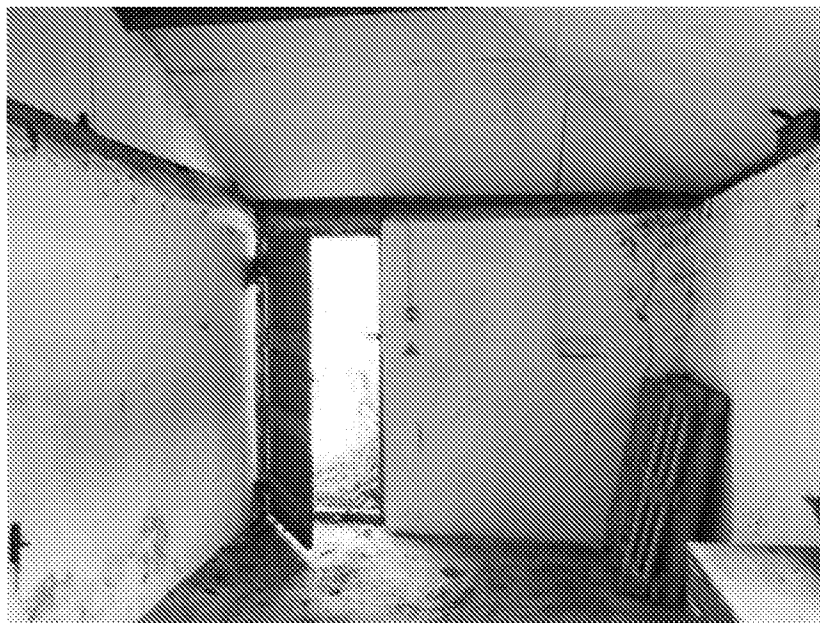
Building 5 – Wall not visible, elements of the timber roof visible only
