Project Name: Stakers Farm Barns, Yapton, BN10 0PU

QED Ref: 19-211

Date of Issue: 26 July 2019

Date of Site Visit: 27 June 2019

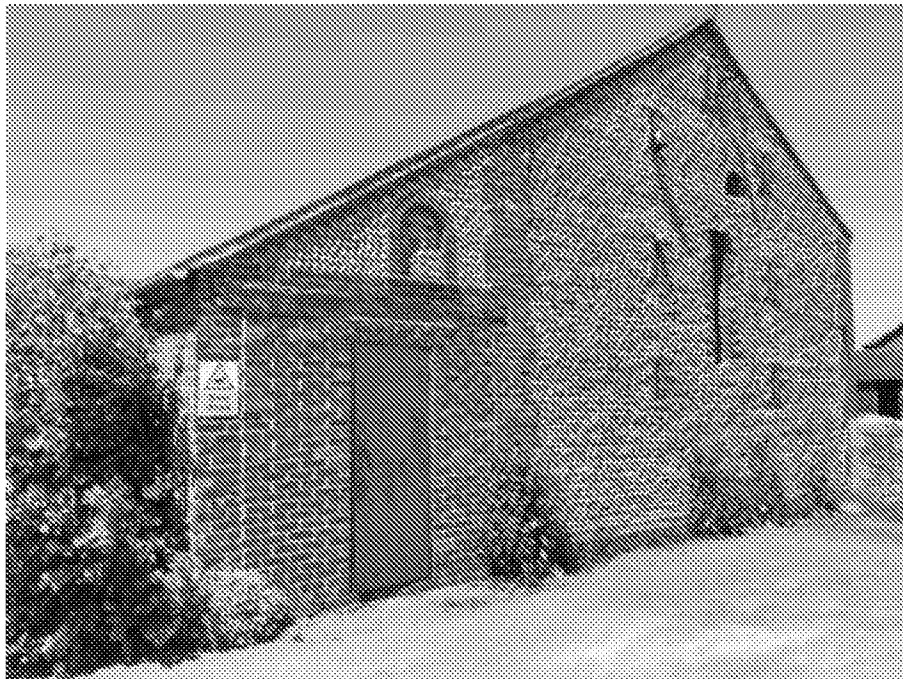
Side Elevation – The side elevation as you enter the courtyard has vertical cracking between the flint and brickwork at the corner of the building.

Building 4 – Side elevation as you enter the courtyard

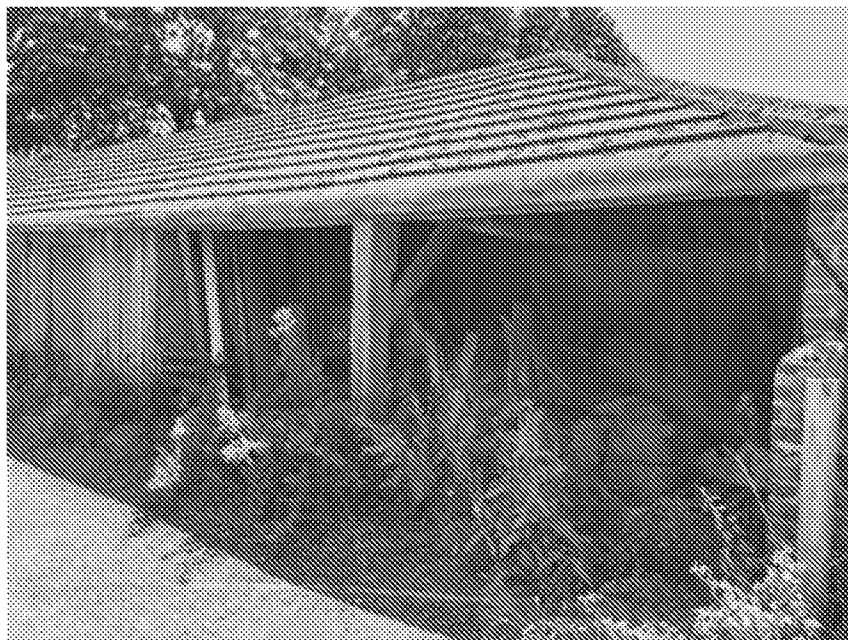
Building 5 – Front elevation showing the open bay end of the elevation

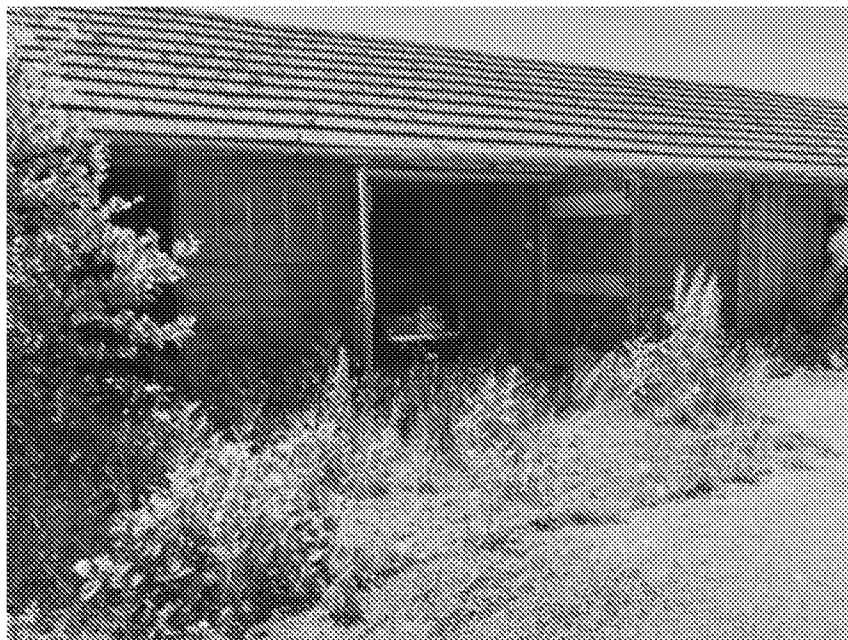
Building 5 – Front elevation showing timber clad sections of the elevation

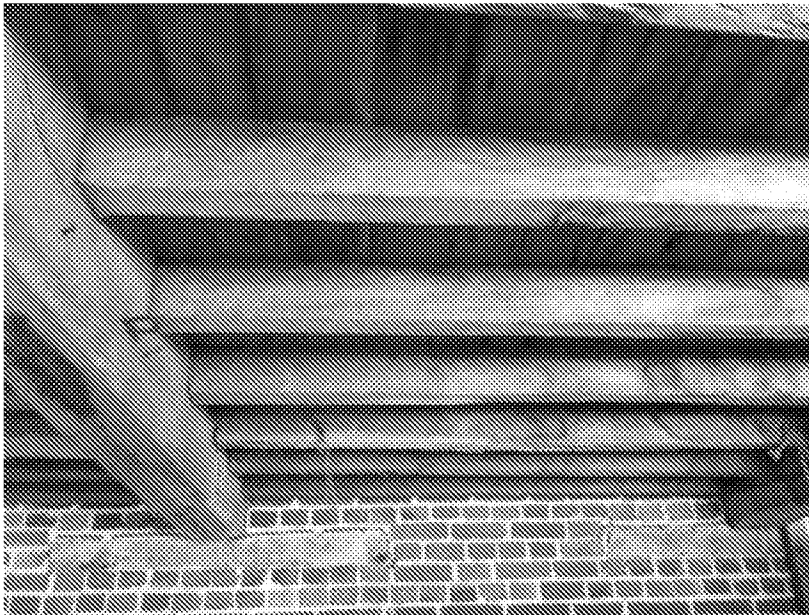
Building 2 - Timber beams and floor joists for first floor and timber padstones in the wall

First Floor – A design check would need to be undertaken on the existing timber beams and joists to ensure they are sufficient for proposed dead and live load requirements. If they are deemed to be insufficient, they can either be strengthened or replaced to suit. It is recommended that the timber bearers under the ends of each timber beam are replaced with concrete padstones.

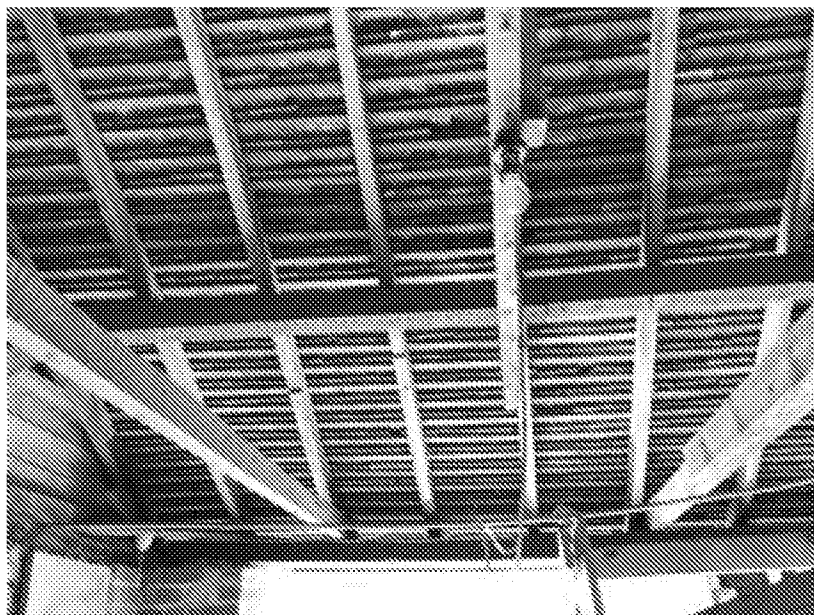
The roof for the building is formed from a series of timber trusses formed of rafters, ties, collars and timber purlins. There is evidence of roof spread at the rear wall. There is also varying degrees of cracking between the rear wall and internal room division walls, which substantiates the lateral movement at eaves level.

Building 3 – Timber roof trusses formed from rafters, ties, collars and purlins

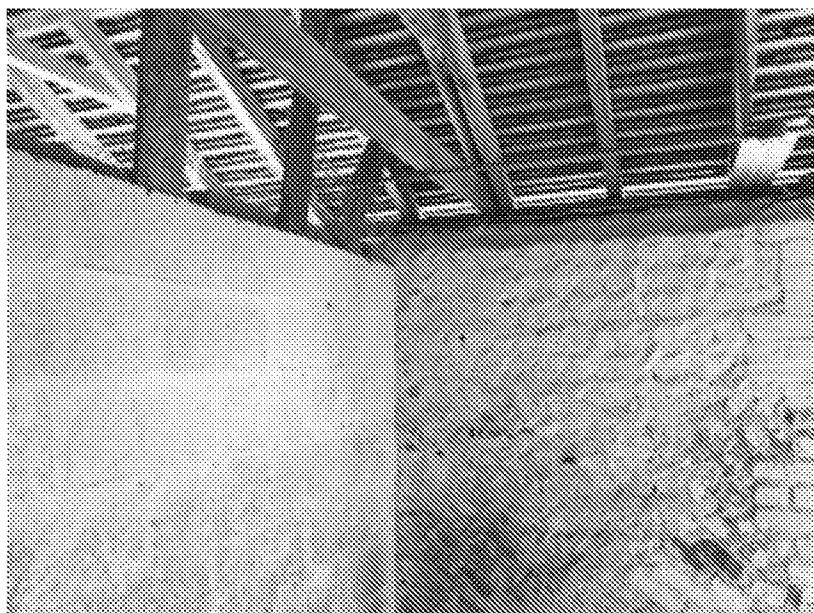
Building 3 – Timber roof trusses formed from rafters, ties, collars and purlins and room division wall

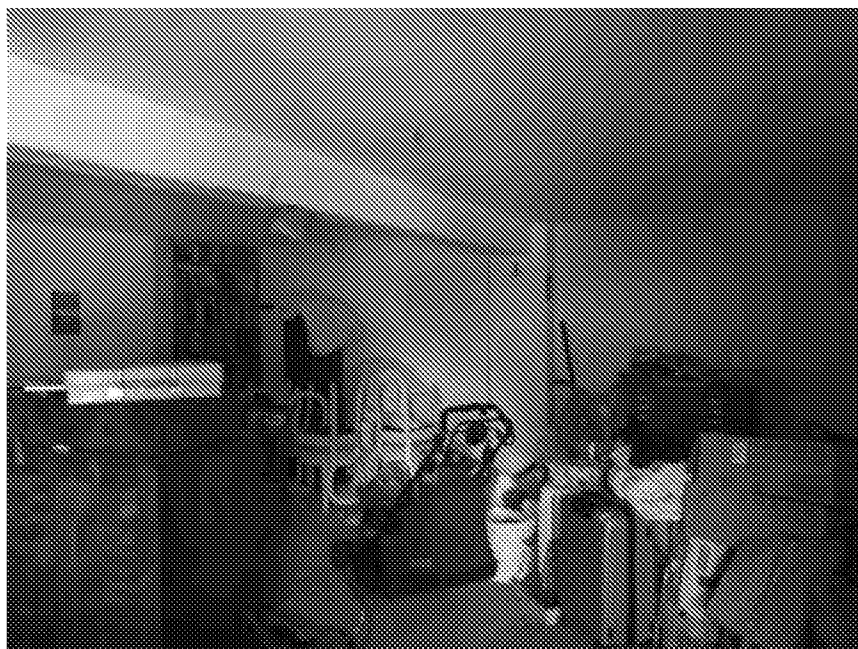
Room 11 – This room has an additional floor added at first floor level, there is a steel beam splitting the span of the timber floor joists, the steel beam is slightly corroded. The steel beam is then supported on masonry piers each end. All walls at ground floor level are boarded or finished therefore it was not possible to see the condition of the brickwork/flint walls. At first floor level the walls are also boarded or finished with some of the timber trusses exposed. The areas of timber truss visible appeared to be in good condition.

Building 4 – Boxed in steel beam supporting first floor joists

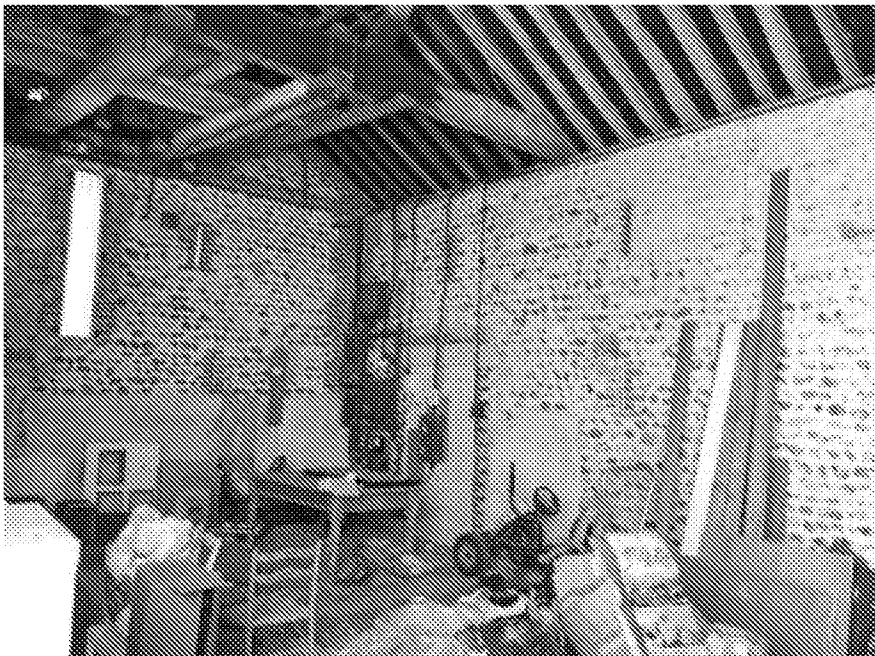
Building 4 – General view of high external walls

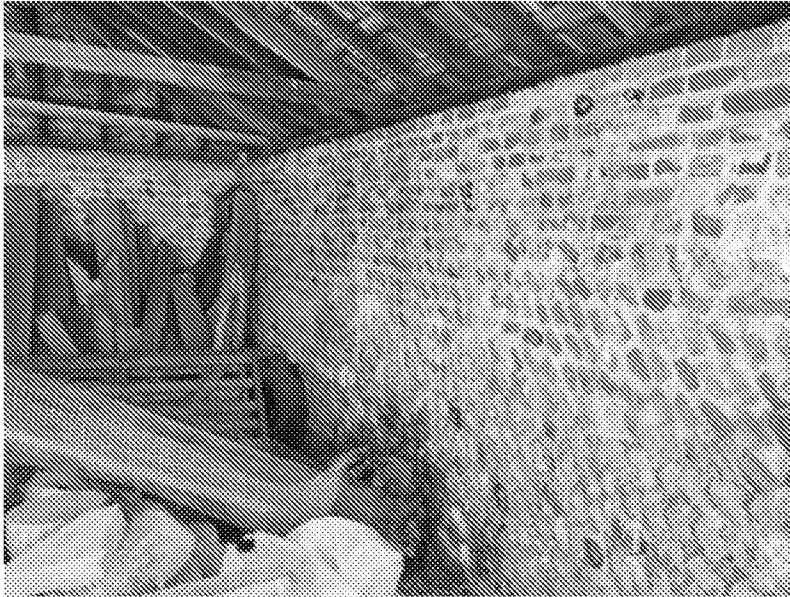
Building 5 – Room 16 exposed walls

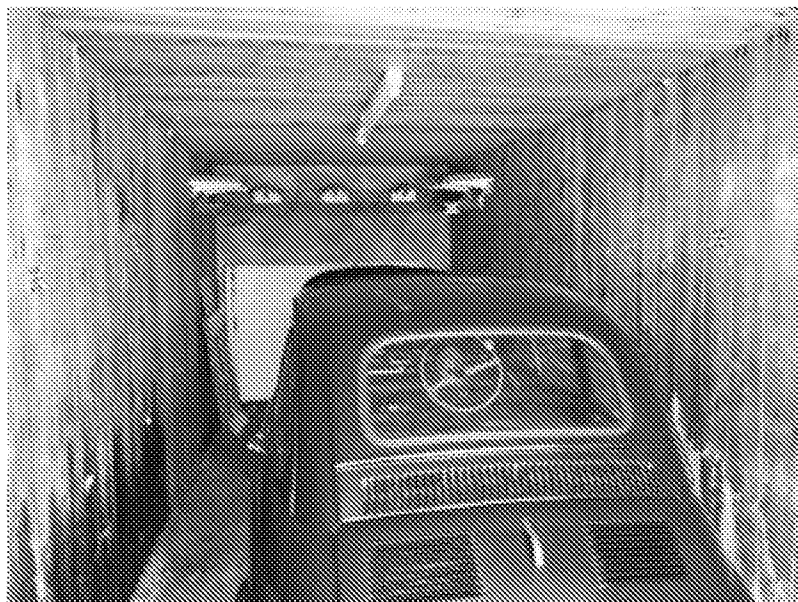
Building 5 – Timber clad room, structure not visible
