| <b>Project Name:</b> | Cinders Nursery, Yapton |
| <b>Document Reference:</b> | 125.5005/SVR |
| <b>Document Name:</b> | SuDS Verification Report |

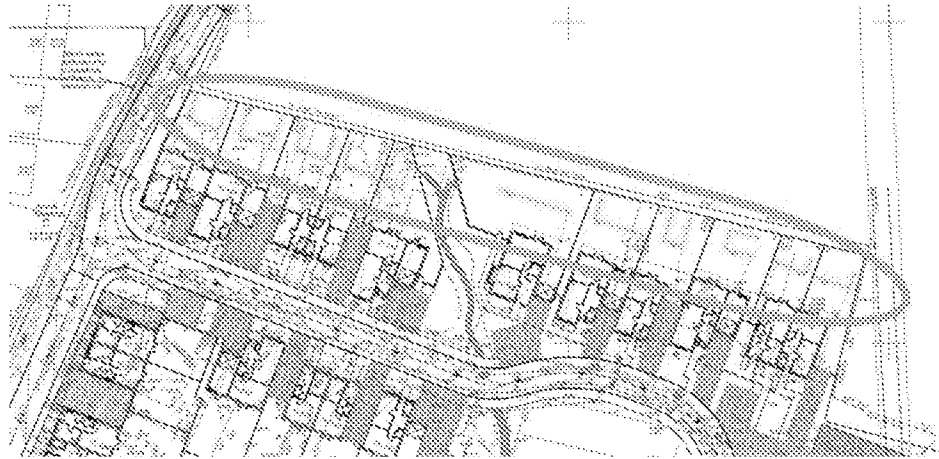
**Figure 1:** Snip of 'As Built' Drawing Showing the Proposed Position of the Infiltration Trench Soakaways.

'As built' drawings show that plots 1 – 11 were to have infiltration trench soakaways installed in their rear gardens. See **Figure 1**. As all of the infiltration trenches are in the rear gardens of dwellings which were occupied at the time of site visit, it was not possible for Paul Basham

- 3.1 As Paul Basham Associates were not present at the time of installation, this report cannot confirm if the trenches were constructed in accordance with the agreed design. However, the site was attended shortly after a rain event and showed no signs of flooding in or around dwellings drained by Infiltration Trench Soakaways. No trees were noted in or around areas that would be detrimental to the infiltration soakaways.

- 5.1 The infiltration trenches shown in the rear gardens of plots 1-11 could not be accessed on site. Photographs provided by Crayfern homes show excavations laid with a permeable geomembrane. This report cannot confirm if the excavations were backfilled in accordance with design. However, Paul Basham Associates attended the site shortly after a rain event and observed no signs of flooding and/or excess surface water flow.

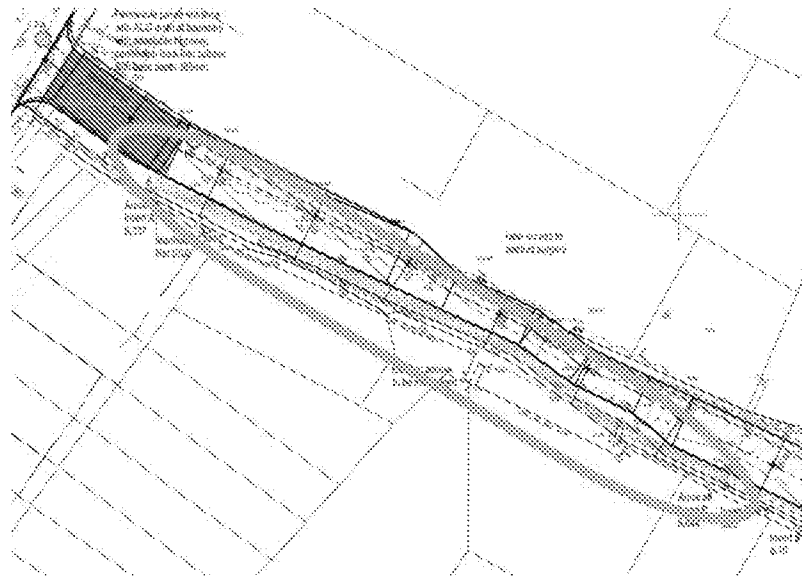
**Figure 4:** Snip of As Built Showing the Proposed Position of Infiltration Crates

- 3.2 The 'as built' drawing indicates that a geocellular infiltration crate system is to be installed along Cinder's Lane. See **Figure 5** and **Figure 5**. Paul Basham Associates were not present during installation of the crates but were provided with photographs from Crayfern homes which show that the excavated trenches were laid with small stone aggregate, the crates were then laid and wrapped in a geomembrane. Pictures provided also show that the crates were then overlaid with small stone aggregate. See **Figure 6** and **Figure 7**.

- 5.2 The as built drawings indicate that geocellular infiltration crates were installed along Cinders Lane. Pictures provided by Crayfern homes show that the excavations were laid with small stone aggregate before the crates were laid. They also show that the crates were then wrapped in permeable Geomembrane and the excavation was then filled with small stone aggregate.

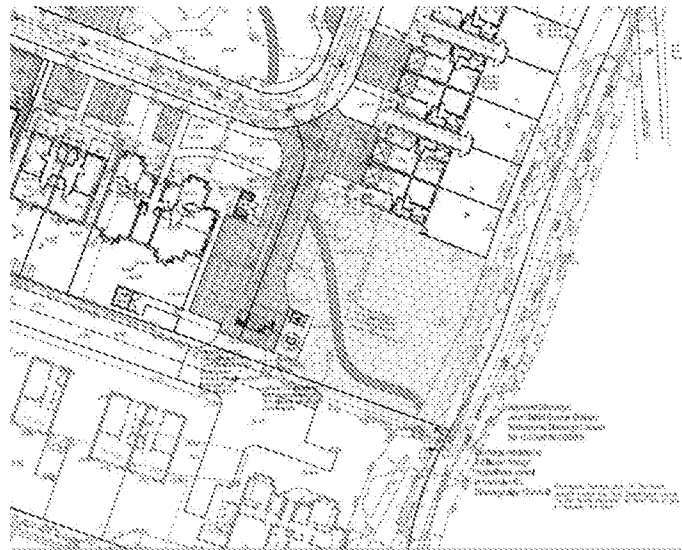
**Figure 10:** Snip of As Built Showing Proposed Position of the Geocellular Attenuation Crates

- 3.4 The as built drawings show that there is a set of Geocellular Attenuation Crates installed in the southeast corner of the site. See **Figure 10**. Paul Basham Associates did not attend the site during the installation of the crates however photographs taken during construction provided to Paul Basham Associates by Crayfern Homes show that the crates were underlain by an impermeable geomembrane. They also show that after being laid, the crates were then covered with an impermeable geomembrane and then a small stone aggregate. See **Figure 11**, **Figure 12**, and **Figure 13**.

- 3.5 It was not possible for Paul Basham Associates to confirm the size of the crates installed on site. No trees were observed in areas that would be detrimental to the geocellular crates.

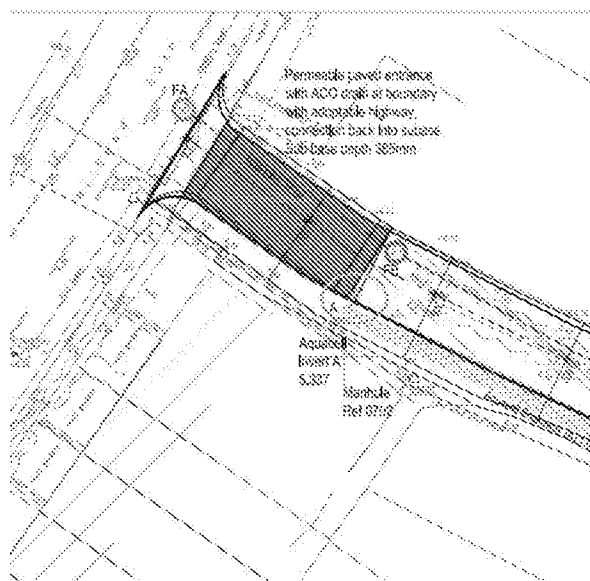
**Figure 15:** Snip of Missing Gully on As Built Drawing

1. **Missing Gully A:** **Figure 15** shows the proposed position of the gully. **Figure 16** shows a photograph taken on site of the proposed position of the gully. It shows that no gully has been installed at the time of the site visit.

- 4.1 **Missing Gully A:** **Figure 27** below shows a stoned-up excavation for a gully in the proposed position of Missing gully A.

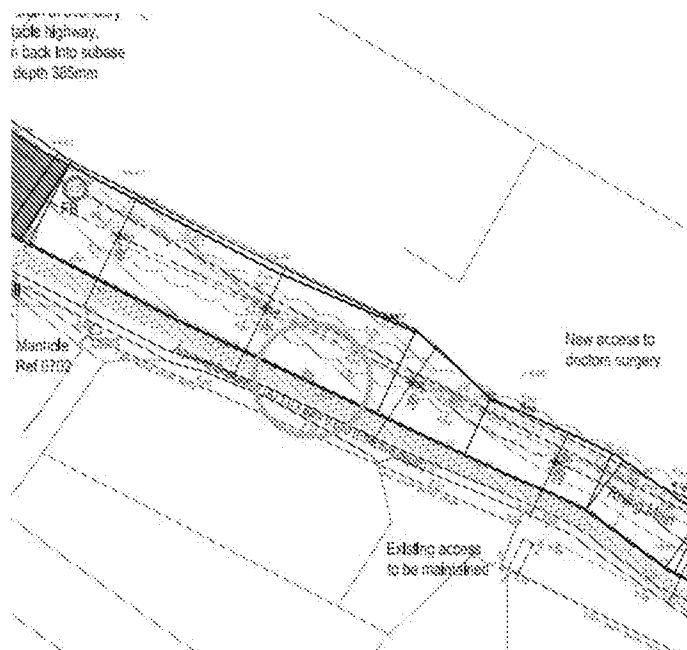
**Figure 17:** Snip of Missing Gully on As Built Drawing

2. **Missing Gully B:** **Figure 17** shows the proposed position of the gully. **Figure 18** is a photograph of the proposed position of the gully. No gully could be observed at the time of site visit.

- 4.2 **Missing Gully B:** Figure 28 below shows a stoned-up excavation for a gully in the proposed position of Missing gully B.

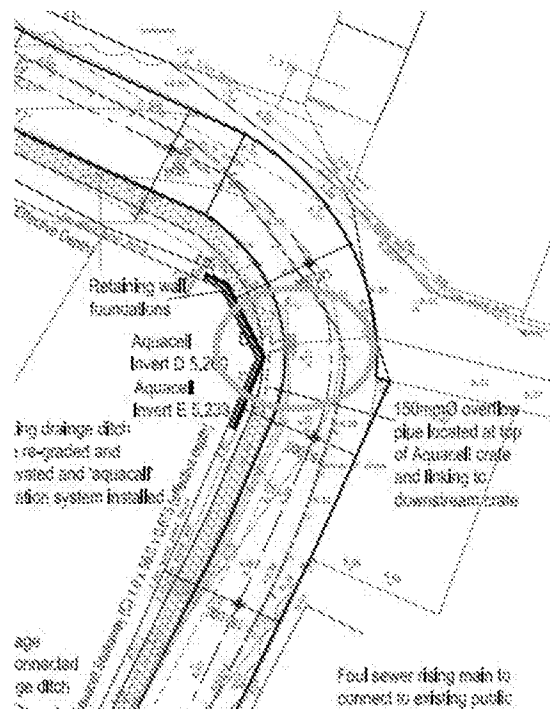
**Figure 19:** Snip of Missing Gullies on As Built Drawing

3. **Missing Gully C:** **Figure 19** shows the proposed position of the gully. **Figure 20** is a photograph of the proposed position of the gully. No gully could be observed at the time of site visit.

- 4.3 **Missing Gully C:** Figure 29 below shows a gully installed in the proposed position of Missing gully C.

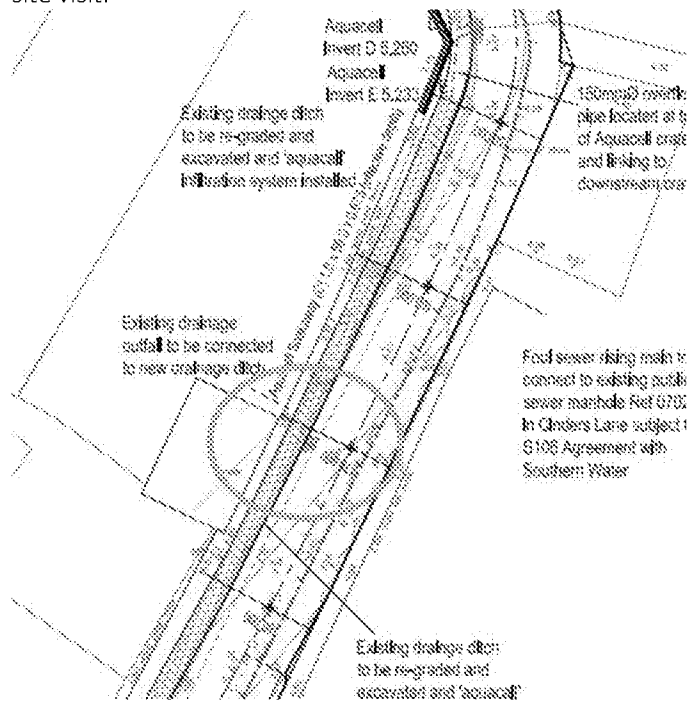
**Figure 21:** Snip of Missing Gully in As Built Drawing

4. **Missing Gully D:** **Figure 21** shows the proposed position of the gully. **Figure 22** is a photograph the proposed position of the gully. No gully could be observed at the time of site visit.

Due to there being a missing gully, longitudinal drawings provided by Crayfern Homes (**Appendix D**) were used in conjunction with the as built drawings to assess whether the gully arrangement on site had adequate spacing to drain the site according to DMRB standards (CD 526, Table D.4). **Appendix E** shows that the current gully spacing between chainages 145 and 185 would not adequately drain the site.

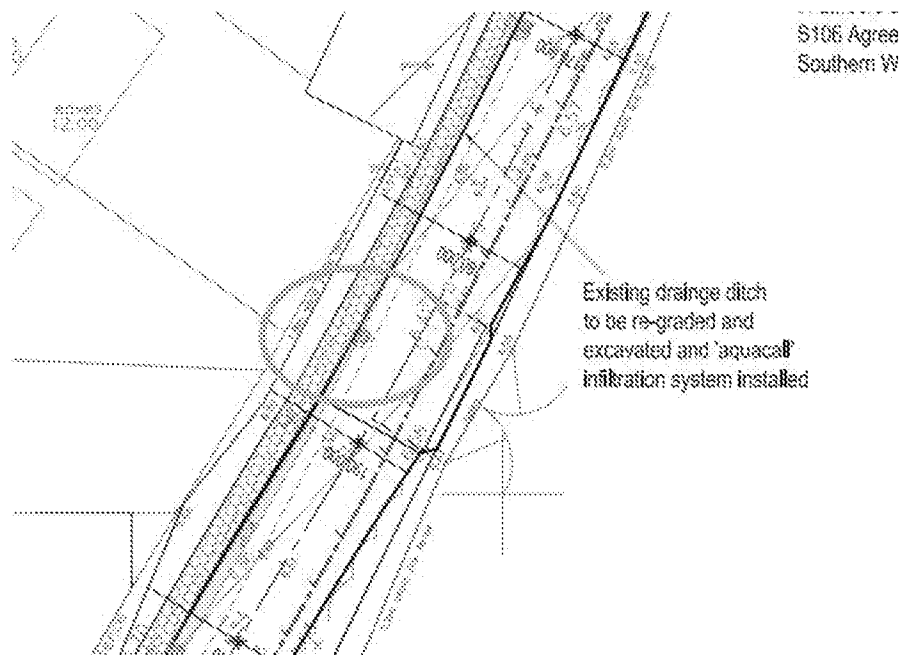
**Figure 23:** Snip of Missing Gully in As Built Drawing

5. **Missing Gully E:** **Figure 23** shows that the proposed position of the gully. **Figure 24** is a photograph of the proposed position of the gully. No gully could be observed at the time of site visit.

- 4.4 **Missing Gully E:** **Figure 30** below shows a stoned-up excavation for a gully in the proposed position of Missing gully E.

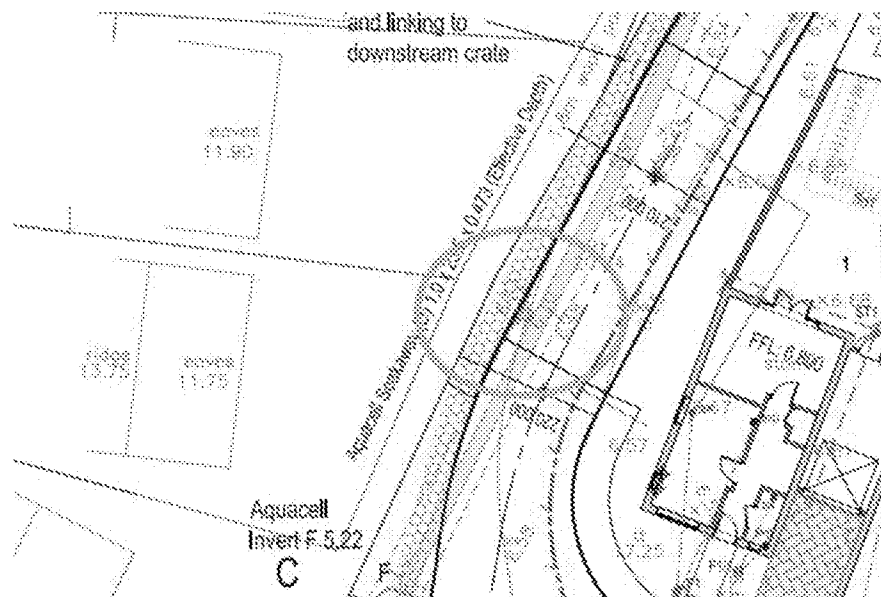
**Figure 25:** Snip of Missing Gully in As Built Drawing

6. **Missing Gully F:** **Figure 25** shows the proposed position of the gully. **Figure 26** is a photograph of the proposed position of the gully. No gully could be observed at the time of site visit.

- 4.5 **Missing Gully F:** Figure 31 below shows a stoned-up excavation for a gully in the proposed position of Missing gully F.
