Job Title
Climping Mill Project

Drawing Title
Mill Thatch
Ground Floor Plan
As Original Form and
as Existing / Current

Drg. No. DGC-21815/MT01 Rev.

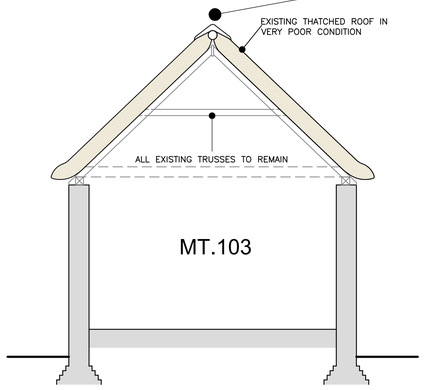
Section 1-1 : As Existing
SCALE 1=50

PHOTO IMAGE SHOWING EVIDENCE OF PREVIOUS MEZZANINE FLOOR LEVEL
