# Former Arundel Gas Works

Further Site Investigation & Outline Remediation Strategy

29780-R02(00)

**Title:** Further site assessment and outline remediation strategy: Former Arundel Gas Works, Ford Road, Arundel.

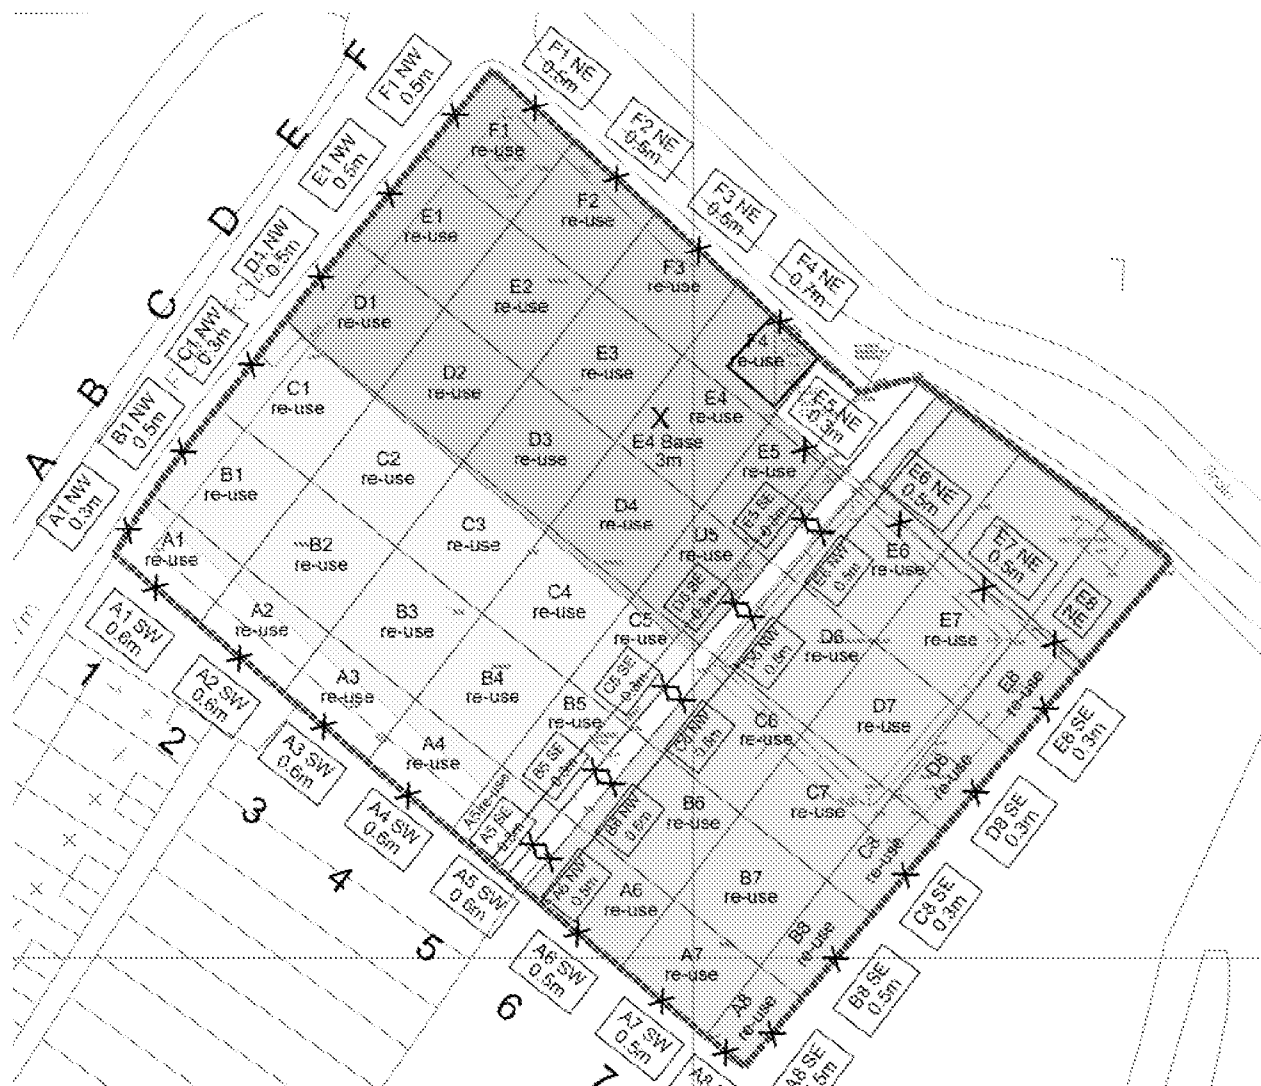
## FIGURE 5 VERIFICATION GRID

Verification Grid (reproduced  
from Celtic remediation report)
