## **Project**

**Project Name:** Arundel Gate BN18 9EX  
**Project Description:** General CCTV - Condition Check  
**Project Number:** JSD10246  
**Project Status:** Complete  
**Project Date:** 17/09/2026  
**Inspection Standard:** MSCC4 Sewers & Drainage GB (SRM4 Scoring)

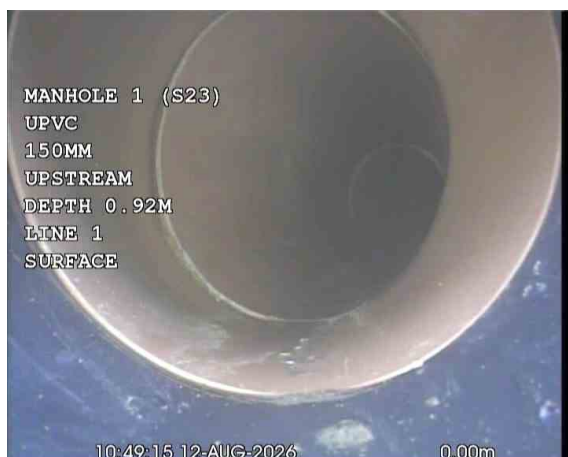
S.

GULLYX\_109764c7-514b-445c-b858-cacd4e694b36\_20260917\_155036\_115.jpg, 00:00:55, 0.00 m  
Start node, manhole, reference: MANHOLE 1 (MH1), (S23)

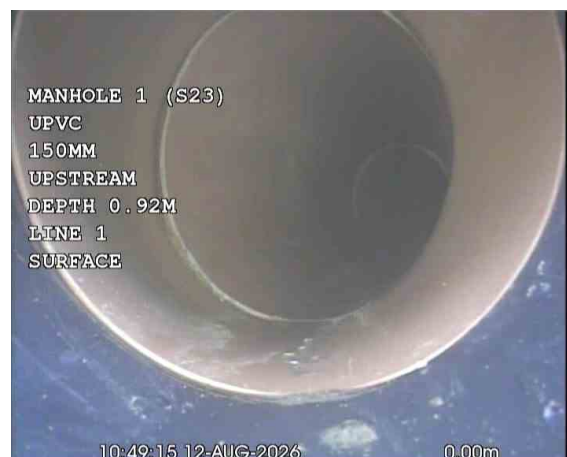
S.

GULLYX\_abb76203-50f5-401d-bfc1-47038f07a9cd\_20260917\_155041\_631.jpg, 00:00:55, 0.00 m  
Water level, 0% of the vertical dimension

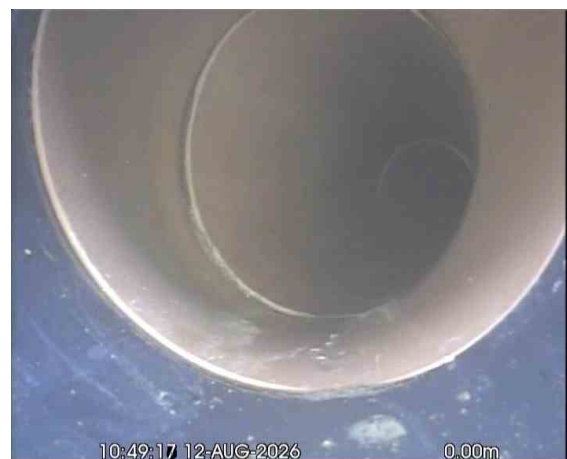
S.

GULLYX\_fb188551-1c84-4334-b949-5f79f49ee4bd\_20260917\_155050\_901.jpg, 00:00:57, 0.02 m  
Line deviates right

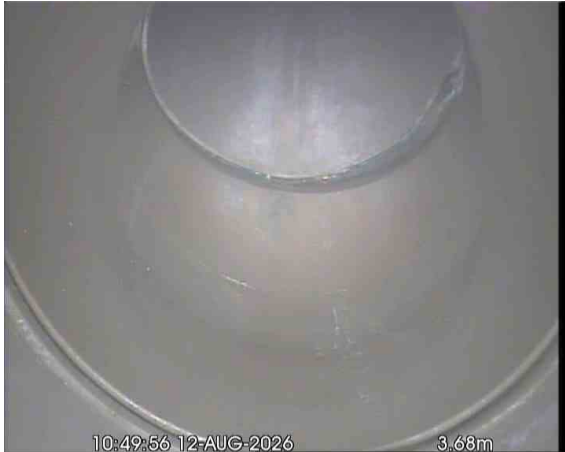
S.  
GULLYX\_c841ab05-4e20-45ef-94d7-4ac12e3120df\_20260917\_155120\_453.jpg, 00:01:35, 3.68 m  
Line deviates up

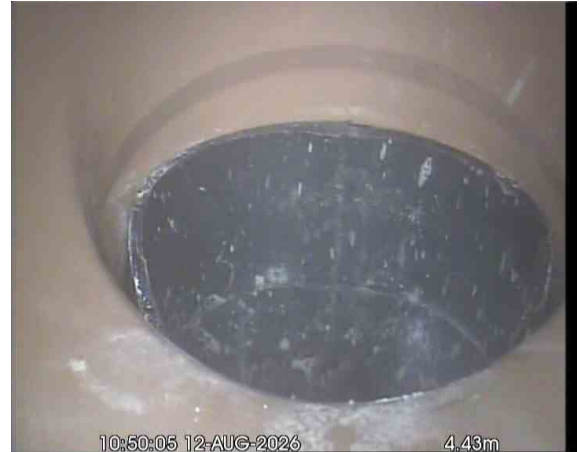
S.  
GULLYX\_23b6788d-ddfa-4c0f-988e-e3344ba8fbbe\_20260917\_155137\_696.jpg, 00:01:45, 4.43 m  
Line deviates down

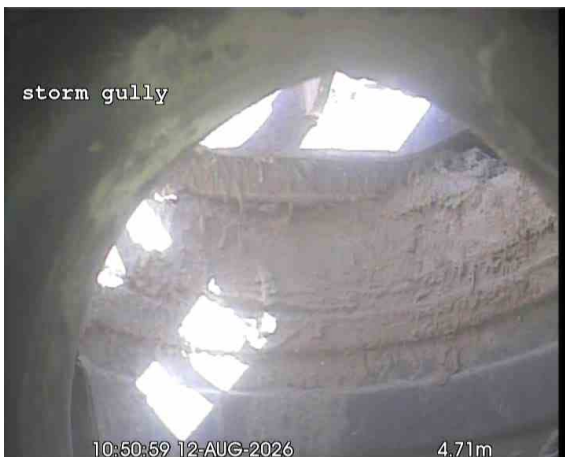
S.  
GULLYX\_3b60e3f0-573d-481c-b75f-bc5ef4611ab7\_20260917\_155150\_610.jpg, 00:01:57, 4.71 m  
Finish node, gully, reference: STORM GULLY

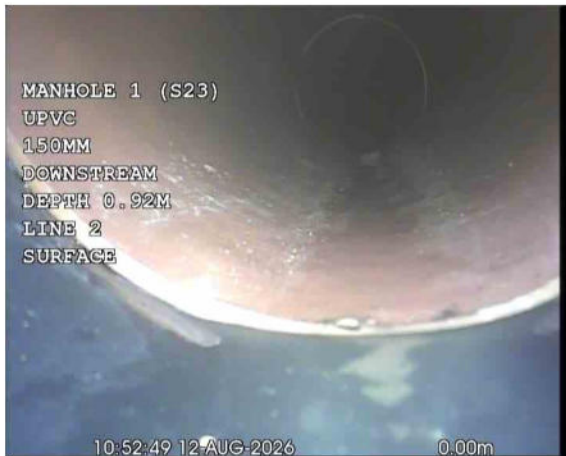
MH1  
(S23)X\_4d4814a7-cf8b-4114-976f-03e03bb0a39d\_20260917\_155148\_736.jpg, 00:00:30, 0.00 m  
Start node, manhole, reference: MANHOLE 1 (MH1), (S23)

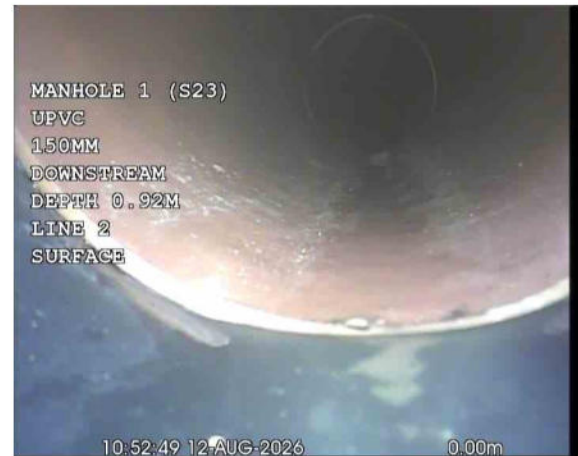
MH1  
(S23)X\_6070be17-7d18-4c32-b2ad-bd1778049acb\_20260917\_155155\_126.jpg, 00:00:30, 0.00 m  
Water level, 0% of the vertical dimension

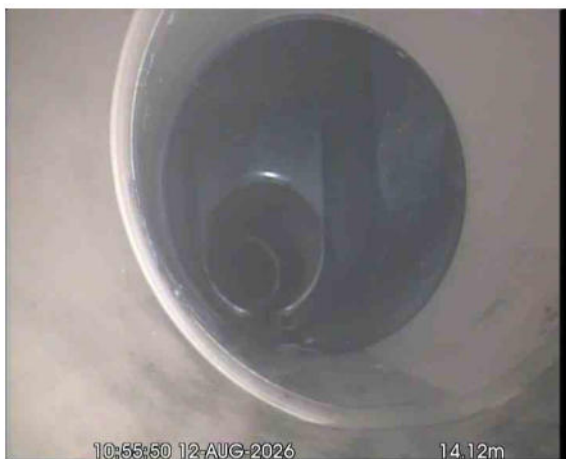
MH1  
(S23)X\_76bf3cf8-8282-4de9-a750-7fe0fe7e797e\_20260917\_155155\_107.jpg, 00:03:30, 4.12 m  
Line deviates left

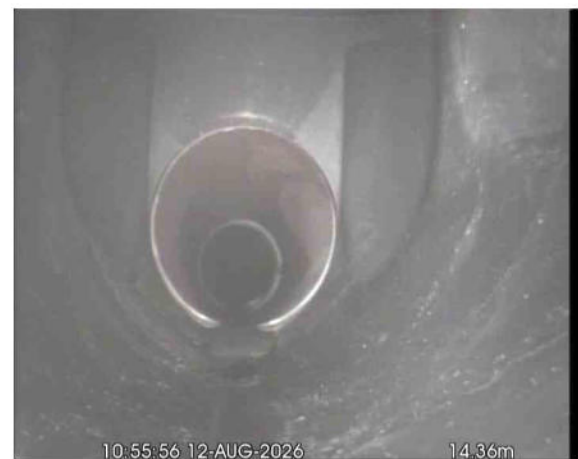
MH1  
(S23)X\_27bbfd78-d76f-43d6-a1f0-9029b7db433e\_20260917\_155533\_220.jpg, 00:03:36, 14.36 m  
Finish node, manhole, reference: MANHOLE 2 (MH2), (S24)

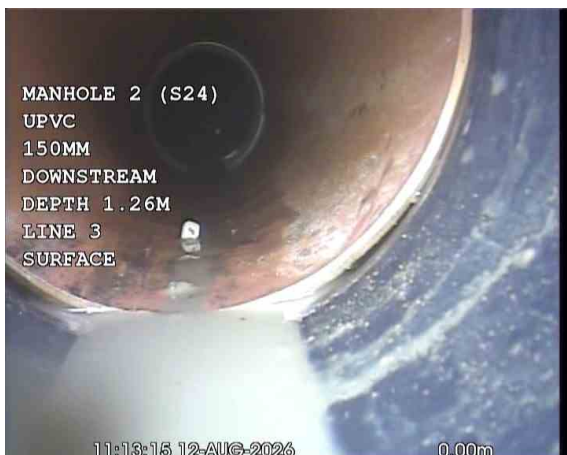
MH2  
(S24)X\_32ea514b-be78-46ea-86b7-50292b24514a\_20260917\_155635\_895.jpg, 00:00:07, 0.00 m  
Start node, manhole, reference: MANHOLE 2 (MH2), (S24)

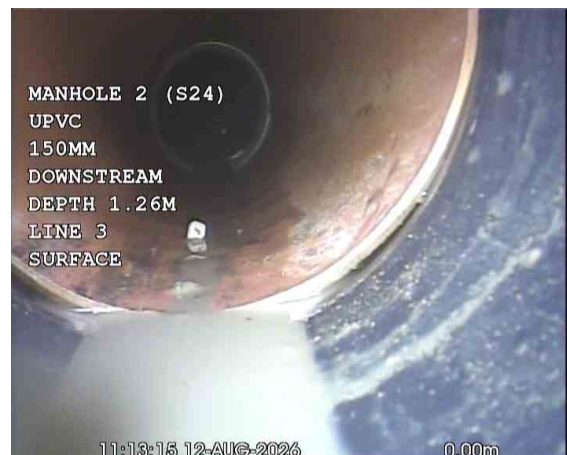
MH2  
(S24)X\_26902208-3caf-4351-868f-afaabecf0fc0\_20260917\_155641\_435.jpg, 00:00:07, 0.00 m  
Water level, 0% of the vertical dimension

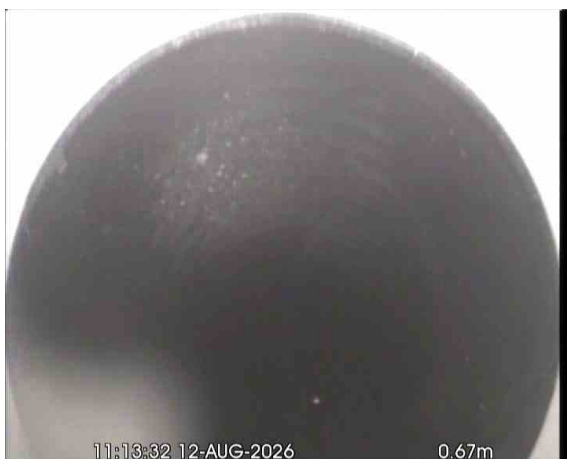
MH2  
(S24)X\_1640f63c-28bf-45fc-97de-4cd679e228b3\_20260917\_155700\_752.jpg, 00:00:25, 0.67 m  
Size changes, new size(s), 225mm high

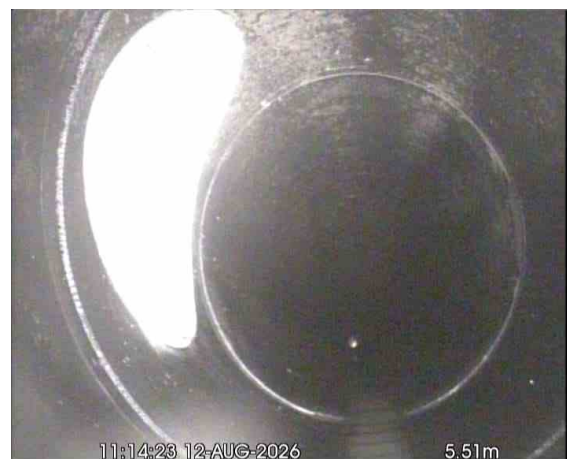
MH2  
(S24)X\_b5ecb4c4-0c32-4ed7-8a51-b194671de47a\_20260917\_155727\_905.jpg, 00:01:16, 5.51 m  
Junction at 9 o'clock, diameter: 150mm

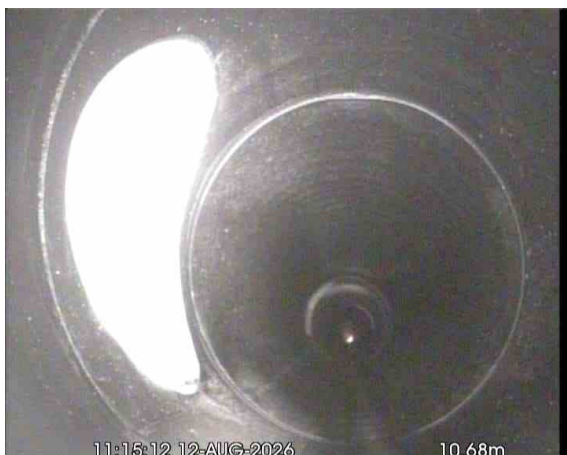
MH2  
(S24)X\_9bc9b007-b930-48ab-9bd4-88c17d308de9\_20260917\_155756\_854.jpg, 00:02:05, 10.68 m  
Junction at 9 o'clock, diameter: 150mm

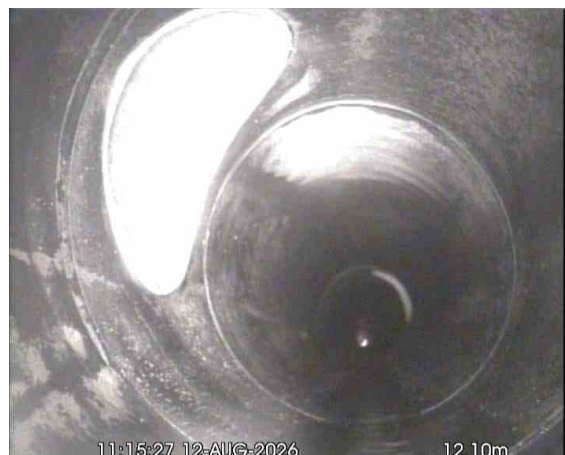
MH2  
(S24)X\_95af4d62-58af-4330-bcfa-b7b9eaa6bf5f\_20260917\_155813\_356.jpg, 00:02:20, 12.10 m  
Junction at 10 o'clock, diameter: 150mm

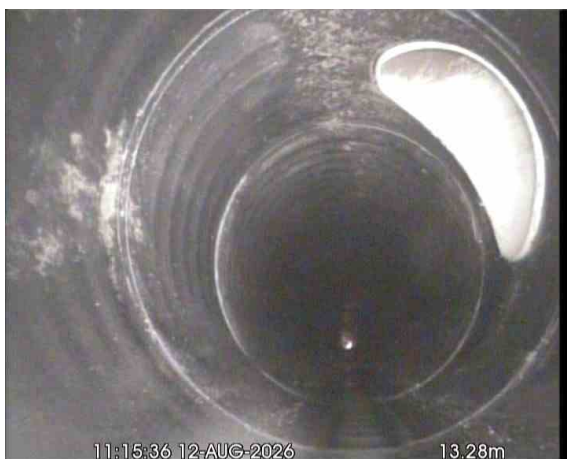
MH2  
(S24)X\_6d0cafe9-aaba-4e45-9438-a7dde209d2f5\_20260917\_155841\_148.jpg, 00:02:29, 13.28 m  
Junction at 2 o'clock, diameter: 150mm

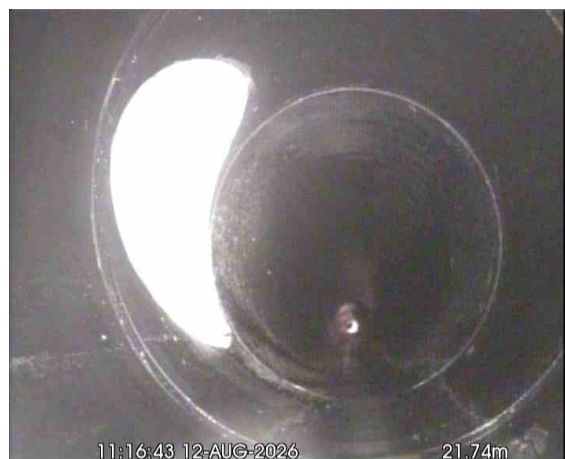
MH2  
(S24)X\_2b4372fb-7b8b-41ea-ad26-3972d5980a12\_20260917\_155917\_684.jpg, 00:03:36, 21.74 m  
Junction at 9 o'clock, diameter: 150mm

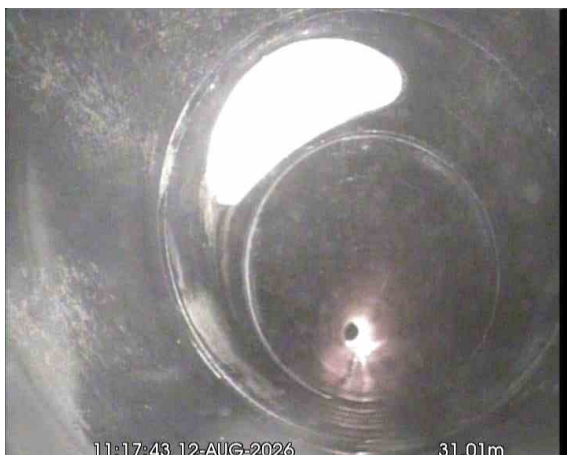
MH2  
(S24)X\_d71bb206-4d3c-4feb-865c-4210ee6c4161\_20260917\_155959\_075.jpg, 00:04:36, 31.01 m  
Junction at 11 o'clock, diameter: 150mm

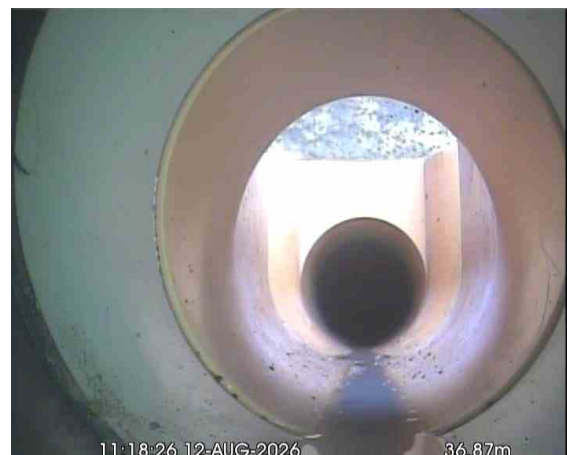
MH2  
(S24)X\_1f274a2c-b6c5-4dc5-a557-e1fbc41492d\_20260917\_160035\_851.jpg, 00:05:19, 36.87 m  
Size changes, new size(s), 150mm high

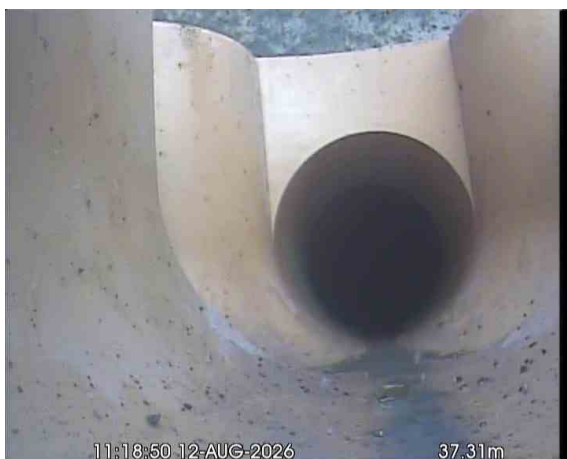
MH2  
(S24)X\_eaf88c2c-cff4-4225-9271-78901f6e91fa\_20260917\_160112\_370.jpg, 00:05:43, 37.31 m  
Finish node, manhole, reference: MANHOLE 3 (MH3), (S25)

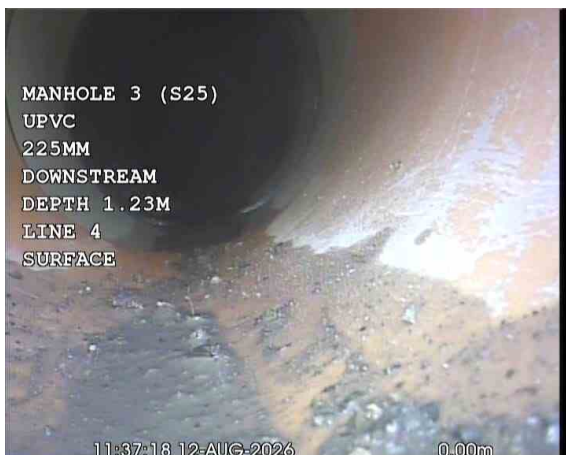
MH3  
(S25)X\_bc5ddc7d-f27a-4e64-b99e-2df88dd07134\_20260917\_160242\_868.jpg, 00:01:09, 0.00 m  
Start node, manhole, reference: MANHOLE 3 (MH3), (S25)

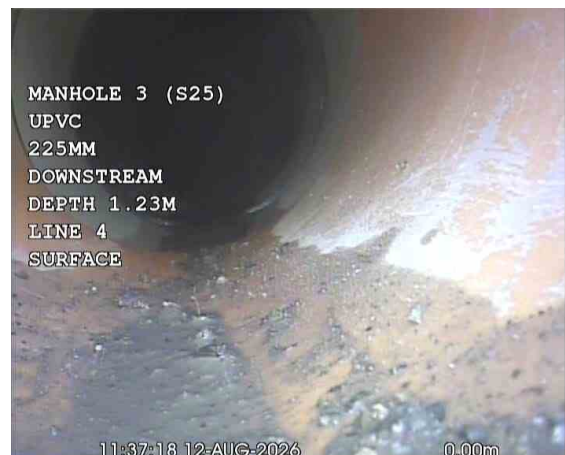
MH3  
(S25)X\_bbd337cd-102c-4321-9ed5-c37510282807\_20260917\_160249\_304.jpg, 00:01:09, 0.00 m  
Water level, 0% of the vertical dimension

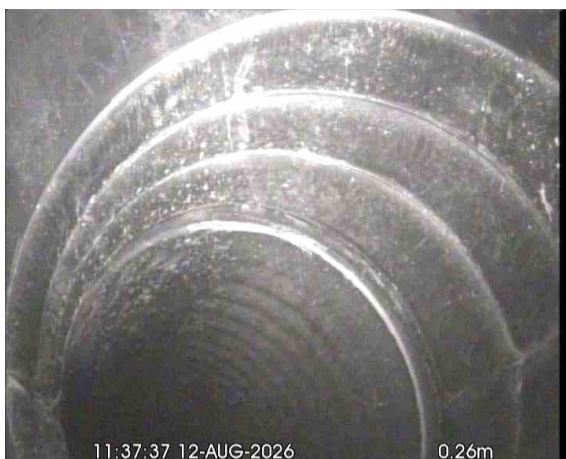
MH3  
(S25)X\_4ba9618a-5a5f-41f0-ae3c-0a1d373c7321\_20260917\_160302\_250.jpg, 00:01:28, 0.26 m  
Line deviates left

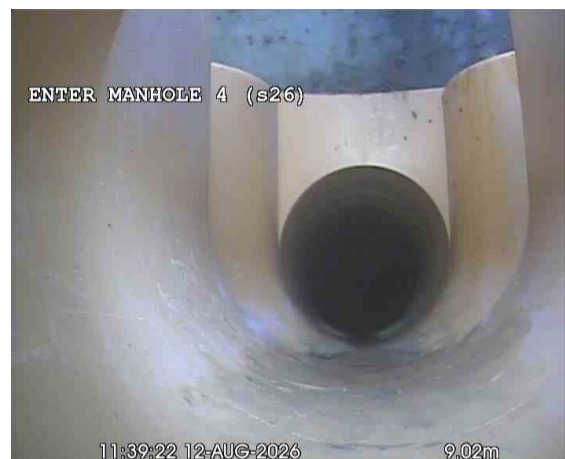
MH3  
(S25)X\_a07b1e89-ad44-4d33-956a-2a54c47cce03\_20260917\_160326\_826.jpg, 00:02:57, 9.02 m  
Finish node, manhole, reference: MANHOLE 4 (MH4), (S26)

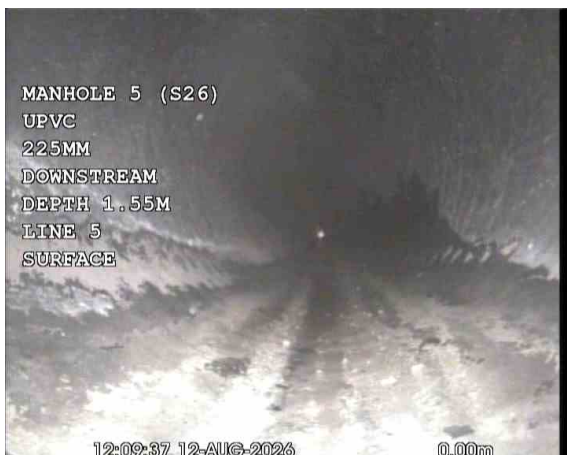
MH5  
(S26)X\_049c4293-9789-4496-bf72-6fb8cae8a49a\_20260917\_160501\_585.jpg, 00:01:14, 0.00 m  
Start node, manhole, reference: MANHOLE 5 (MH5), (S26)

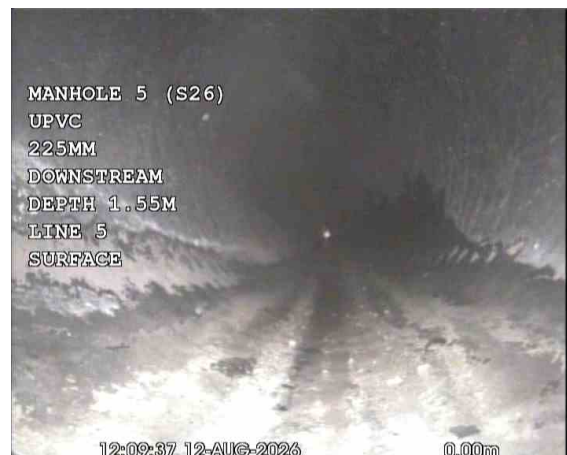
MH5  
(S26)X\_fb4723c3-3e9c-44c7-a87d-8ac8732bb7bf\_20260917\_160507\_474.jpg, 00:01:14, 0.00 m  
Water level, 0% of the vertical dimension

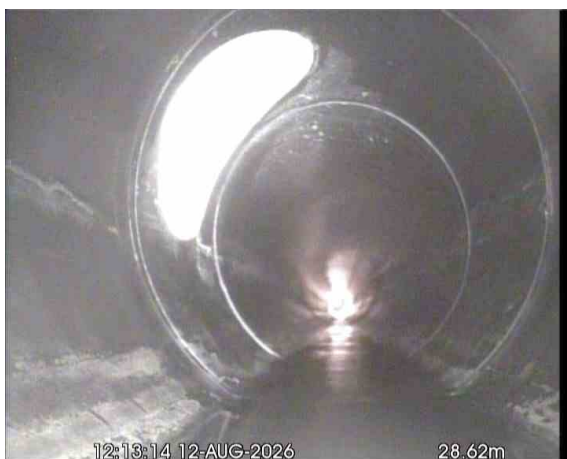
MH5  
(S26)X\_65b27f55-c831-4031-afb9-47e4ef07d4c3\_20260917\_160551\_209.jpg, 00:04:51, 28.62 m  
Junction at 10 o'clock, diameter: 150mm

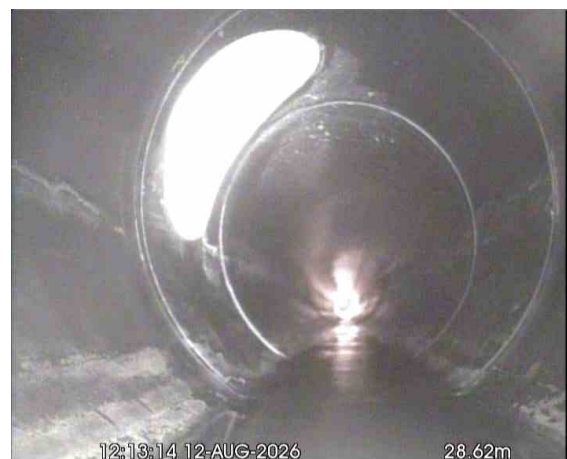
MH5  
(S26)X\_3a3654d2-9b1b-4e04-9694-8c7e2273311f\_20260917\_160559\_119.jpg, 00:04:51, 28.62 m  
Water level, 5% of the vertical dimension

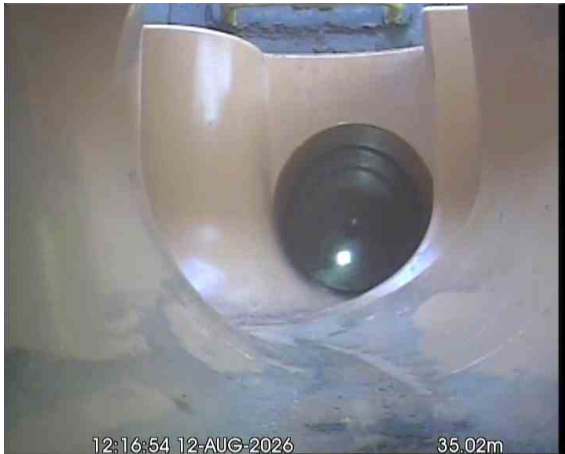
MH5  
(S26)X\_2effd61c-e6ce-4a24-8800-0160cd8d6e55\_20260917\_  
160754\_053.jpg, 00:08:31, 35.02 m  
Finish node, manhole, reference: MANHOLE 4 (MH4), (S27)

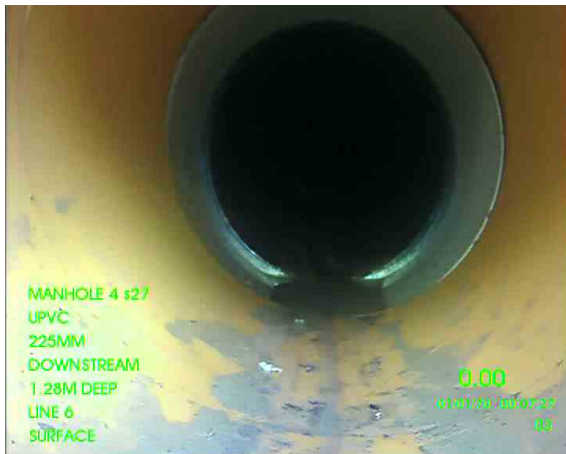
MH4

(S26)X\_f838ba4e-127e-47d2-9614-f5e8e0b390e8\_20260917\_160946.png, 0.00 m  
Start node, manhole, reference: MANHOLE 4 (MH4), (S26)

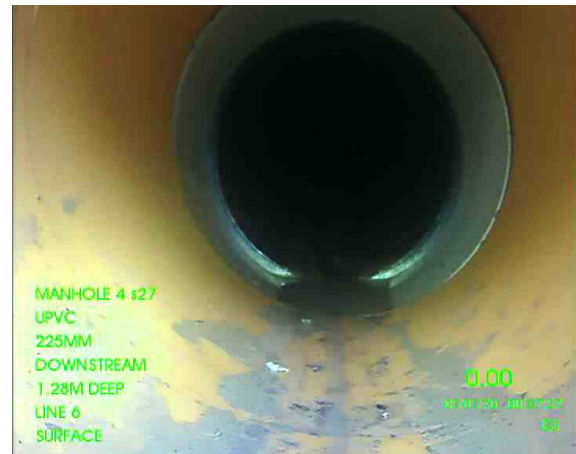
MH4

(S26)X\_e649b1d4-8702-4322-bd08-b738e10fda99\_20260917\_161012.png, 0.00 m  
Water level, 0% of the vertical dimension

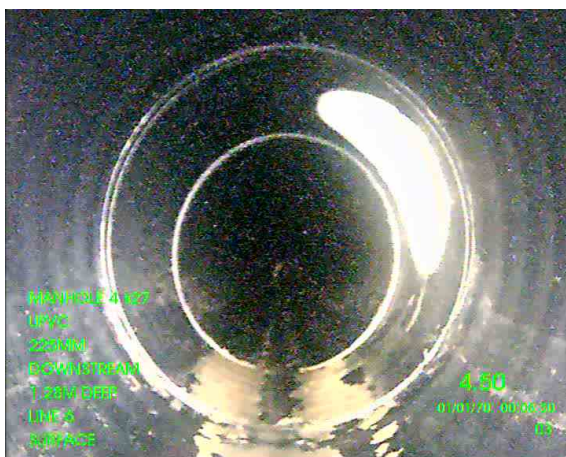
MH4

(S26)X\_e48caf5f-78ab-4cb8-a0fb-7c2fb848a50e\_20260917\_161057.png, 4.50 m  
Junction at 2 o'clock, diameter: 150mm

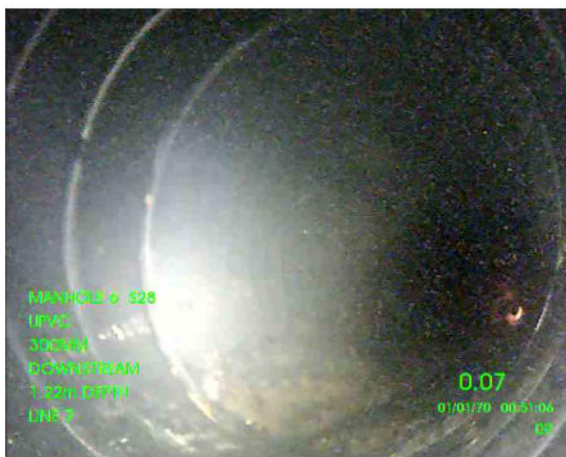
MH6  
(S28)X\_0572d9ae-b482-4f06-ad13-5a0d335b5bf1\_20260917\_161445.png, 0.07 m  
Line deviates right

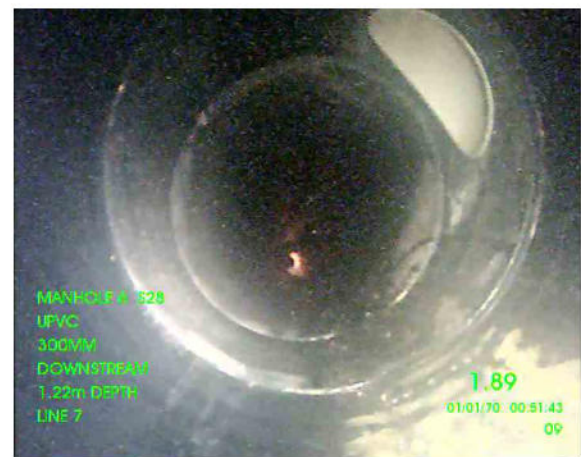
MH6  
(S28)X\_f57b6097-6d31-4ada-8367-ff2e3ea0c0ce\_20260917\_161451.png, 1.89 m  
Junction at 2 o'clock, diameter: 150mm

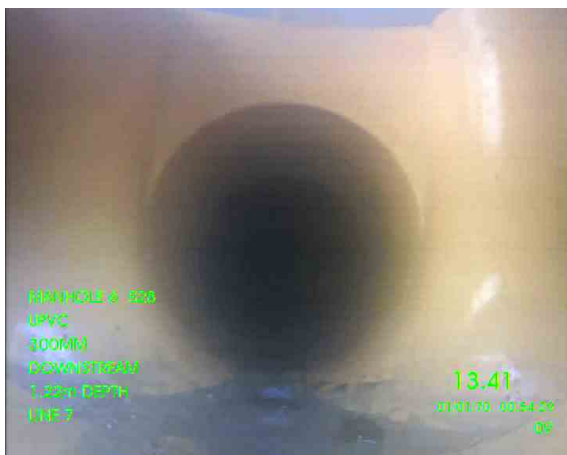
MH6  
(S28)X\_7e920f37-da11-4577-bff2-d13314ea7b33\_20260917\_  
161500.png, 13.41 m  
Finish node, manhole, reference: MANHOLE 7 (MH7), (S29)

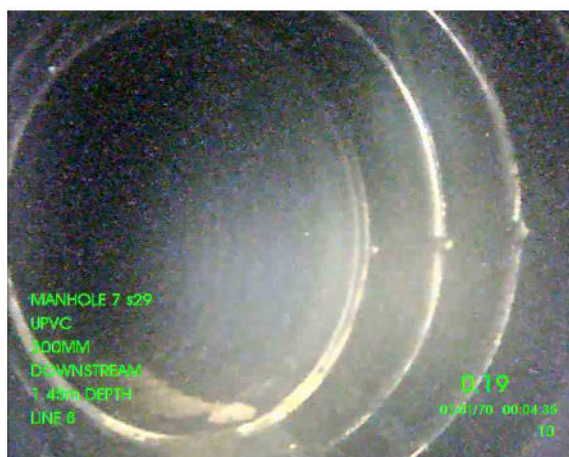
MH7  
(S29)X\_d7dcf0f8-609e-4756-ba6c-0d55cc8bb014\_20260917\_161846.png, 0.19 m  
Line deviates right

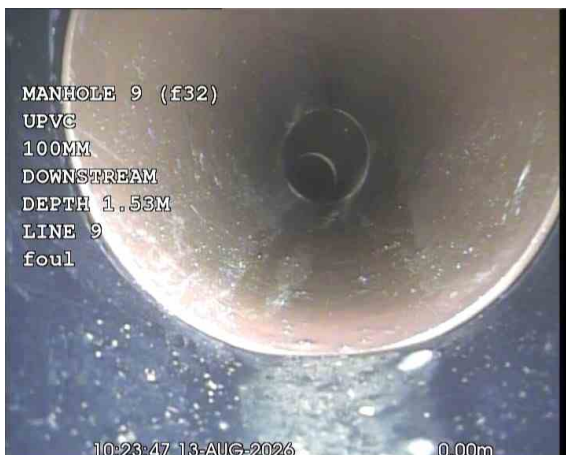
MH9  
(F32)X\_489cd220-7614-4143-8eff-ce8eab942a81\_20260917\_162353\_874.jpg, 00:00:41, 0.00 m  
Start node, manhole, reference: MANHOLE 9 (MH9), (F32)

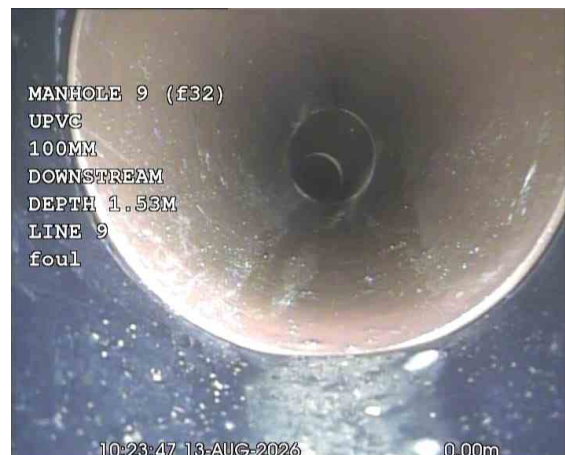
MH9  
(F32)X\_e3973f59-9613-42f8-9210-aab46720dede\_20260917\_162400\_532.jpg, 00:00:41, 0.00 m  
Water level, 0% of the vertical dimension

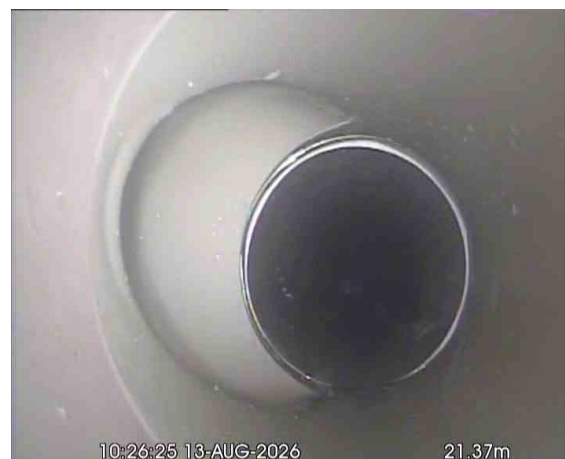
MH9  
(F32)X\_8025571e-a2ca-4ecc-98a6-1866d1e8da4c\_20260917\_162428\_474.jpg, 00:03:19, 21.37 m  
Junction at 9 o'clock, diameter: 110mm

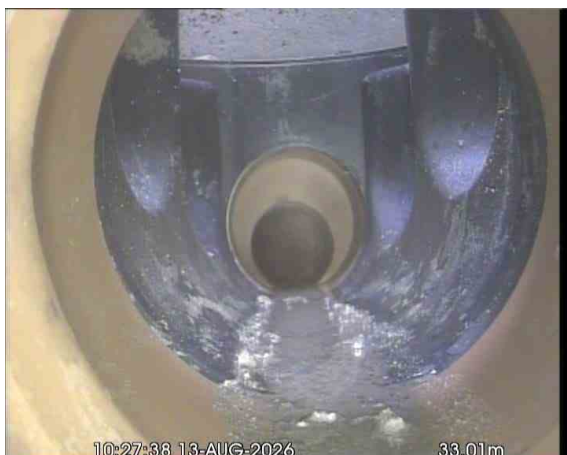
MH9  
(F32)X\_fd623ebe-d1d6-449f-a4a3-b1a95742cd59\_20260917\_162458\_154.jpg, 00:04:32, 33.01 m  
Size changes, new size(s), 150mm high

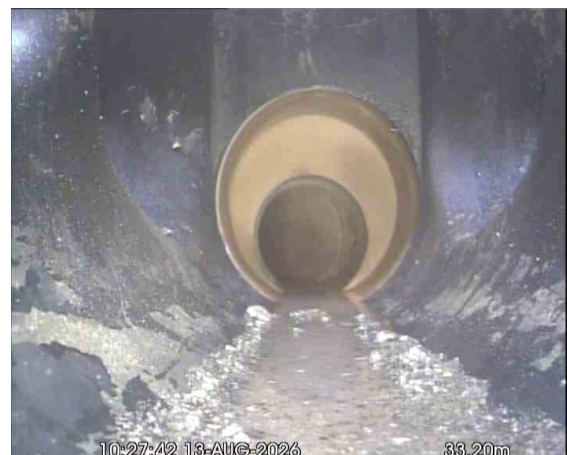
MH9  
(F32)X\_4e9ac8c6-0901-45d4-917d-3c1168824f94\_20260917\_162519\_220.jpg, 00:04:36, 33.20 m  
Finish node, manhole, reference: MANHOLE 10 (MH10), (F33)

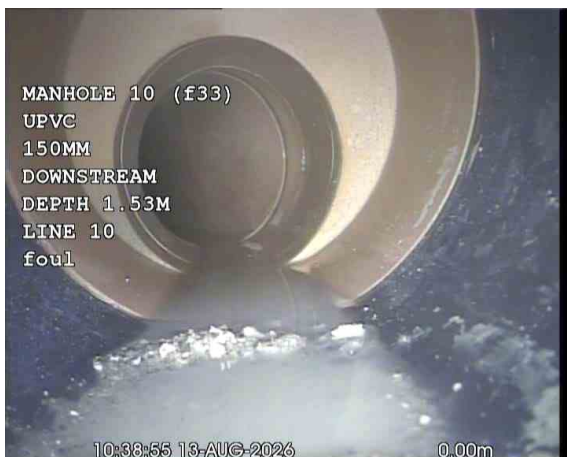
MH10  
(F33)X\_53dbb7e5-9dde-4b18-97cf-4fa8b41e333a\_20260917\_162659\_649.jpg, 00:00:57, 0.00 m  
Start node, manhole, reference: MANHOLE 10 (MH10), (F33)

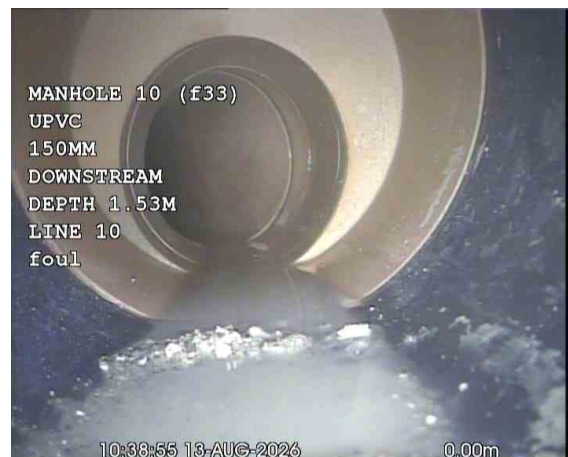
MH10  
(F33)X\_d878b1ba-4f3d-4473-877b-22a78de67df5\_20260917\_162705\_885.jpg, 00:00:57, 0.00 m  
Water level, 5% of the vertical dimension

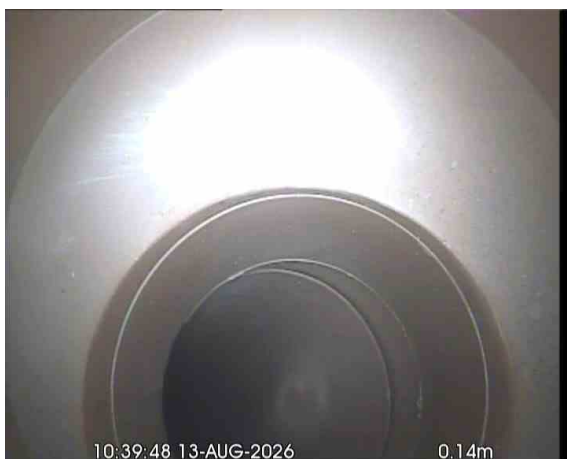
MH10  
(F33)X\_611c9cc4-c847-4f8c-be2e-970db7baba0f\_20260917\_162752\_448.jpg, 00:01:50, 0.14 m  
Size changes, new size(s), 110mm high

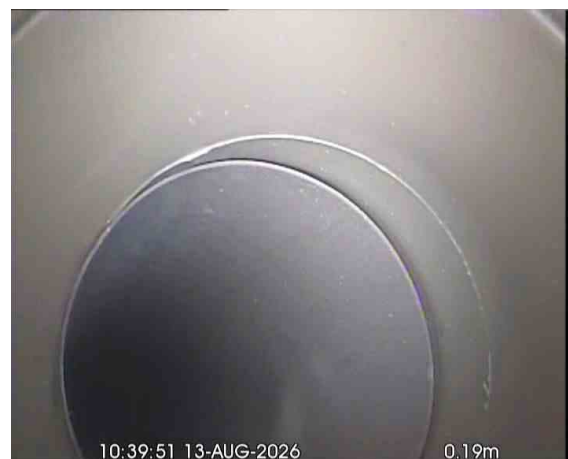
MH10  
(F33)X\_cf6c9501-8720-47d1-8897-0ad26da18fac\_20260917\_162801\_379.jpg, 00:01:53, 0.19 m  
Line deviates left

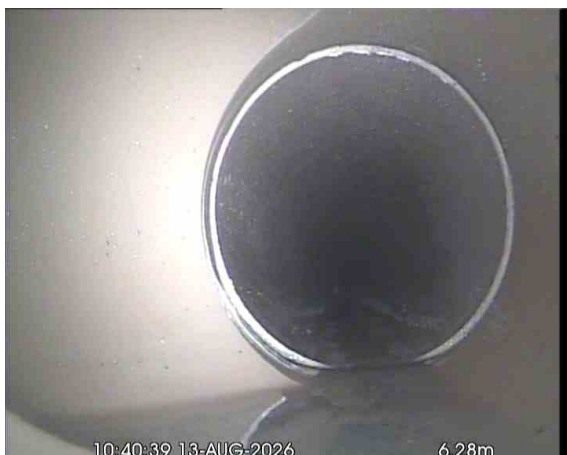
MH10  
(F33)X\_ab7df427-aa82-4b2d-aef8-1b8bd624a4aa\_20260917\_163020\_967.jpg, 00:02:41, 6.28 m  
Junction at 9 o'clock, diameter: 110mm

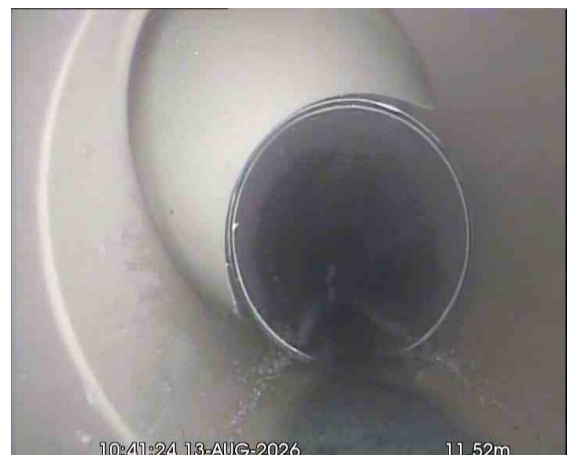
MH10  
(F33)X\_bf568a71-e48d-480d-80ff-eb7b6dc9d9f\_20260917\_163054\_265.jpg, 00:03:26, 11.52 m  
Junction at 10 o'clock, diameter: 110mm

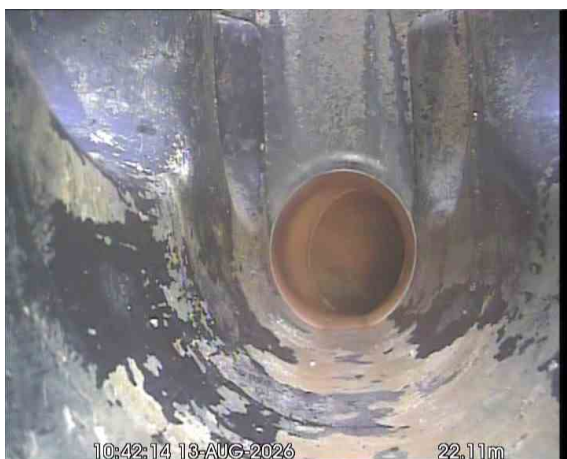
MH10  
(F33)X\_09784df2-4f93-46ba-9049-4ed3d1541d28\_20260917\_163151\_061.jpg, 00:04:16, 22.11 m  
Finish node, manhole, reference: MANHOLE 11 (MH11), (F34)

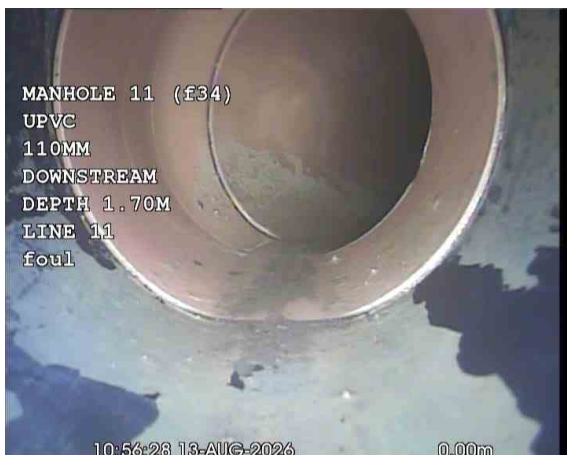
MH11  
(F34)X\_7c6f545c-8f02-44fd-9219-0492384b7187\_20260917\_163842\_569.jpg, 00:00:31, 0.00 m  
Start node, manhole, reference: MANHOLE 11 (MH11), (F34)

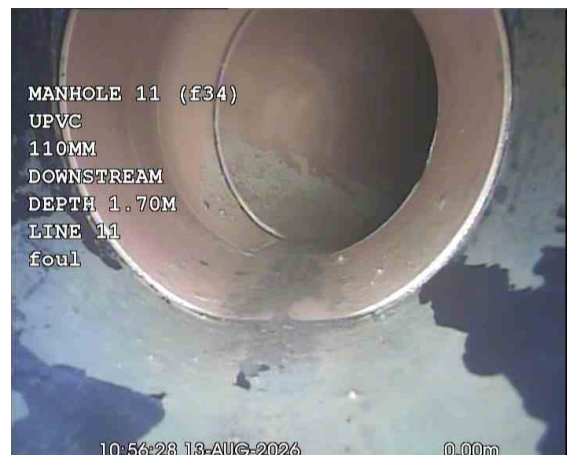
MH11  
(F34)X\_136808cb-5ccc-4bae-9277-86e9c56e0d3a\_20260917\_163848\_292.jpg, 00:00:31, 0.00 m  
Water level, 0% of the vertical dimension

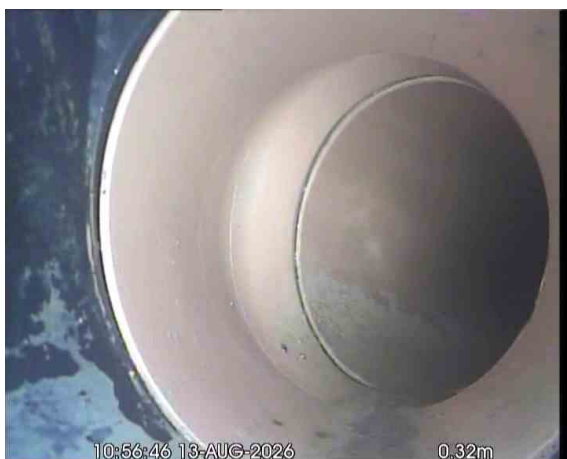
MH11  
(F34)X\_5ef1f7c6-ea67-4b36-998e-debf4a3d4f3e\_20260917\_163906\_805.jpg, 00:00:49, 0.32 m  
Line deviates right

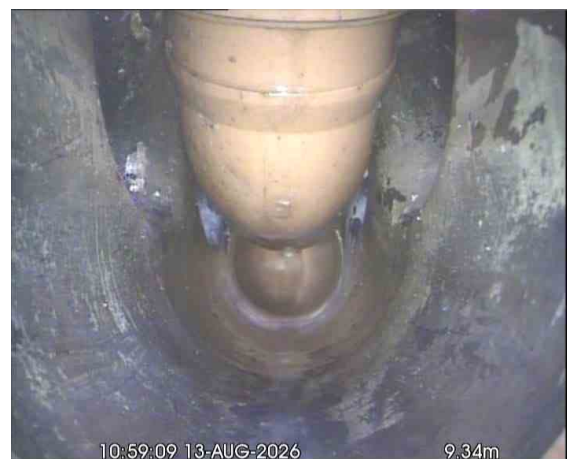
MH11  
(F34)X\_2c3b0f7a-188f-4f48-b23e-ffca18901513\_20260917\_163929\_591.jpg, 00:03:12, 9.34 m  
Finish node, manhole, reference: MANHOLE 12 (MH12), (F35)

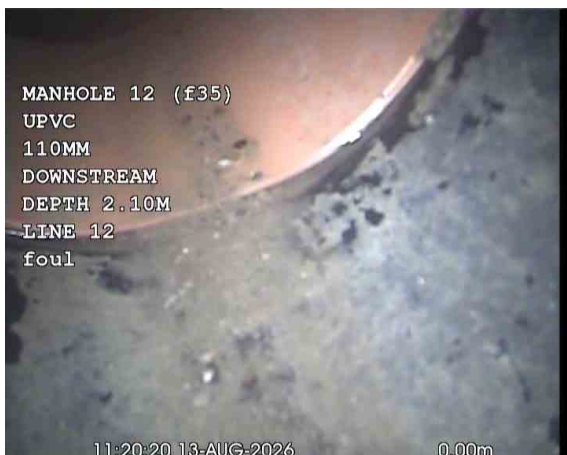
MH12  
(F35)X\_65c4e705-f367-41ad-a17c-f5910dea6bd0\_20260917\_165107\_059.jpg, 00:00:50, 0.00 m  
Start node, manhole, reference: MANHOLE 12 (MH12), (F35)

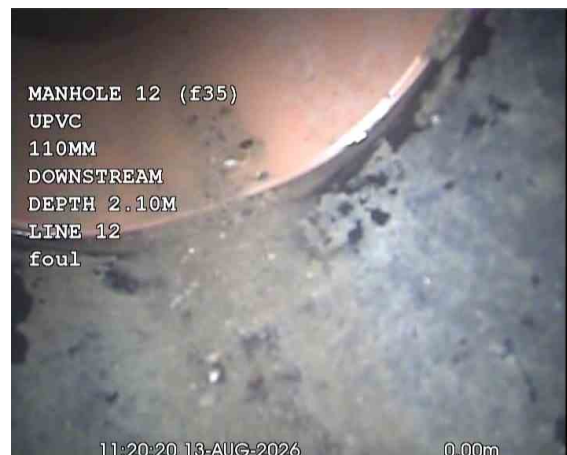
MH12  
(F35)X\_327e1128-c05e-4ce9-a1c1-64d9b2cac9c2\_20260917\_165113\_019.jpg, 00:00:50, 0.00 m  
Water level, 0% of the vertical dimension

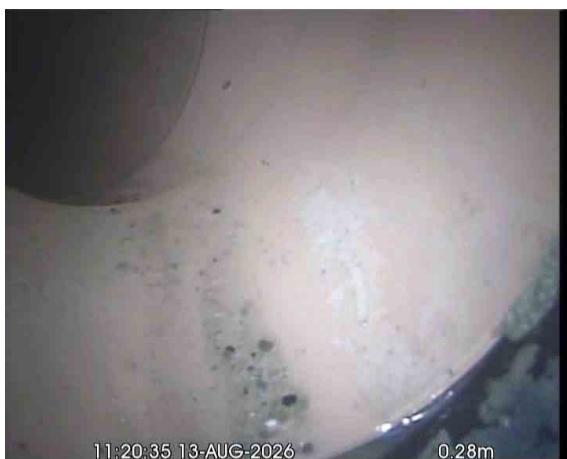
MH12  
(F35)X\_4e2e42c5-9a6c-4f90-afbd-c80d628e3121\_20260917\_165124\_557.jpg, 00:01:05, 0.28 m  
Line deviates left

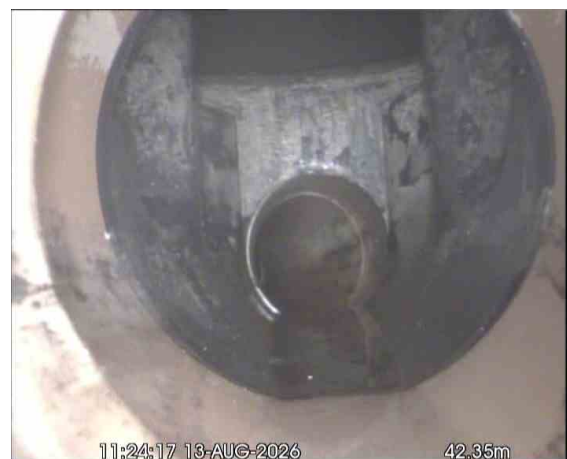
MH12  
(F35)X\_76902c83-d27e-4e16-98a6-616105d60454\_20260917\_165241\_666.jpg, 00:04:47, 42.35 m  
Size changes, new size(s), 150mm high

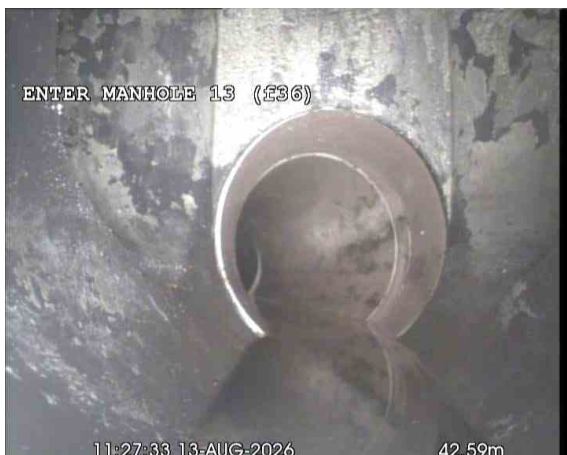
MH12  
(F35)X\_2b49fbef-b497-449d-b358-a987b8e1c597\_20260917  
\_165158\_583.jpg, 00:05:43, 42.59 m  
Finish node, manhole, reference: MANHOLE 13 (MH13), (F36)

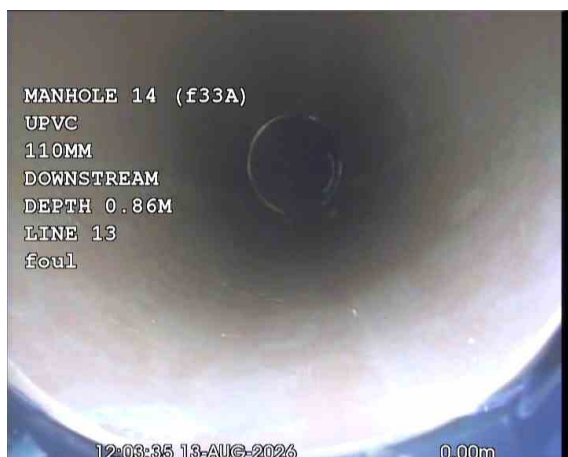
MH14  
(F33AX\_c128a3d8-e5f8-48ef-931e-8feba2648af1\_20260917\_165344\_759.jpg, 00:00:34, 0.00 m  
Start node, manhole, reference: MANHOLE 14 (MH14), (F33A)

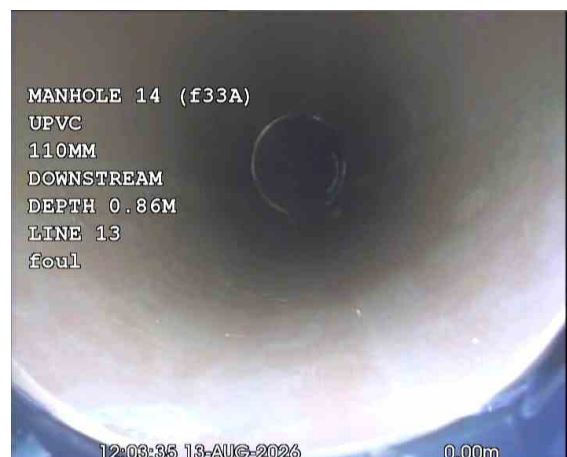
MH14  
(F33AX\_2c50aafe-6bcb-4f6c-a860-c40fdadf5679\_20260917\_165350\_778.jpg, 00:00:34, 0.00 m  
Water level, 0% of the vertical dimension

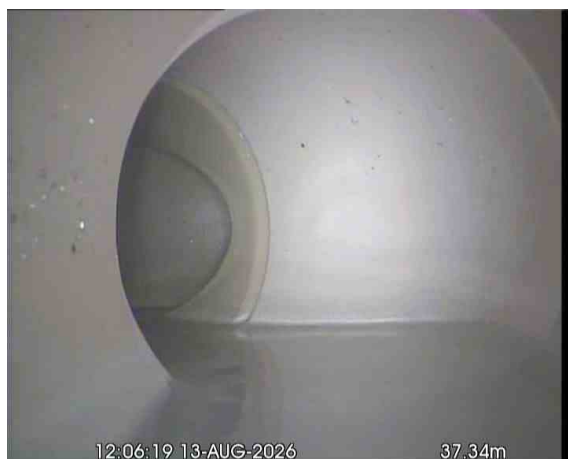
MH14  
(F33AX\_b46a8a86-547b-4291-951b-af5988893b71\_20260917\_165430\_683.jpg, 00:03:18, 37.34 m  
Line deviates left

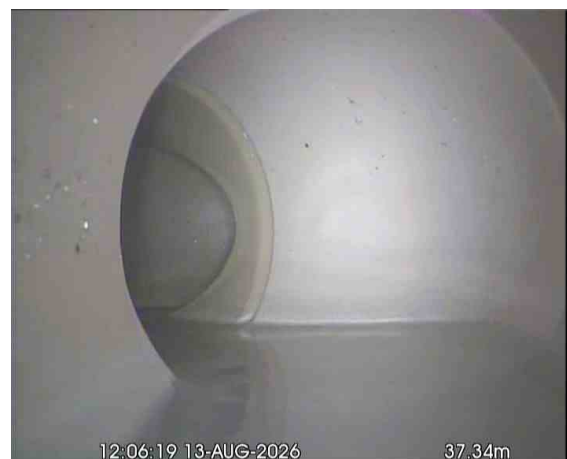
MH14  
(F33AX\_c8caa492-caf9-4867-bdec-ade6c186e3d0\_20260917\_165438\_125.jpg, 00:03:18, 37.34 m  
Water level, 10% of the vertical dimension

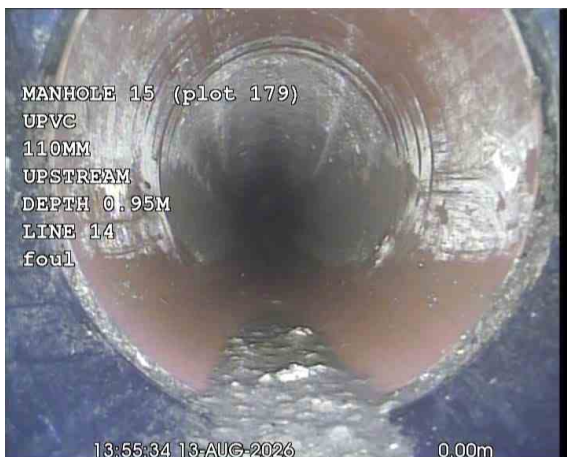
SVPX\_b177d65f-3e32-4885-93b1-34f03347b9b5\_20260917\_165723\_780.jpg, 00:00:31, 0.00 m  
Start node, manhole, reference: MANHOLE 15 (MH15)

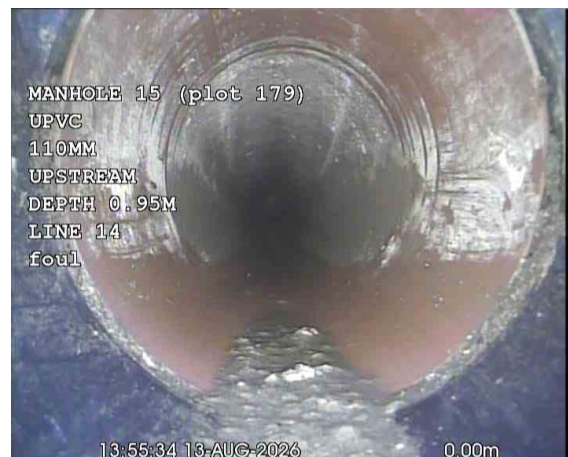
SVPX\_494f5175-2b96-4cad-a9fa-91e1e0b156f8\_20260917\_165729\_693.jpg, 00:00:31, 0.00 m  
Water level, 0% of the vertical dimension

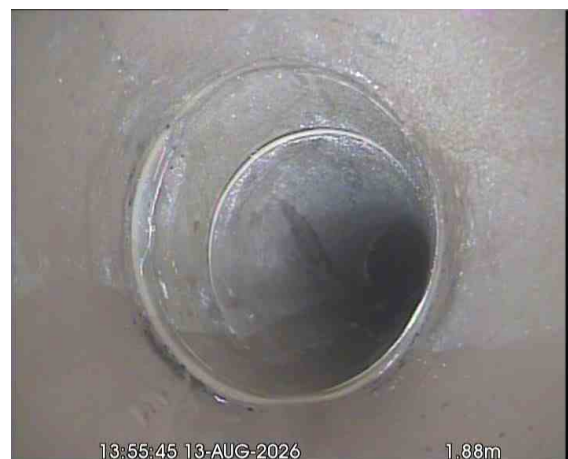
SVPX\_522d8c10-0f75-4268-8945-1182ee759427\_20260917\_165750\_365.jpg, 00:00:41, 1.88 m  
Line deviates right

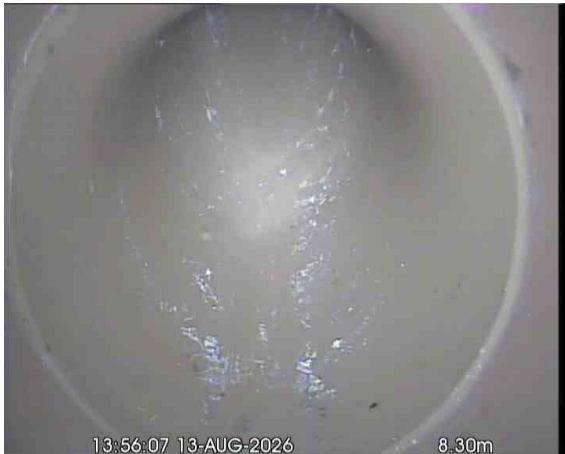
SVPX\_9d28b386-32ca-434f-a99a-b130670ade5b\_20260917\_165803\_576.jpg, 00:01:04, 8.30 m  
Line deviates up, REST BEND

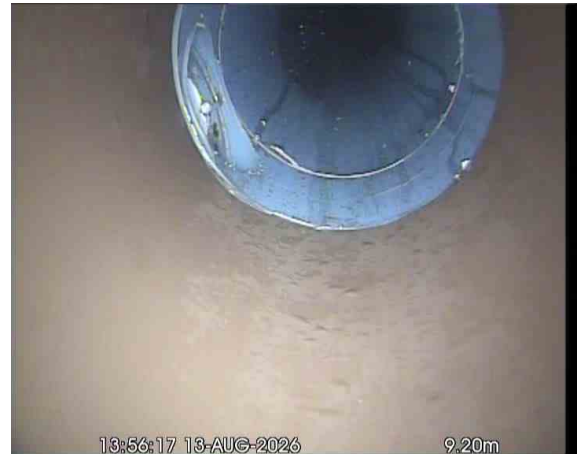
SVPX\_dcc6d24c-69b0-44c0-9e6a-ca820a073452\_20260917\_165828\_107.jpg, 00:01:14, 9.20 m  
Finish node, major connection without manhole, reference:  
SOIL VENT PIPE (SVP) & KITCHEN SINK

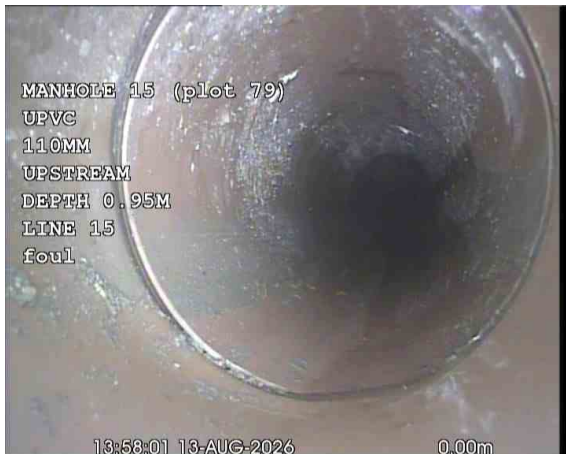
SINKX\_e99ecd11-2a5c-428c-8e05-58eadc530422\_20260917\_165920\_949.jpg, 00:00:18, 0.00 m  
Start node, manhole, reference: MANHOLE 15 (MH15)

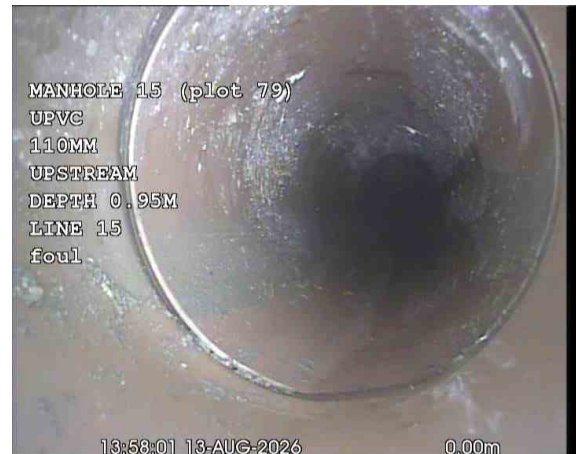
SINKX\_f44c6ad8-8a03-4fc1-aa86-6b80dd88e28b\_20260917\_165926\_730.jpg, 00:00:18, 0.00 m  
Water level, 0% of the vertical dimension

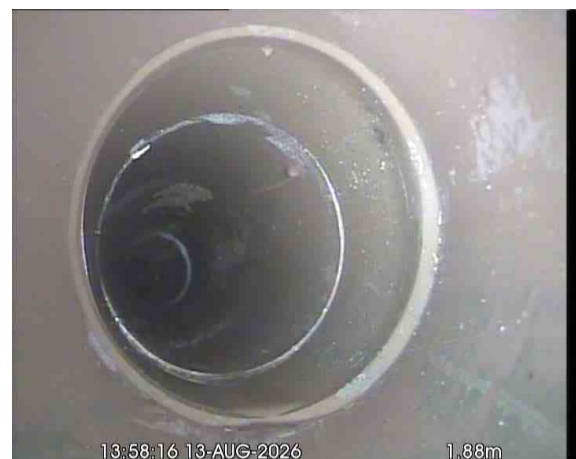
SINKX\_9242fc08-5646-4e53-93ad-5e3e9793315b\_20260917\_165949\_924.jpg, 00:00:33, 1.88 m  
Line deviates left

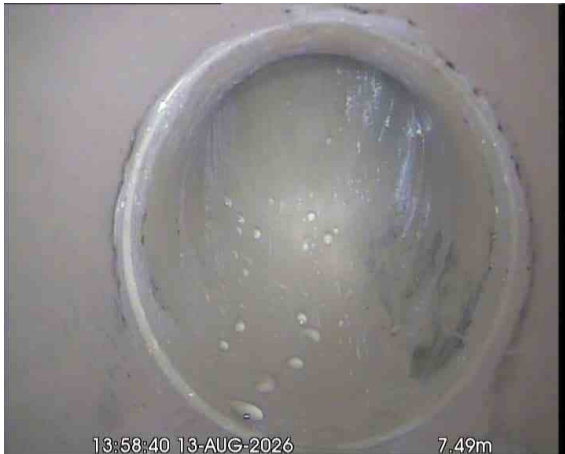
UTIL.  
SINKX\_5626fec3-1c3c-4485-a61d-6a0c0dc85c02\_20260917\_170008\_894.jpg, 00:00:57, 7.49 m  
Line deviates up, REST BEND

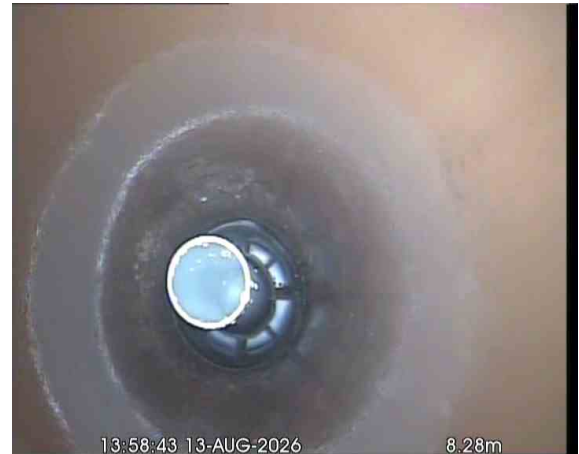
UTIL.  
SINKX\_71ab30d1-153f-4a48-acd6-95216f9ec830\_20260917\_170024\_769.jpg, 00:01:00, 8.28 m  
Finish node, major connection without manhole, reference:  
UTILITY SINK

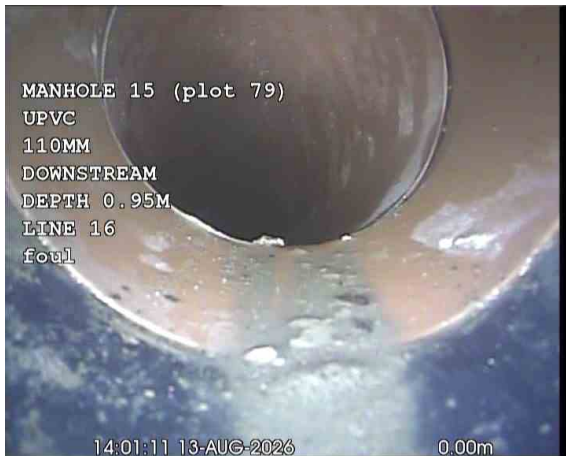
MH15X\_63ecdd8e-6071-4a89-9ccf-77f62818ab1b\_20260917\_170120\_156.jpg, 00:00:23, 0.00 m  
Start node, manhole, reference: MANHOLE 15 (MH15)

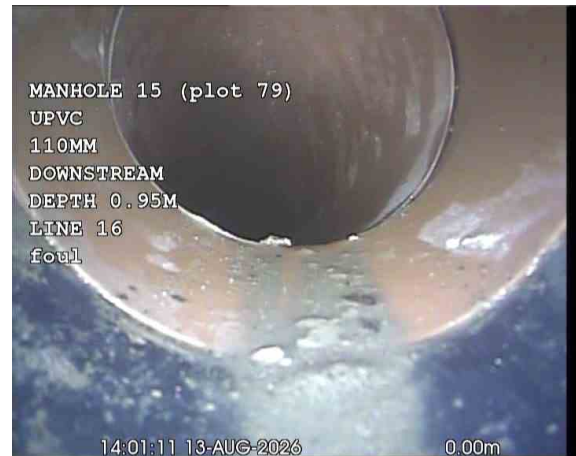
MH15X\_13dafcd0-1061-4afb-8137-8211d73f61b7\_20260917\_170125\_581.jpg, 00:00:23, 0.00 m  
Water level, 0% of the vertical dimension

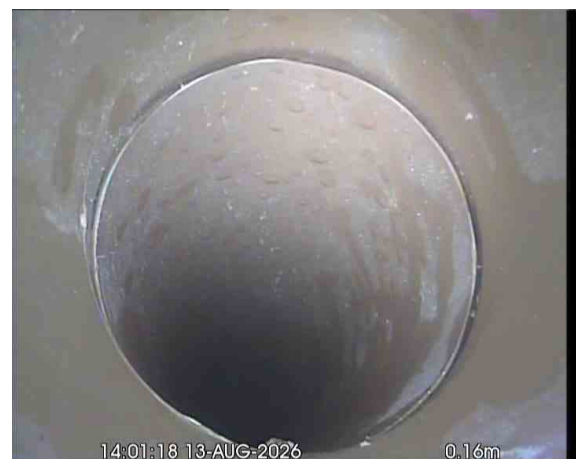
MH15X\_44809b83-cdf5-49f5-81d1-d98588b7e15e\_20260917\_170146\_168.jpg, 00:00:31, 0.16 m  
Line deviates down

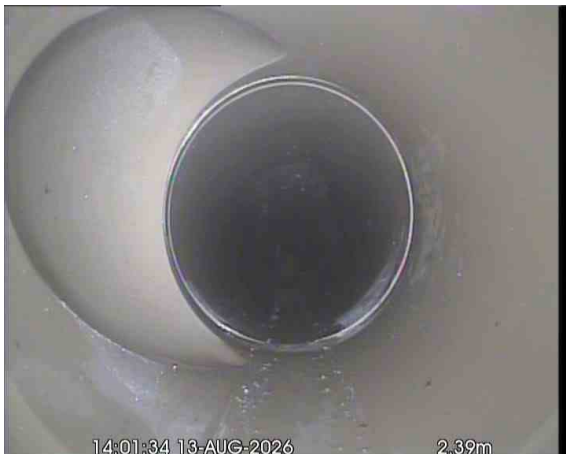
MH15X\_5f45bb79-bc8c-4ba4-a2ae-7eff7c7fb217\_20260917\_170239\_300.jpg, 00:00:46, 2.39 m  
Junction at 9 o'clock, diameter: 110mm, SECTION 22 (S22)

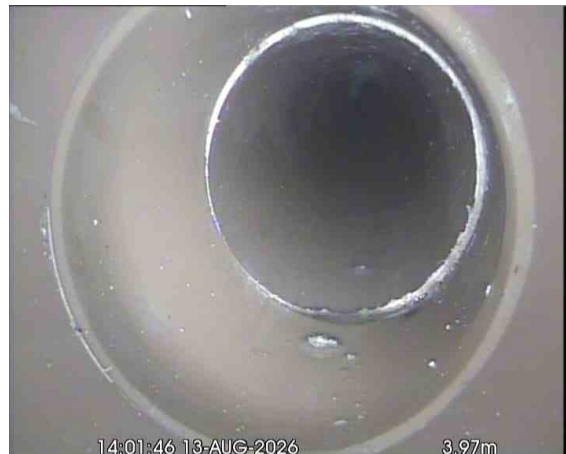
MH15X\_87962072-6ce7-428c-a931-a891d0940a54\_20260917\_170250\_140.jpg, 00:00:59, 3.97 m  
Line deviates up
